CONCRETE BRIDGE SURVIVES CRASH TO RISE AGAIN

After a backhoe ripped through the Hays, Kansas, bridge, the damaged span was repaired with cast-in-place concrete to reopen the roadway in just six months

HALL STREET BRIDGE / HAYS, KANSAS

BOX GIRDER BRIDGE/KANSAS DOT, OWNER

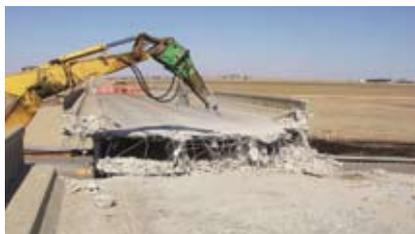
Kansas DOT crews moved quickly to prop up the damaged bridge in Hays, Kansas. The central column of the bridge, which spans I-70 near the west-central Kansas town, was undamaged by the impact with the backhoe.

piers. Within hours, KDOT supplied Super Props to stabilize the damaged bridge. The four Super Props were installed under each web to support the weight of the now almost suspended portion of the superstructure so that the backhoe could be removed.

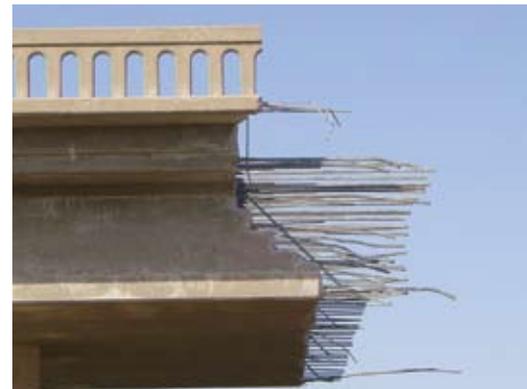
Demolition crews left 3 ft or more of reinforcement exposed to allow splicing of new reinforcement.

It was decided to replace the section using the same construction as the original structure rather than try to widen the bridge during this rapid replacement project. This required casting a three-cell concrete box. To tie the new section into the existing construction, the demolition crew left 3 ft or more of the existing reinforcing bars exposed on either side of the opening. This exposed reinforcement was then lap-spliced with Grade 60 uncoated steel reinforcement. A new box-girder section then was cast in place.

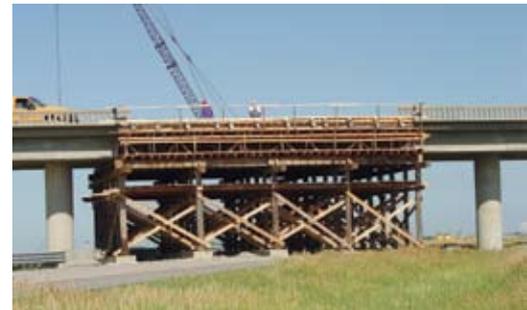
Scaffolding supported the forms while a new concrete box girder was cast to replace the missing damaged bridge section.

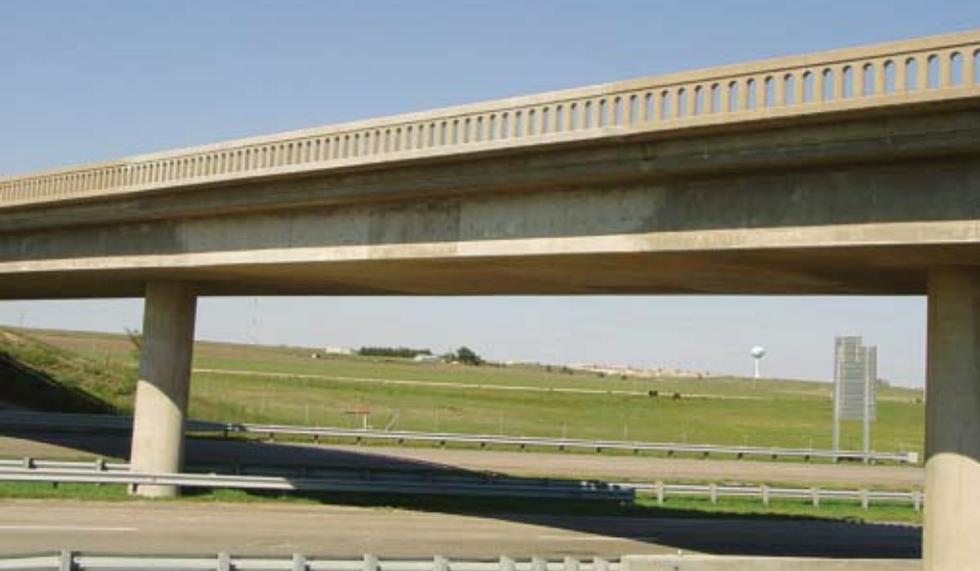
The new section of the Hays bridge is nearly indistinguishable from the original portions of the structure. The bridge was reopened to traffic in less than six months after the accident.
