Longitudinal Cracks in the Webs of Precast, Prestressed Concrete Girders: To Repair or not to Repair?

by Steve Seguirant,
Concrete Technology Corporation

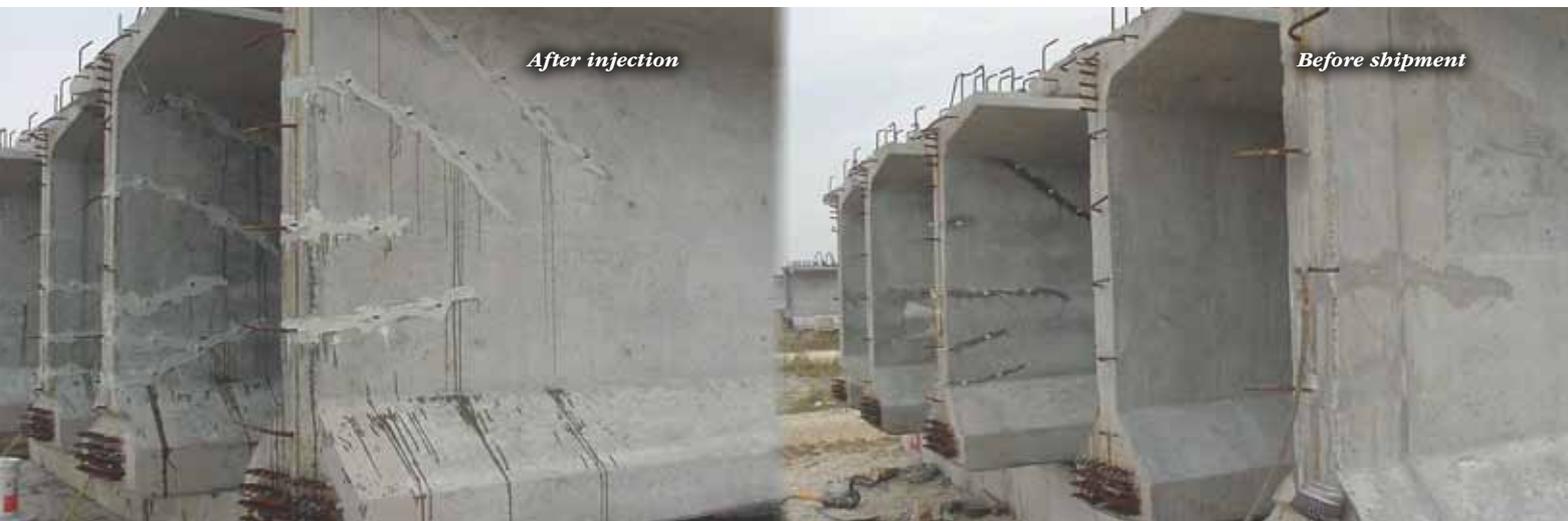
Cracks ranging in width from 0.025 in. to 0.05 in. should be filled by epoxy injection. Photos: Mobsen Shabawy, SDS Engineering Consultants Inc., Tallahassee, Fla.

- Cracks narrower than 0.012 in. may be left unrepaired.
- Cracks ranging in width from 0.012 in. to 0.025 in. should be repaired by filling the cracks with approved specialty cementitious materials, and coating the end 4 ft of the girder web side faces with an approved sealant.
- Cracks ranging in width from 0.025 in. to 0.05 in. should be filled by epoxy injection and the end 4 ft of the girder web coated with a sealant.
- For girder webs exhibiting cracks wider than 0.05 in., the research team recommends that the girders be rejected unless shown by detailed analysis that structural capacity and long-term durability are sufficient.
