## Plymouth Avenue Bridge

by Jason Caravello, Dywidag Systems International USA Inc.

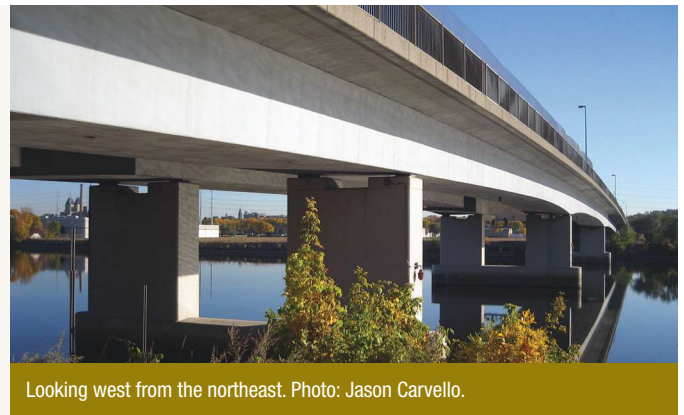
Looking west from the northeast. Photo: Jason Caravello.
