RAPID RISE FROM THE ASHES

GDOT's team rebuilds I-85 segment in 44 days using precast concrete bulb tees after devastating fire destroys three spans in both northbound and southbound directions

INTERSTATE 85 BRIDGE OVER PIEDMONT ROAD / ATLANTA, GEORGIA

BRIDGE DESCRIPTION: Replacement of three spans both northbound and southbound (six in all) of the 4150-ft viaduct of Interstate 85 over Piedmont Road following fire

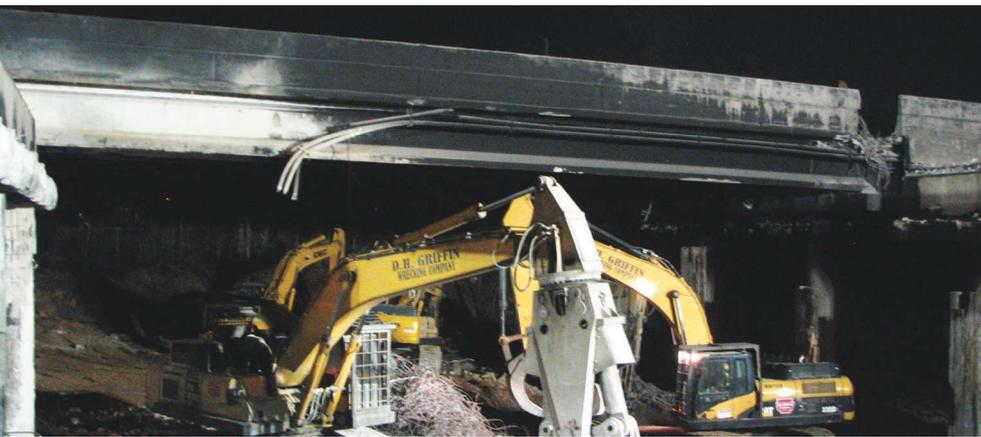
The heat of the fire caused enough damage to the concrete and prestressing strands that the bridge collapsed. It also caused significant damage to the intermediate bents supporting that span and those spans directly north and south. The concrete bents experienced loss of concrete cover, buckling of column reinforcement, and significant cap damage. GDOT bridge inspectors later found extensive delamination and

Evaluations found that three spans in each direction needed to be replaced as well as four bents, with round columns and inverted-tee bent caps. Demolition of the spans began immediately. All Photos: Georgia Department of Transportation.

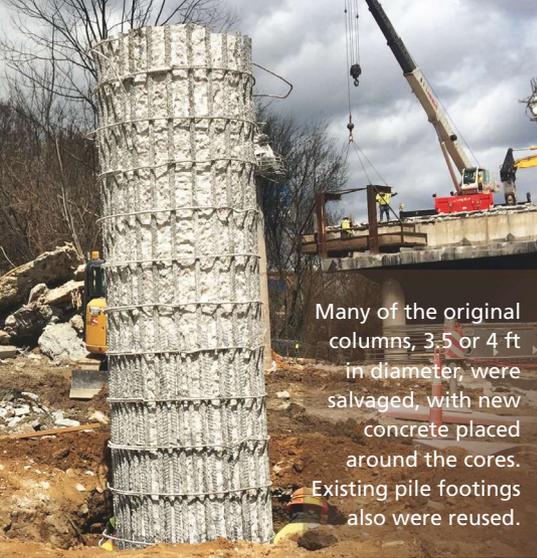
Many of the original columns, 3.5 or 4 ft in diameter, were salvaged, with new concrete placed around the cores. Existing pile footings also were reused.

The existing spans were demolished in tight quarters, crushed, and cleared from the site. Crews used small pneumatic hammers to expose the concrete column cores and footings on all columns. The original columns were 3.5 or 4 ft in diameter and many of them could be salvaged, with new concrete placed
