Protecting Against FIRE

Concrete can help bridges resist a blaze's high heat and return quickly to service

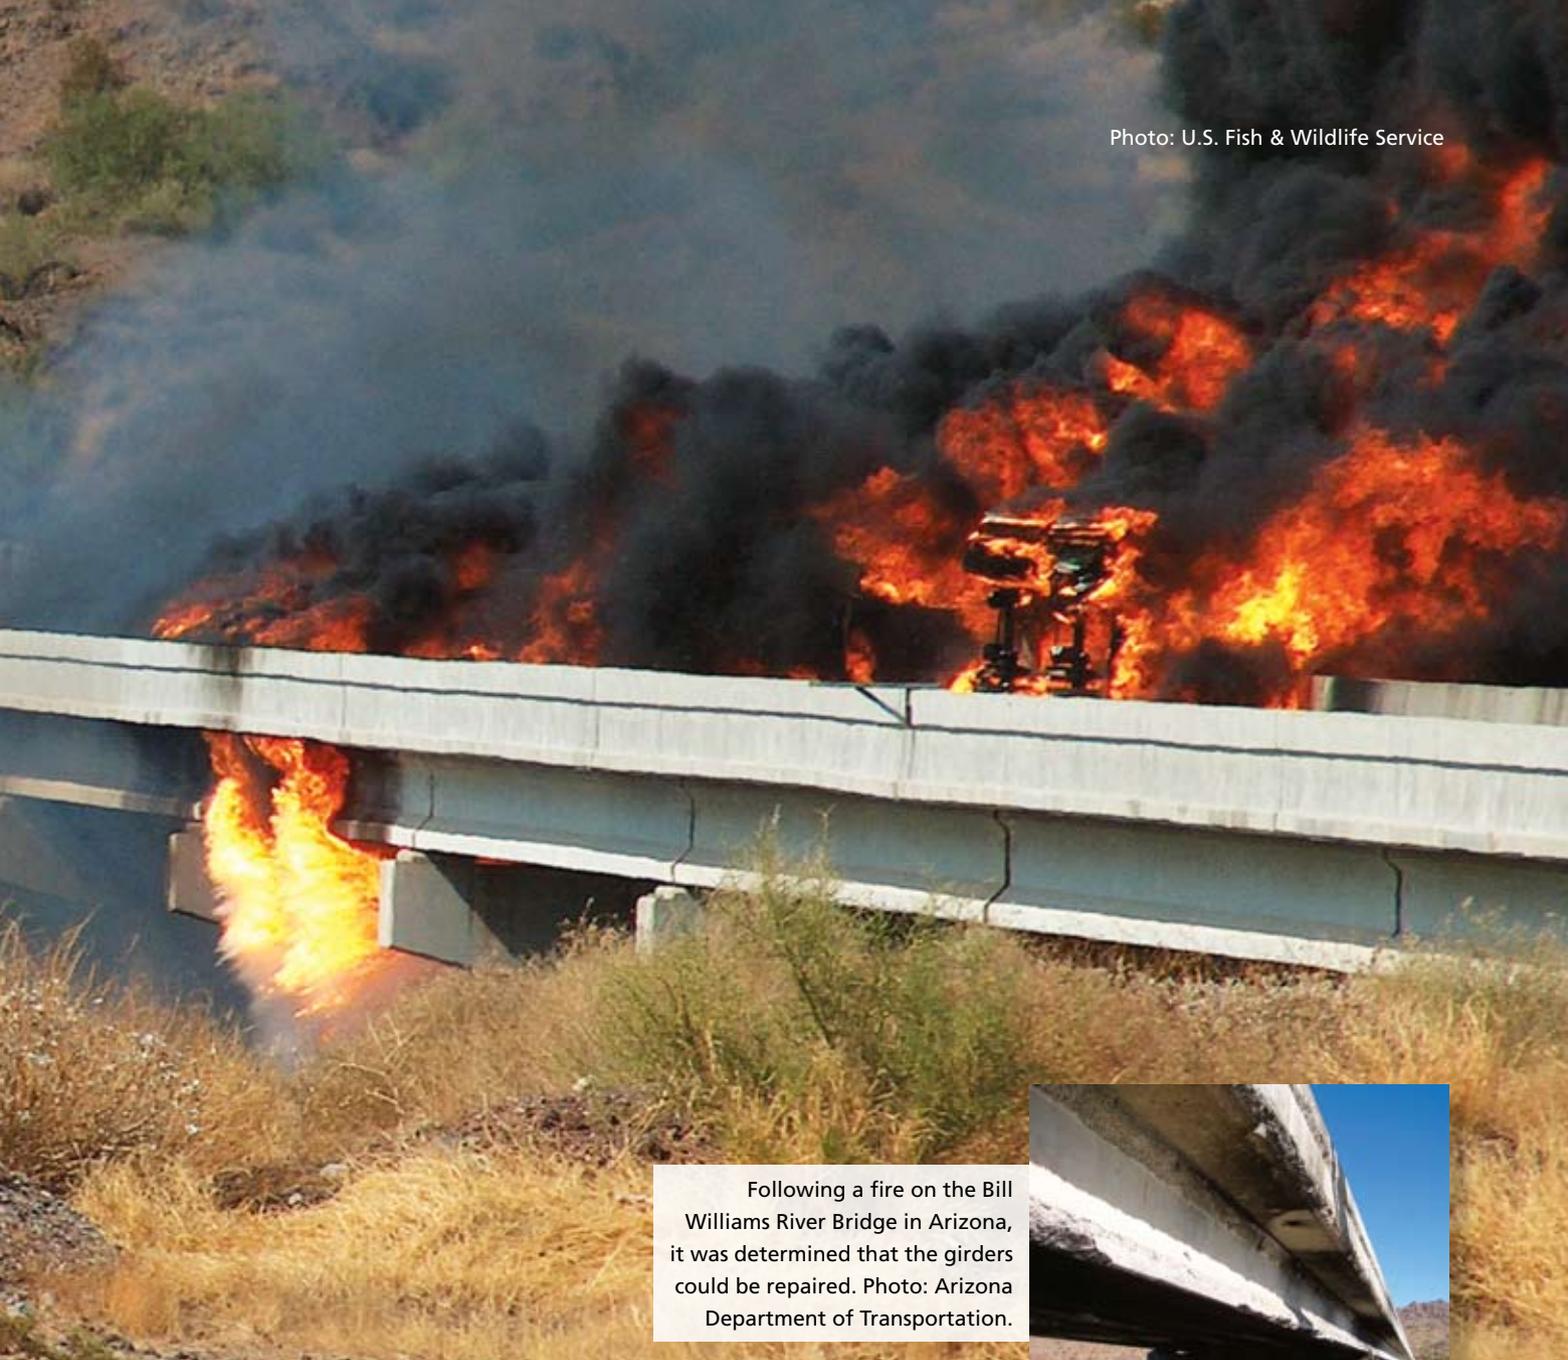
Following a fire on the Bill Williams River Bridge in Arizona, it was determined that the girders could be repaired. Photo: Arizona Department of Transportation.

The tanker spilled approximately 7600 gallons of diesel fuel onto and under the bridge, which then ignited and burned on the bridge's AASHTO Type III precast, prestressed concrete girders and composite reinforced concrete deck. The fire-damaged girders did not show visible signs of loss of prestress but experienced varying degrees of spalling. A reduced

girder section was rated for flexure and shear and compared to a prefire condition. It was determined that the fire resulted in a 6 percent reduction in the bridge load rating for the short term and a 12 percent reduction for the long term. Based on these results, and following a study of multiple alternatives, it was determined that the girders could be repaired. Both lanes on the bridge have remained open to traffic since the accident.

Their assessment found that the overhang and shoulder in three spans, especially the ninth span, needed to be replaced. "The fuel spilled through the deck drains and expansion joints, spreading the fire under the bridge, and the wind whipped the fire along

Those repairs are still to be scheduled, she notes. The plan is to save as much of the existing reinforcement as possible and rebuild the overhang, repair damage to the girders where reinforcement was exposed and concrete spalled, and add a protective coating to the deck to inhibit corrosion. The bridge also is being monitored to ensure no signs of additional damage arise.

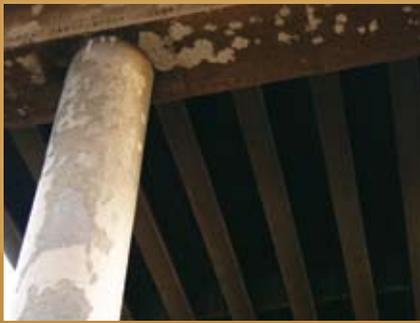
The heat from the Puyallup River Bridge fire was intense enough to cause damage to all 15 lines of girders.

Although flame temperatures at this methanol-fueled tanker fire under the Puyallup River Bridge, Wash., reached 3000 °F, the precast concrete bridge was reopened to traffic the next day.

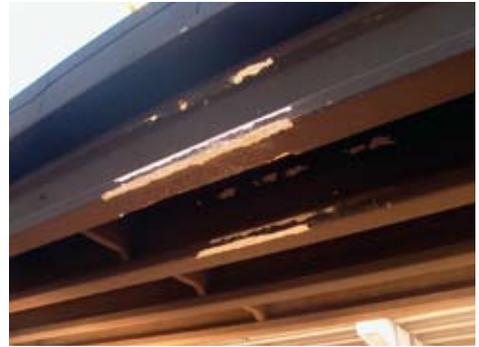
"There was superficial damage that we repaired," explains Walter Peters, Assistant Bridge Engineer for Operations in the Bridge Division of the Oklahoma Department of Transportation. "It was mostly smoke damage and minor spalls."

The blackened beams of the Bell Isle Bridge, Oklahoma City, Okla., were cleaned and the bridge was reopened.
Photo: Oklahoma DOT.

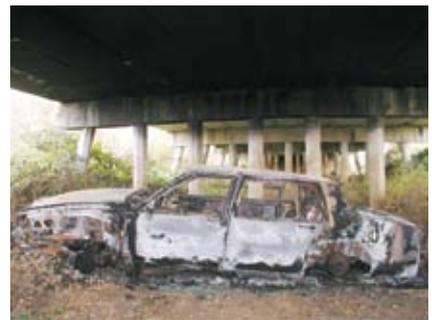
An inspection of the bridge showed that spalling occurred in an approximate area of 2 sq ft and was 1/2- to 3/4-in. deep. In several areas, the concrete also turned pink, indicating it had been exposed to heat of at least 500 °F. Following pressure washing to remove soot, a detailed inspection took place, including hammer tests at various locations.

A blazing car fire caused damage to a bridge in Washington County, Ore., but the affects were minimal and the bridge was reopened to traffic after an inspection.

Although the department considered cleaning and repairing the spalled areas immediately, the damage was determined to be so minor that the bridge instead was put onto the county's accelerated inspection list.

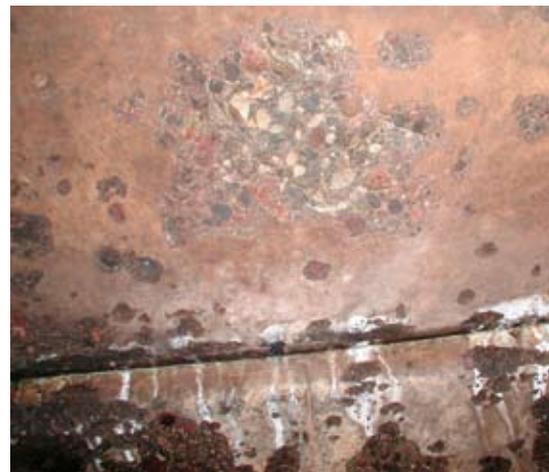
Some spalling and exposed aggregate were noted during the inspection of the Washington County, Ore., fire, but it was not sufficient to require repairs.

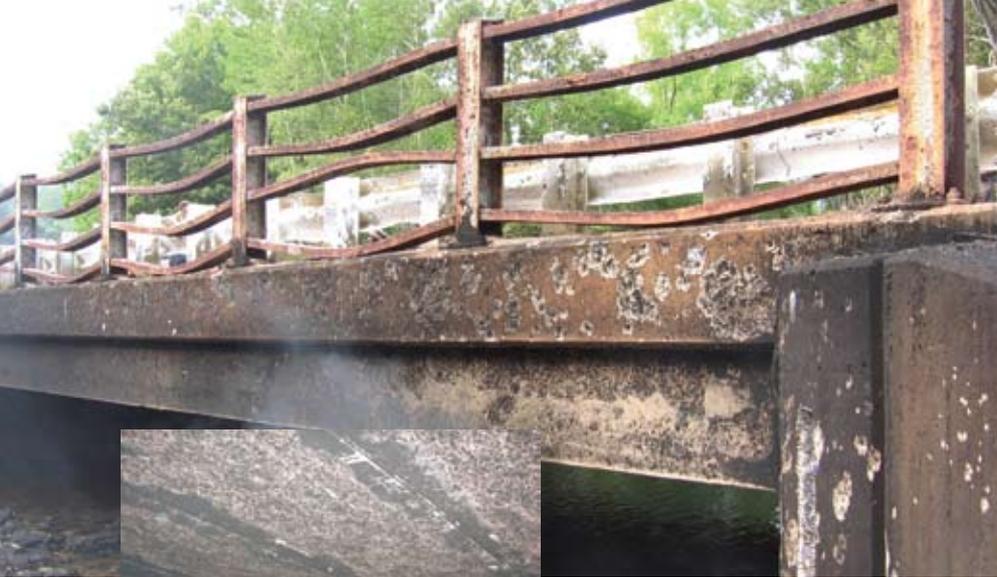
Gasoline that spilled from the tanker-truck accident on the bridge over the Norwalk River caused spalling on the precast concrete but left it in “reasonably good shape,” engineers reported.

The 50-year-old bridge, one of the first precast concrete bridges built in the United States, suffered significant amounts of spalled concrete on its beams, reports Arthur Gruhn, Chief Engineer. Reinforcement was exposed in a number of locations. “We really had no idea how strong the bridge still was,” he says. Despite its age, the bridge had been in good condition, and there had been no plans to replace it.

Two heavy steel support beams were added, one under either edge for the length of the span, and three additional, shorter beams were inserted perpendicular to these at the one-quarter and one-half points. In addition, a Jersey barrier was placed along the damaged bridge railings.

After a tanker truck overturned, caught fire, and burned out on a bridge spanning the Norwalk River near Ridgefield, Conn., engineers decided to resupport the 50-year-old precast concrete bridge with intermediate supports. The bridge reopened to traffic in four days.
