Bridge Deck Replacement and Extending Webs of Precast Concrete Bulb-Tee Girders to New Superelevation

by Dr. Tanarat Potisuk and Craig Shike, Oregon Department of Transportation, and Craig Gries, Oregon State Bridge Construction Inc.

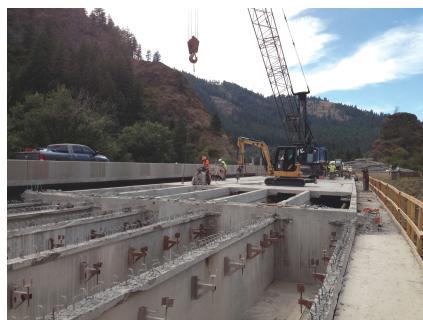
Deck removal operation is shown. The precast concrete flanges were cut with the removal of the existing bridge deck. A jack hammer was used to expose stirrups before they were bent and extended by mechanical couplers. Photo: Oregon Department of Transportation.

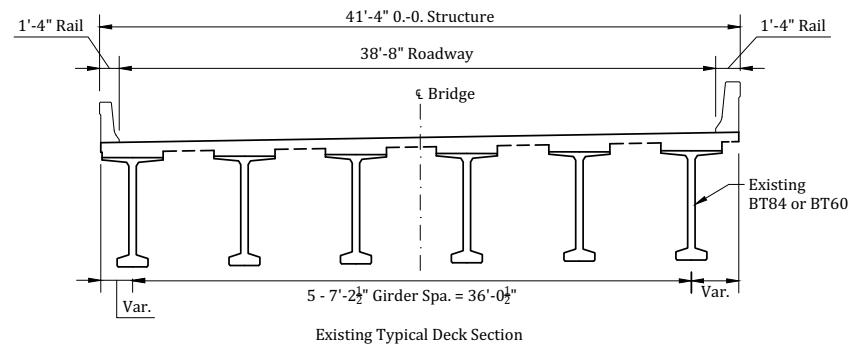
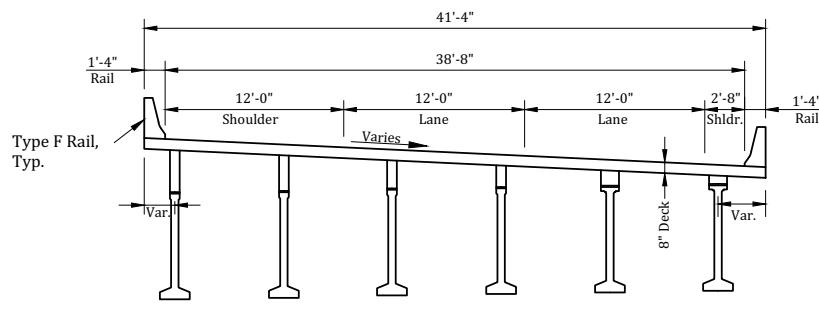
Existing and new typical sections for bridge deck replacement with new superelevation. Figure: Oregon State Bridge Construction and McGee Engineering.

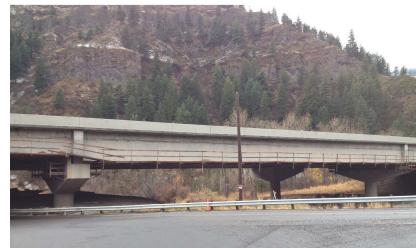
cracks were closed after the new bridge deck was constructed. Near interior bents, cracks in the new extended webs were observed and later injected with epoxy. Skin steel was not adequately provided in these portions.

New bridge deck with extended webs of precast concrete bulb-tee girders. Photo: Oregon Department of Transportation.
