The Franklin Avenue Bridge: Investigation and Rehabilitation Design

by John S. Lawler and Arne P. Johnson, Wiss, Janney, Elstner Associates Inc.; Dan Enser, HNTB; and Paul Backer, Hennepin County Transportation Department

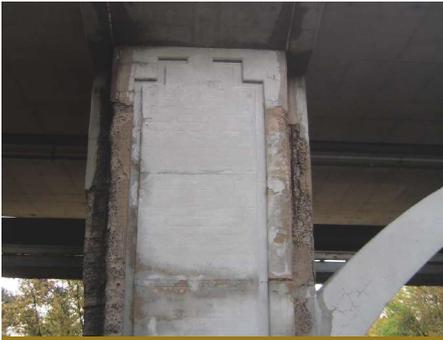
Concrete deterioration and reinforcement corrosion below deck expansion joints. Photo: WJE.

The deterioration in the various bridge elements was largely determined by their exposure to chloride-laden water from deicing salts leaking through expansion joints or by drainage of water onto the concrete surfaces. For example, the deck soffit, cap beams, and some of the spandrel columns located below expansion joints exhibited widespread and sometimes advanced delamination, spalling, and corrosion of embedded reinforcement due to chloride contamination of the concrete; in contrast, elements away from deck joints were in much better condition. High levels of chloride in the deck had also begun to produce corrosion-related damage.

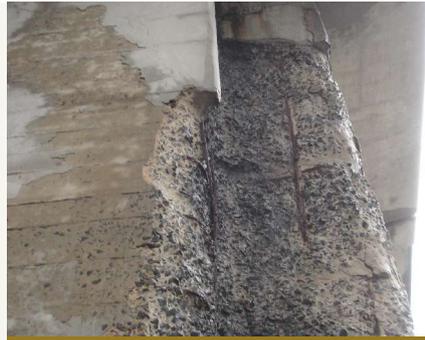
Close-up view of same pier showing loss of concrete cover at pier corner. Photo: WJE.

The assessments identified widespread concrete deterioration in the original concrete piers, abutments, and arch ribs to a depths as great as 22 in. below the surface, as well as longitudinal cracking along the top and bottom surfaces of the arch ribs (generally aligned with the upturned legs of the embedded steel angles). Testing showed that the causes of the deterioration were primarily chloride-related corrosion of the embedded trusses and conventional reinforcement, long-term exposure to moisture, and freezing-and-thawing cycles.

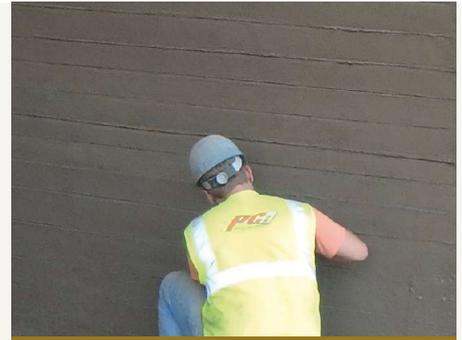
Applying board-form finish to dry-method shotcrete repair on the underside of an arch rib. Photo: HNTB.

In portions of the bridge most visible to the public, the new concrete repairs were specified with a board-form finish to match the original surface texture. The new surface-coating and concrete-repair materials were colored to a light-buff

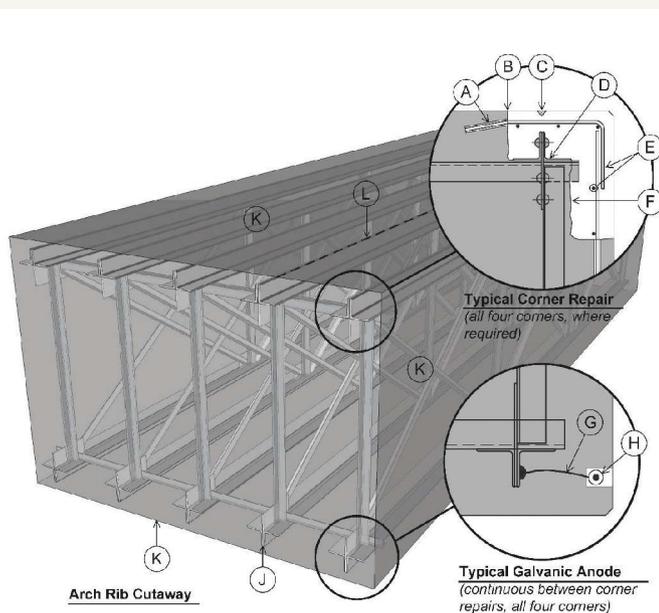
Cutaway view of arch rib showing Melan truss reinforcement and typical concrete repairs. Figure: WJE.

Concrete surface repairs were specified and detailed for all locations where delaminations and spalls were present. The specifications demanded high-quality concrete repair techniques, including perimeter saw cutting, removal to sound concrete using light chipping hammers, substrate preparation via sandblasting, sandblast cleaning and coating of exposed reinforcement, and anchorage using epoxy-grouted bars. The specifications were designed to allow the contractor to choose form-and-pour, form-and-pump, or shotcrete methods with either prepackaged or ready-mixed concrete for each type of repair. The contractor chose prepackaged dry-mix shotcrete for most repairs.

A – epoxy-grouted dowels for anchorage;
 B – saw cuts at repair perimeter;
 C – tooled joint with sealant;
 D – clean and coat existing steel;
 E – crack-control reinforcement;
 F – properly prepared, sound concrete substrate;

G – intermittent slots and wire connections to existing steel;
 H – continuous zinc anode in sawcut slot;
 J – Melan truss reinforcement;
 K – typical surface repairs;
 L – grout and seal crack
