- Model x +
- Engineer's Notebook
 - INSPECTION
 - DEPRESSION NOTE #1
 - SPALL NOTE #1
 - CRACK NOTE #1
 - SPALL NOTE #2
 - CONTRACTOR
 - Folder 3

Ivan.Liu Sunday, February 4, 2018

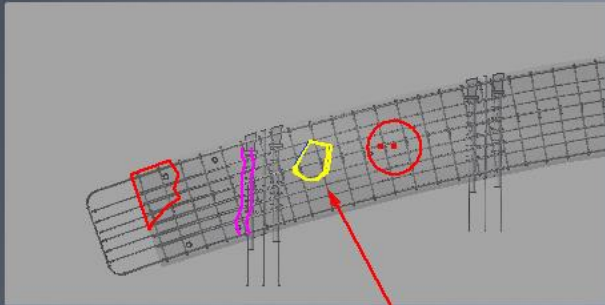
Ivan.Liu Sunday, February 4, 2018
SPALL MADE ON 02/04/2018
USE REPAIR PROCEDURE SikaRepair 222
(SEE PDF BELOW)

DOCUMENT REPAIR PROCEDURE IN WORD DOC BELOW:
