WSDOT Policies and Criteria for Girders Damaged in Service

by Dr. Bijan Khaleghi, Washington State Department of Transportation

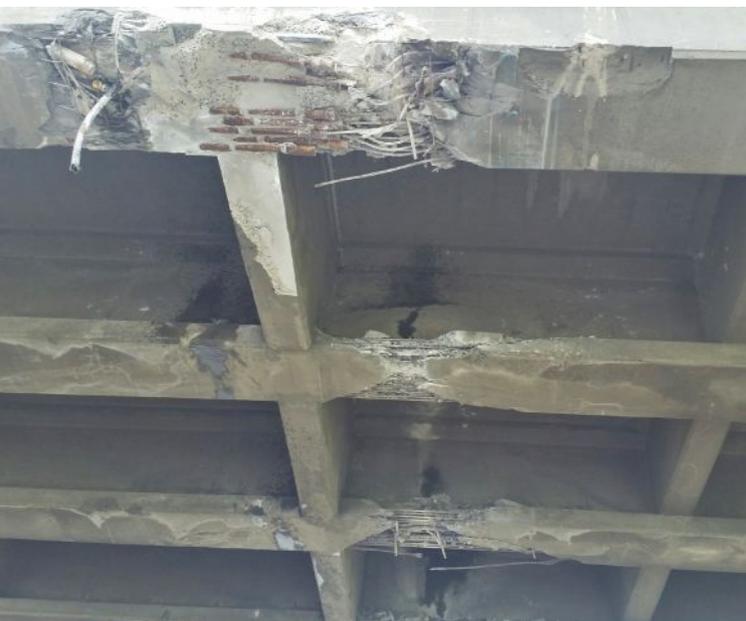
Girder damage due to overheight collisions is relatively common in Washington state. **Figure 1** shows an example of the damage to the Interstate 5 (I-5) Chamber Way overpass bridge caused when a semitruck hauling a pair of excavators hit a portion of the bridge spanning southbound I-5 in Chehalis on July 22, 2016. The existing Chamber Way overpass was built in 1958 with a vertical clearance of only 14 ft 8 in. Though this clearance is adequate for the 14-ft-maximum vehicle height allowed without a permit, it does not meet the modern design standard of 16 ft 6 in. that is required for new construction highway crossings in Washington. Before the 2016 incident, this bridge had been damaged and repaired with strand splice anchors, as shown in **Fig. 2**. As a

Figure 1: In July 2016, a collision by an overheight vehicle damaged the prestressed concrete girder bridge over southbound Interstate 5 at Chamber Way in Chehalis, Wash. All Photos: Washington State Department of Transportation.

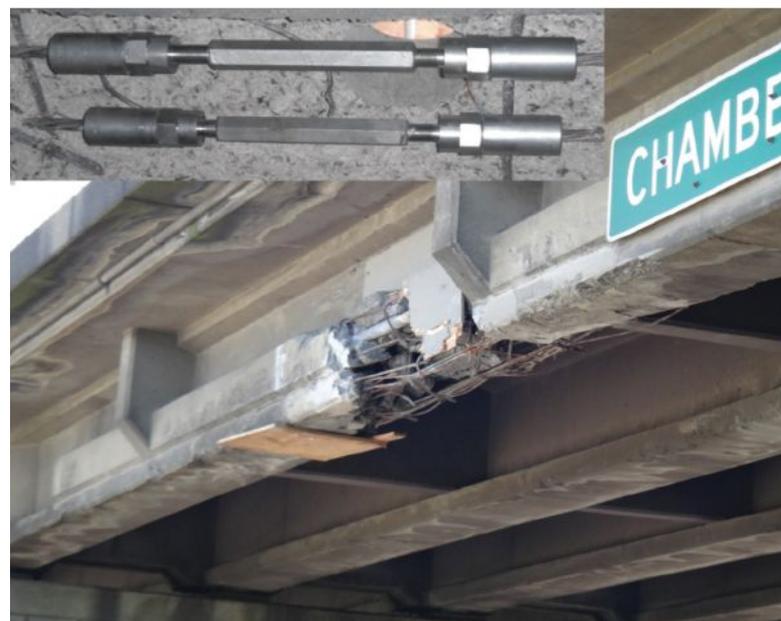
Figure 2: Before the 2016 collision, the same bridge had been damaged at the same location. The severed prestressing strands were repaired using strand splices (shown in inset photo and visible in the first girder in Fig. 1).

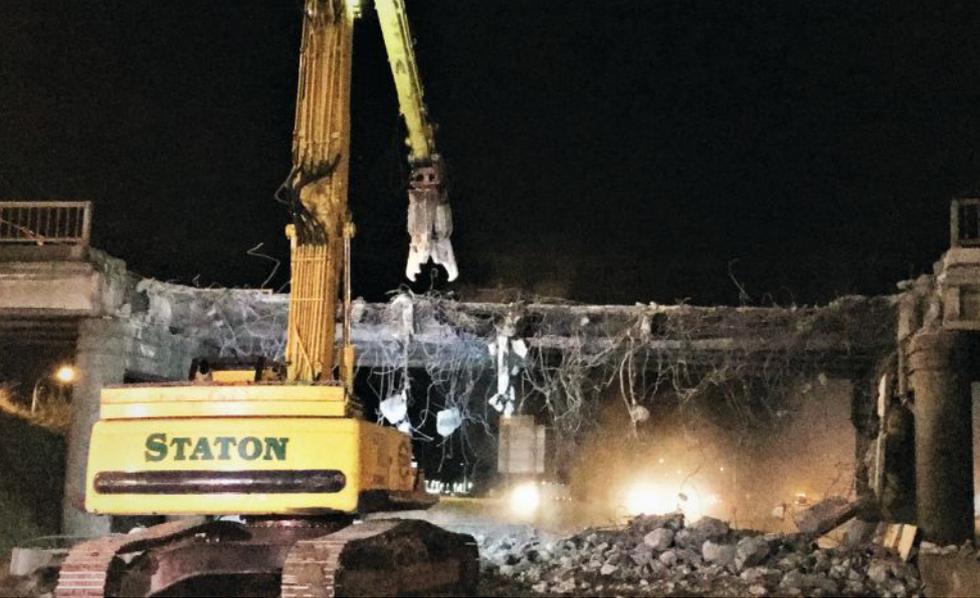
result of the significant structural damage incurred in 2016, WSDOT demolished the damaged span in its entirety (**Fig. 3**) and installed a temporary bridge until the replacement span could be constructed.

Figure 3: Because significant structural damage was incurred during the 2016 collision, the Washington State Department of Transportation demolished the damaged span in its entirety and installed a temporary bridge until the replacement span could be constructed.
