Successful Collaboration and Stewardship Preserve Prestressed Concrete Bridge

by Susan M. Kovich, Nicholls Kovich Engineering PLLC

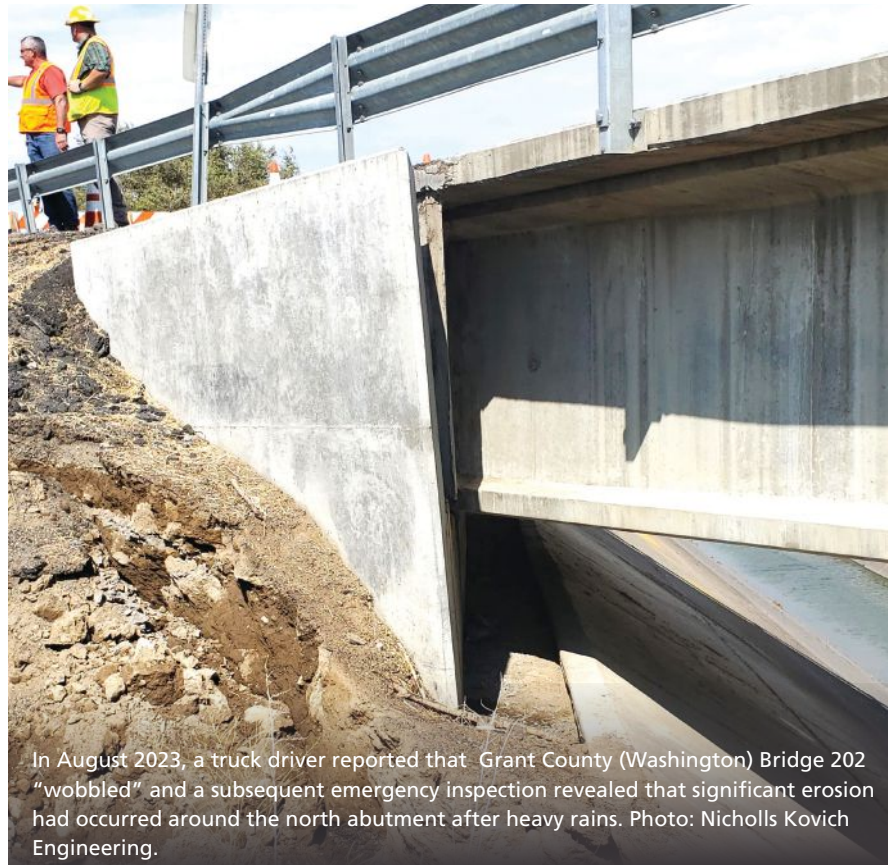
The emergency inspection identified severe erosion around the northwest corner of the bridge, which had resulted in a large void beneath the north abutment footing. The abutment wall exhibited significant vertical cracking and spalling, and one exterior girder had

In August 2023, a truck driver reported that Grant County (Washington) Bridge 202 “wobbled” and a subsequent emergency inspection revealed that significant erosion had occurred around the north abutment after heavy rains. Photo: Nicholls Kovich Engineering.

completely lost bearing support. The void also extended below the concrete-lined canal.

Subsurface exploration confirmed that the original spread footing was founded on erodible silty sand, with competent basalt located 3 ft below the footing elevation. The abutment failure was attributed to a combination of surface runoff, groundwater seepage, and soil erodibility—conditions that led to catastrophic undermining of the abutment.

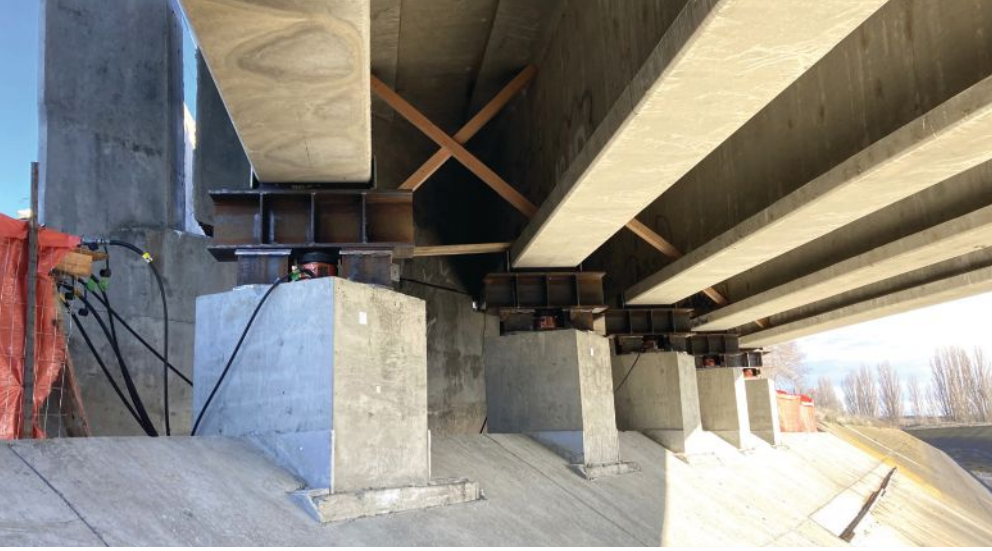
To preserve the bridge superstructure, all five prestressed concrete girders at the north abutment were simultaneously jacked and temporarily supported by cast-in-place concrete shoring columns founded on micropiles. Photo: N. A. Degerstrom Inc.

Extensive excavation was not possible close to the canal. Therefore, to temporarily support the bridge during reconstruction, a micropile-supported shoring system was designed and installed. Workers used a limited-access drill rig to install thirty 3.5-in.-diameter production micropiles and one test pile into the underlying basalt. The micropiles supported a continuous footing, which

in turn supported five cast-in-place concrete shoring columns and steel jacking beams—one positioned beneath each girder. This system temporarily transferred superstructure loads directly to competent bedrock, bypassing the weaker soil zone and facilitating the safe removal of the damaged abutment.

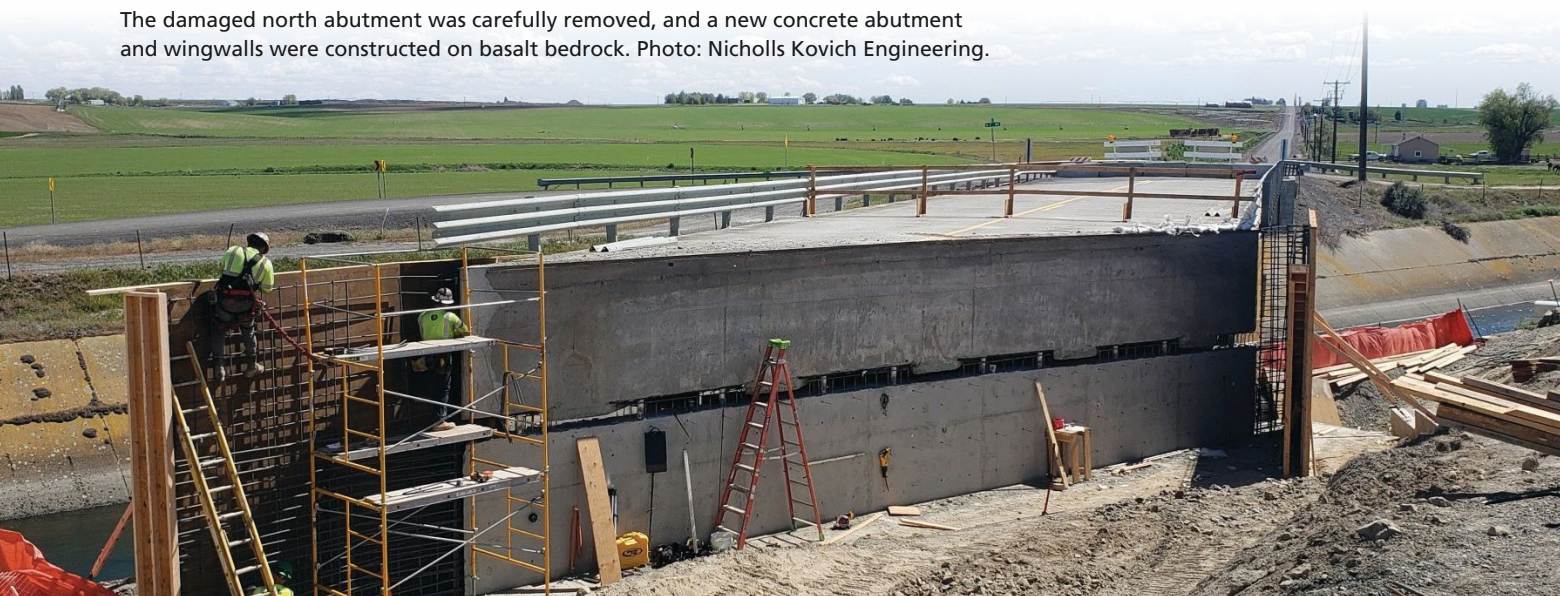
The damaged north abutment was carefully removed, and a new concrete abutment and wingwalls were constructed on basalt bedrock. Photo: Nicholls Kovich Engineering.

Following the successful transfer of load to the temporary support system, crews carefully removed and reconstructed the damaged abutment. A concrete leveling pad was placed directly on basalt to support a new spread footing, improving foundation reliability relative to the original design. The new substructure includes the following:

- 8-ft-wide concrete spread footings with a 6-ft-tall, cantilevered concrete abutment wall
- 13-ft-tall reinforced concrete wingwalls
- A structural earth retaining wall to support the approach embankment

A drainage gallery was incorporated into the design to intercept and convey groundwater and stormwater. This feature reduces the potential for future erosion and hydrostatic pressure buildup behind the abutment, thereby addressing the root cause of the abutment failure. Grant County further supplemented the repair with a stormwater management plan addressing runoff from adjacent roadways and agricultural lands.

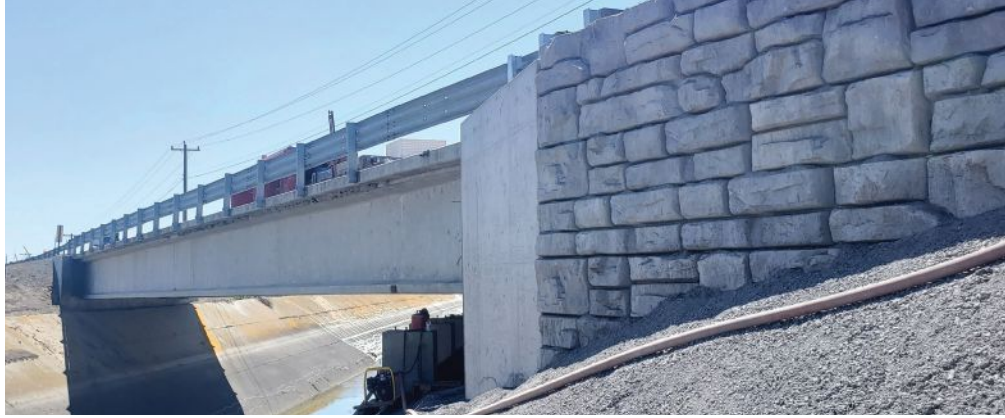
The completed Bridge 202 project illustrates successful concrete bridge stewardship, in which a critical substructure failure offers an opportunity to preserve the existing prestressed concrete girders and extend the bridge's service life. The bridge's projected service life is 50 years from the time of the repair. Photo: Nicholls Kovich Engineering.

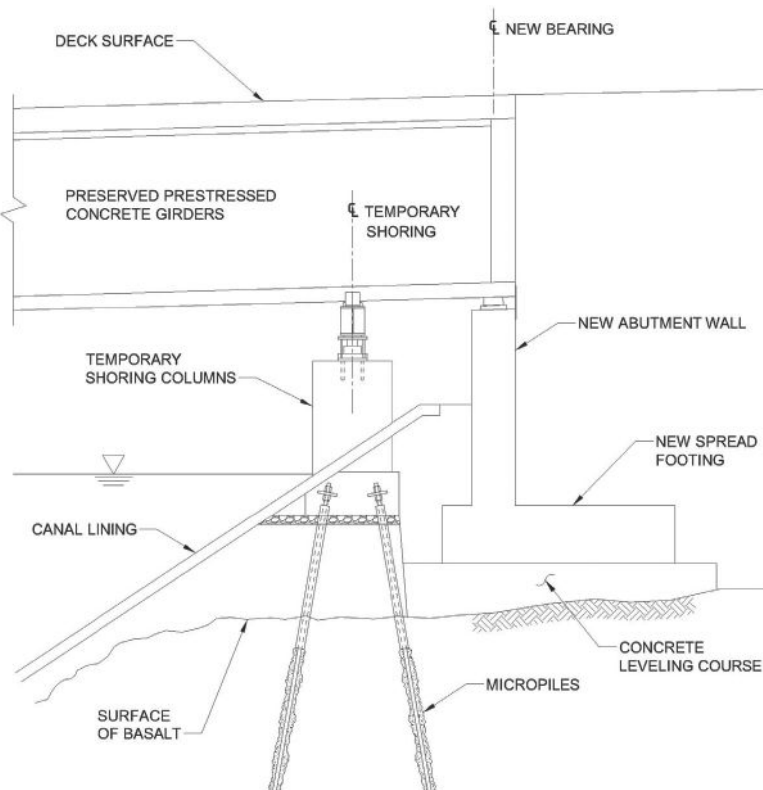
The temporary shoring system and new abutment cross section show the tight physical constraints of the reconstruction adjacent to the irrigation canal. Figure: Nicholls Kovich Engineering.
