## PARTNERSHIP PAYS OFF

Updating the 1932 Minisa Bridge along West 13th Street in Wichita, Kansas, involved a variety of unusual challenges. In essence, the bridge was torn away completely in the rehabilitation work, leaving only the sidewalks and ornamental elements on both sides supported by standalone shoring of steel and wood to provide access for children to their school on the other side. The bridge then was reconstructed beginning in January over a major river. The work not only preserved the historic portions of the bridge but opened less than 6 months later, ahead of schedule.

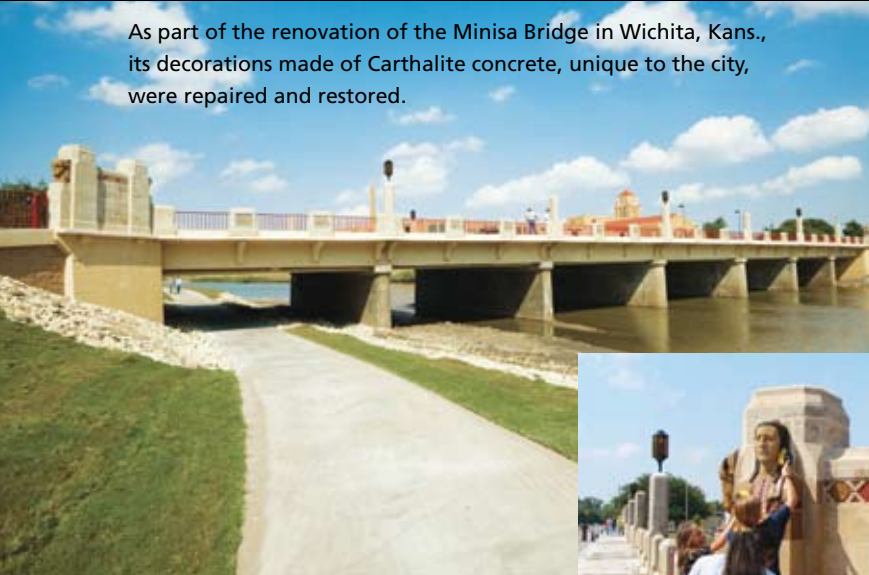
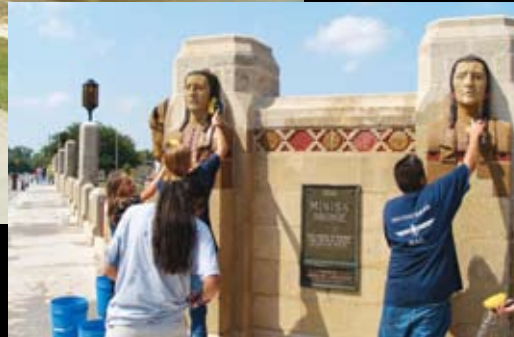
Community residents helping to restore some of the decorative sculptures on the Minisa Bridge.

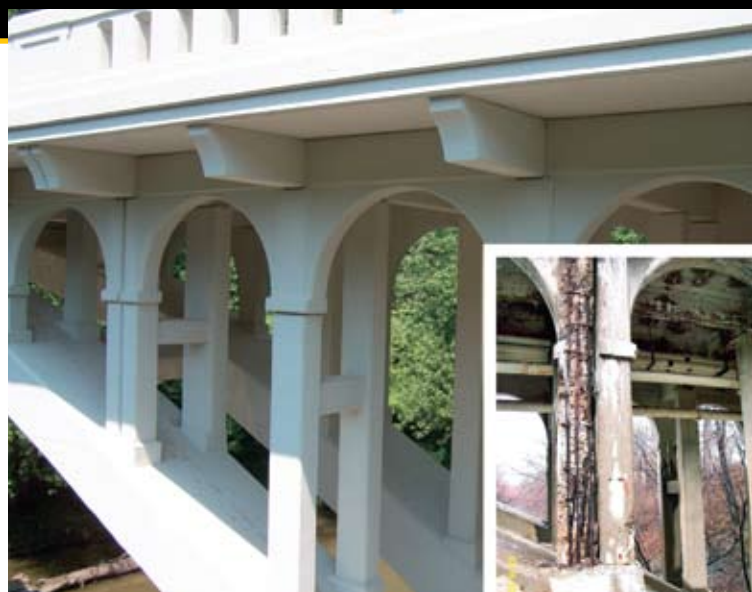
Precast concrete components, including columns and spandrel walls were carefully fabricated to replicate the look of the original concrete pieces replaced on the historic Spring Street Bridge in Floyd and Clark Counties, Ind.

Precast columns were attached to pedestals on the arch ribs with grouted NMB splice sleeves. These sleeves also were used to tie the floor beams to the tops of the columns. The precast spandrel walls were constructed to the same size and shape as the existing ones, as

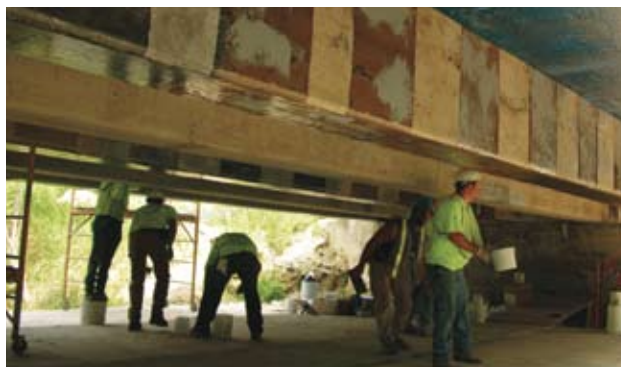
The bridge, built in the 1940s, consists of a 48-ft-long span using six reinforced concrete tee beams. By 2008, the bridge was showing signs of corrosion damage and could not support the loads required for modern truck traffic. PennDOT officials worked with researchers at Penn State University and West Virginia University to evaluate the bridge's condition and investigate repair options.

Repairs to the bridge on State Route 4012 in Pennsylvania, which used carbon-fiber reinforcement and cementitious repair mortar, will serve as the standard by which other bridges will be repaired in the state.

The strengthening system consists of carbon-fiber sheets that are applied to the surface of the concrete structure to restore or increase its strength without changing the dead load. After the extent of the deterioration in the concrete was determined, each area to be addressed was prepared by sandblasting the surface. Then a two-part epoxy coating was applied with a roller. The MBrace sheets, which have the thickness and texture of denim, were cut to size and applied to the affected area. Another layer of epoxy was then added over the sheets.

The repair mortar was applied to damaged concrete areas and to the cross section of the bridge beams where needed. A special corrosion inhibitor also was included in the mix to provide additional protection.
