# Saving A Piece Of History

### ELK AVENUE-DOE RIVER BRIDGE / ELIZABETHTON, TENNESSEE

## Reconstruction of a 1926 reinforced concrete arch bridge

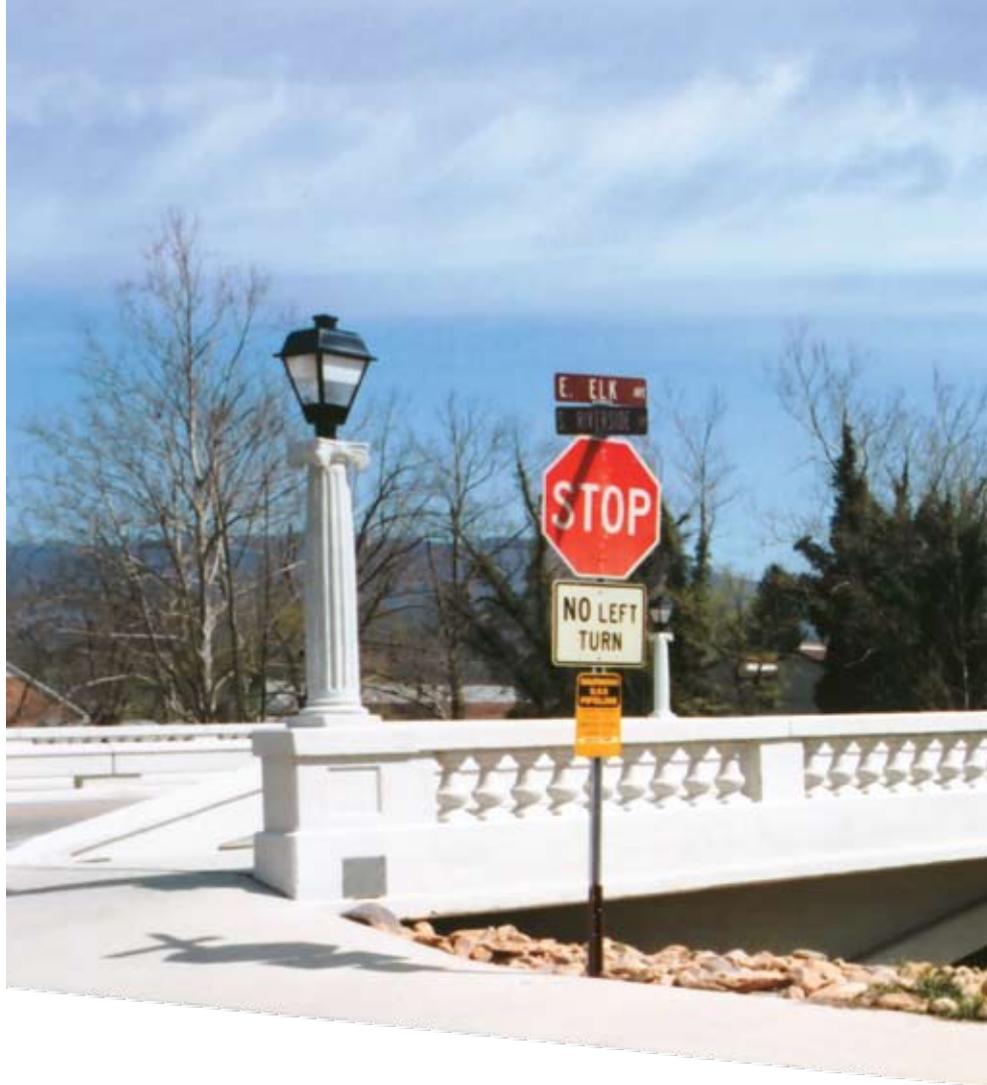
As a result of its restoration,  
the bridge can now carry all  
legal loads. All photos: TDOT

The restoration was completed within 12 months, and the bridge is ready for its second 80 years of service. The bridge can now carry all legal loads.

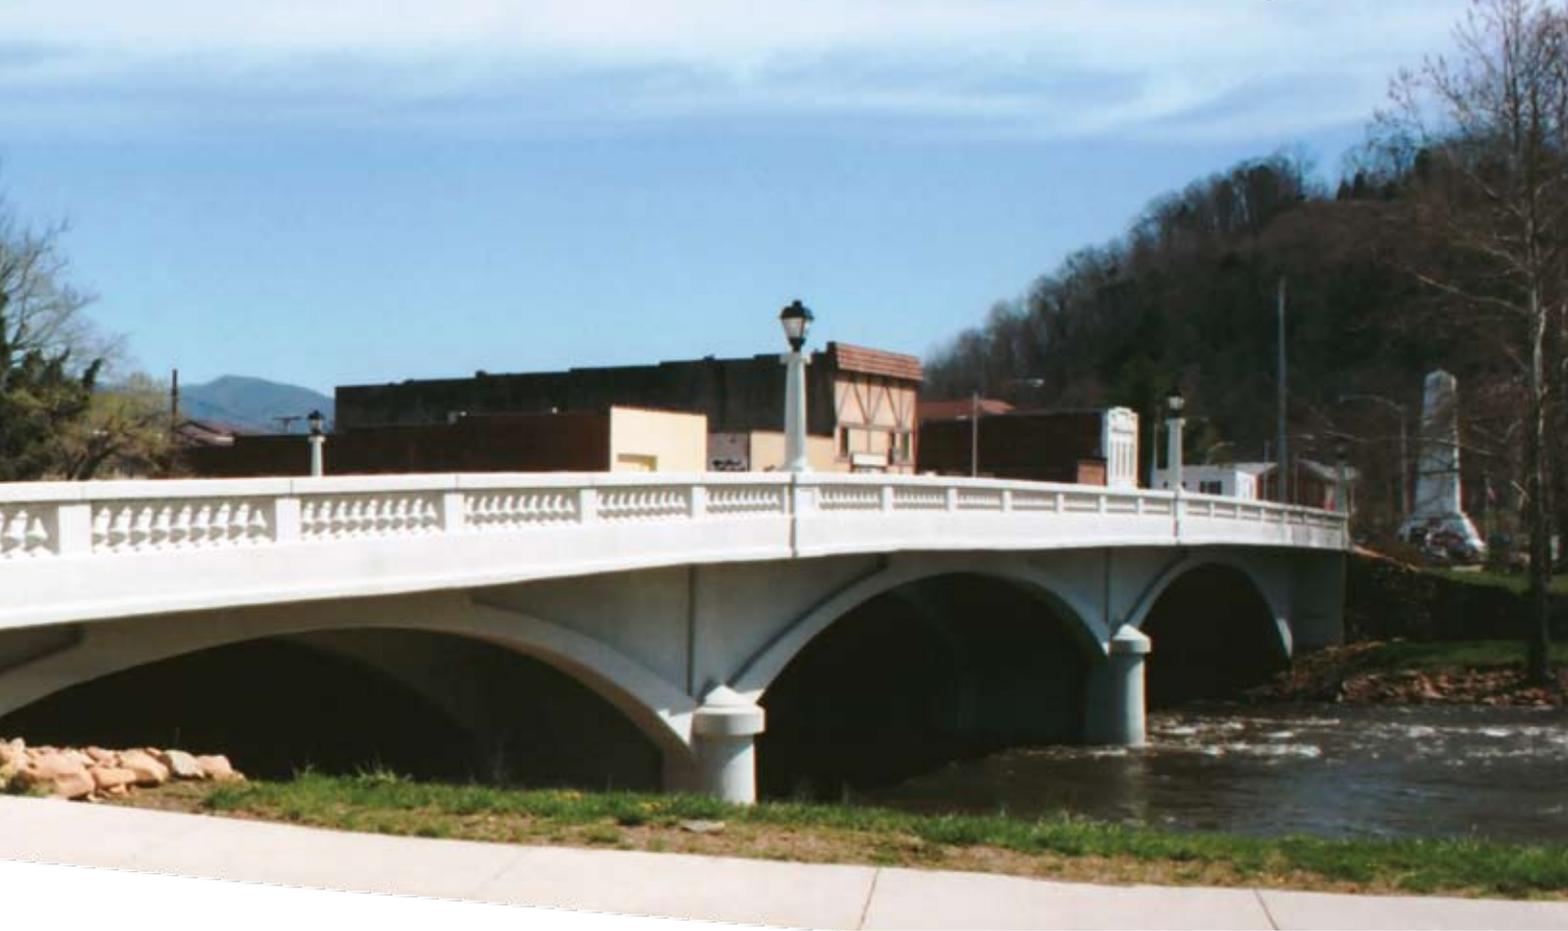
The seven arch ribs support a 54-ft-wide roadway and two 12-ft-wide sidewalks on a 1-ft-thick concrete deck.

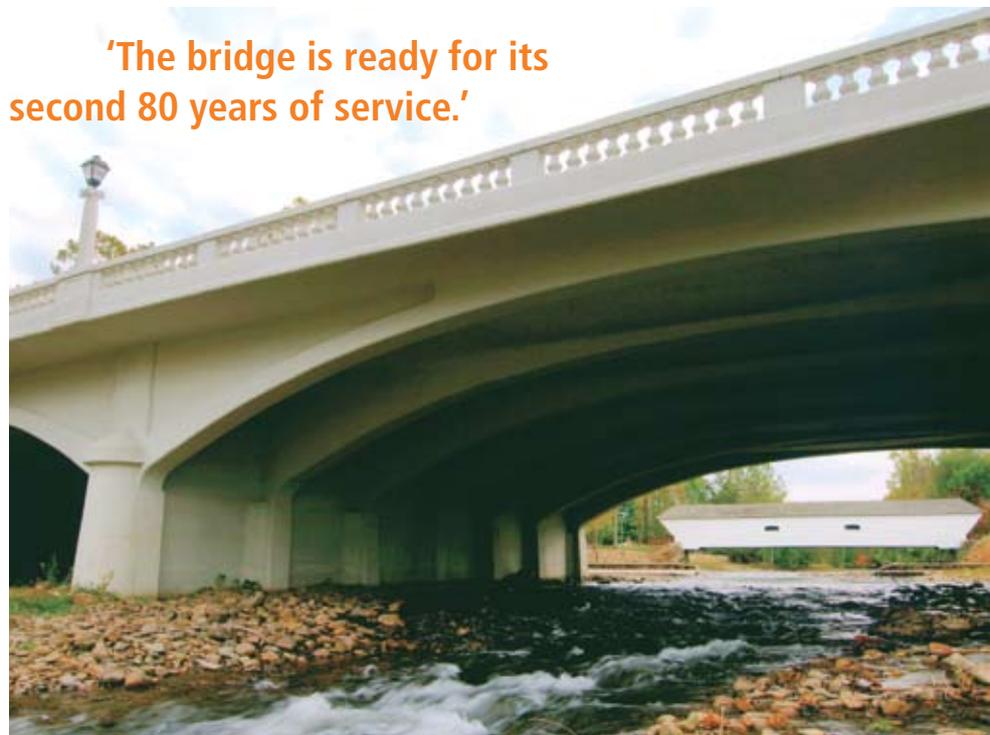
The original spindles were made using a mortar and were replaced with precast concrete spindles.

The spindles of the original barrier were made using a cement-sand mortar and were badly deteriorated. The replacements, made of Class A concrete, were individually cast in a mold fashioned from one of the original spindles. The top rail was cast in place.
