Noblestown Road Bridge: REHABILITATED WITH SHOTCRETE

Chesapeake Bay: REPAIRING THE WORLD'S LARGEST BRIDGE-TUNNEL COMPLEX

Sunshine Skyway Bridge: CARBON FIBER REPAIRS GIRDERS

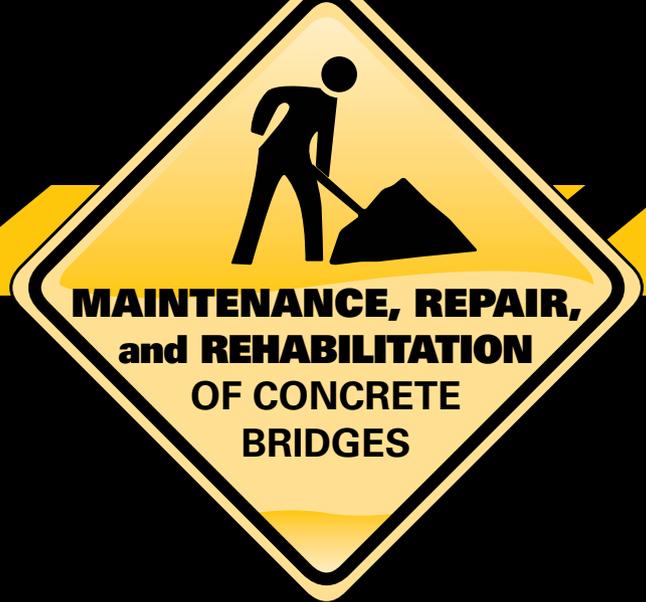
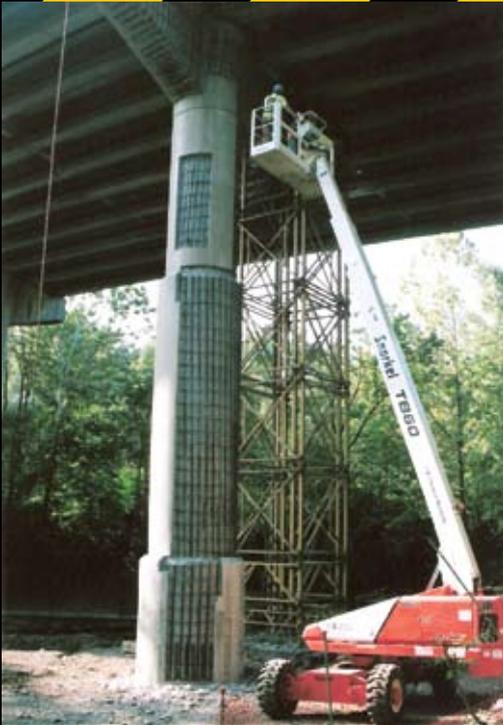
A drymix shotcrete process was used to repair the badly deteriorated piers on the Noblestown Road Bridge near Pittsburgh, Pa. The repair method allowed the bridge to remain open during construction and return to full operation quickly.

Utilizing the drymix process permits the nozzleman to make adjustments in water content at the nozzle and allows the material to be placed with less water content. The material being installed was essentially a zero-slump pneumatically placed concrete. The contractor saw-cut the perimeter of the repair areas, chipped out the deteriorated concrete, sandblasted the reinforcing bars, and added new reinforcing bars where needed. Welded wire reinforcement was installed, holes were drilled for epoxied anchor bars, and shotcrete gunned in place to restore the concrete piers to their original contours.

eliminated the need for on-site mixing, providing better quality control for the mixture. The prepackaged material was dampened with an auger-type predamper, and the Shotcrete MS was gunned in place with a rotary gunite machine.

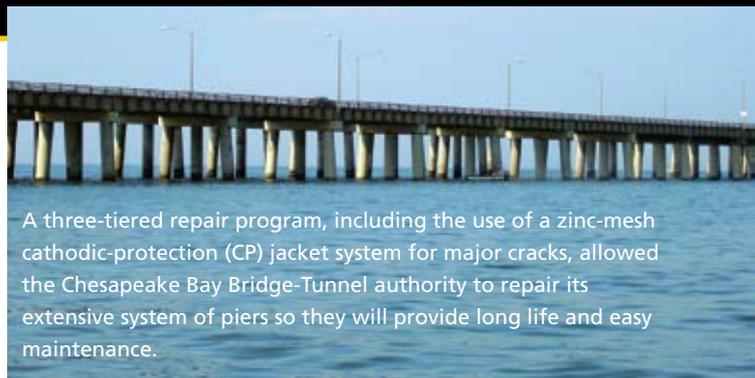
A three-tiered repair program, including the use of a zinc-mesh cathodic-protection (CP) jacket system for major cracks, allowed the Chesapeake Bay Bridge-Tunnel authority to repair its extensive system of piers so they will provide long life and easy maintenance.

Piles with cracks wider than 1/16 in., were repaired with a zinc-mesh cathodic-protection (CP) jacket system from Electro Tech CP in Tequesta, Fla., and Jarden Zinc Products in Greenville, Tenn. This system was selected to provide long-term protection that would remain maintenance free. CP jackets were installed on 215 piles and will help prevent future corrosion by creating a barrier against chlorides, moisture, and oxygen.

The first step in installing the jackets was to connect each piece of steel in the concrete sections to the pile's CP system. Installers drilled from the face of the pile into the concrete to expose a portion of the reinforcing steel, including the spiral wire and each prestressing strand. Then, they brazed a copper wire onto the steel. The crews then applied epoxy at the connection point and plugged the drill hole with grout material.

Each fiberglass jacket was installed in four sections. Crew members pumped grout comprising portland cement and sand from the bottom of the jacket to the top from alternate pumping ports to create a single monolithic fill approximately 2 in. thick. When the grout fill cured, lead wires from the reinforcing steel in the pile were connected with the zinc anode in the junction box. The existing concrete and the grout fill in the jacket formed a common electrolyte.

Finally, the repair contractor bolted two 48-lb bulk zinc anodes to the bottom of each jacketed pile and connected them to the pile's CP system to add protection to the pile's submerged portion and prevent current dump-off from the jacket's lower region. The repair system, designed to protect the piles for more than 25 years, will self-adjust to meet changes in temperature, humidity, concrete resistivity, and other factors.

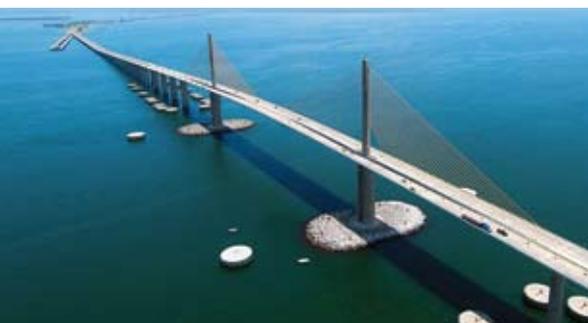
To restore the shear deficiencies at the end of the AASHTO girders on the 5.5-mile-long Sunshine Skyway Bridge in Tampa Bay, Fla., designers used a bidirectional carbon-fiber fabric wrapped in a specific sequence to limit the number of plies while supplying additional strength.

To increase shear strength at the end of the AASHTO girders, a bidirectional carbon-fiber fabric from Sika Corp. in Lyndhurst, N.J. was used to wrap the members. The carbon fiber was applied in a specific way to achieve the strength necessary and meet the design live load requirement.

A 24-in.-wide strip was placed vertically down the girder web, around the bottom flange and up the other face to create a U-wrap similar to a stirrup. Then a strip was wrapped around the bottom flange of the girder to strengthen the flange. Finally, another strip was placed longitudinally along and under the top flange adjacent to the soffit of the bridge deck. The bidirectional fabric allowed the members to achieve supplemental strength in multiple directions without having to install additional plies.
