# A TIME TO REPLACE— Constructing a Safer Tomorrow

### **BIG BEAR BRIDGE / SAN BERNARDINO MOUNTAINS AT BIG BEAR LAKE, CALIFORNIA**

POST-TENSIONED, CAST-IN-PLACE CONCRETE ARCH SUPPORTING CAST-IN-PLACE BOX GIRDER / CALIFORNIA DEPARTMENT OF TRANSPORTATION, OWNER

**BRIDGE DESCRIPTION:** A 474-ft-long structure with two 237-ft equal spans of post-tensioned, cast-in-place concrete box girder. The 10-ft deep box girder superstructure rests on a cast-in-place concrete arch. The arch cross-section is hollow, trapezoidal in shape, with a depth that varies from 10 ft at the crest to approximately 15.5 ft at the base. The arch splits into two legs that are combined at the crest with a width of 45 ft. Each leg is 22.5 ft wide at the base.

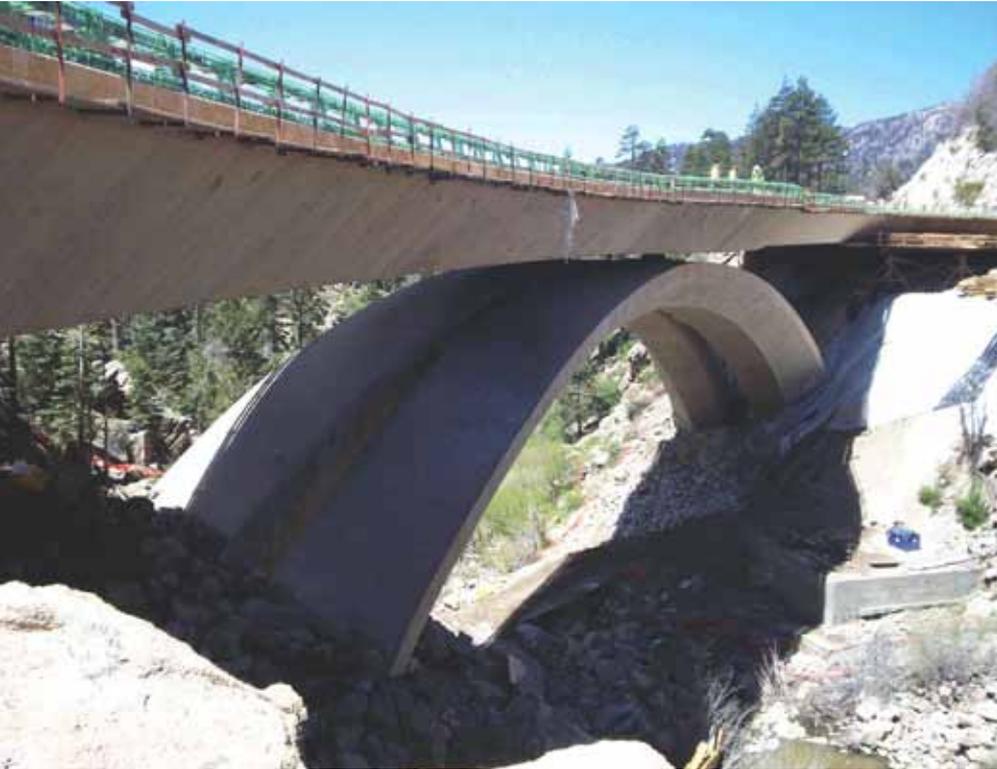
The Big Bear Bridge nears completion.

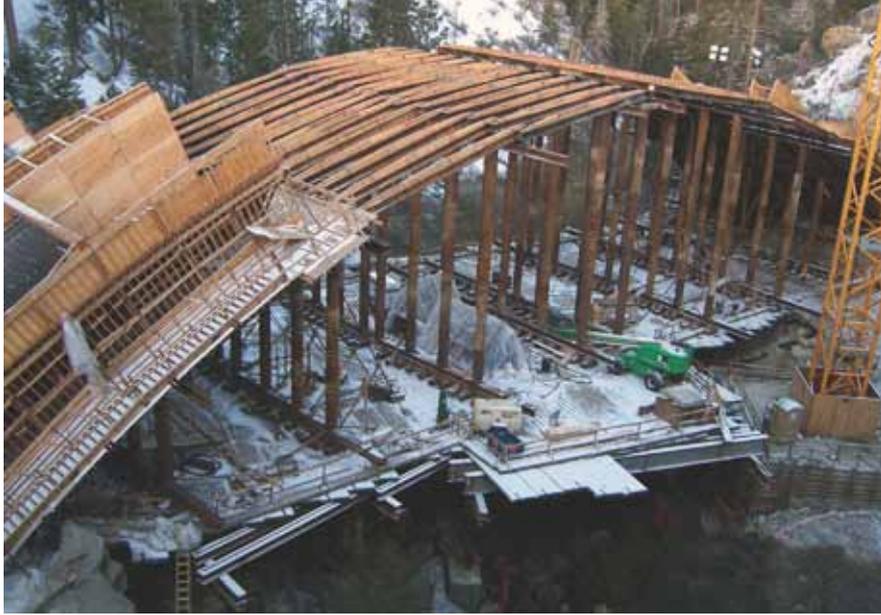
Falsework and forming for the arches.

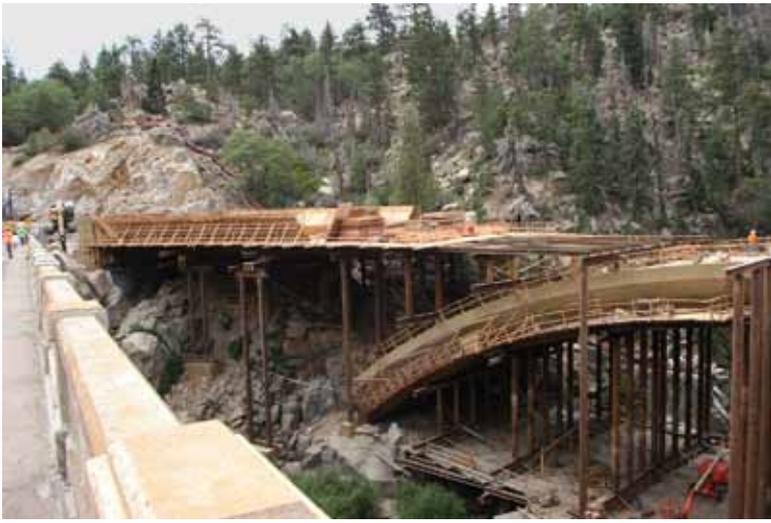
All but the bottom form for the arches have been removed while forming begins for the box girder.

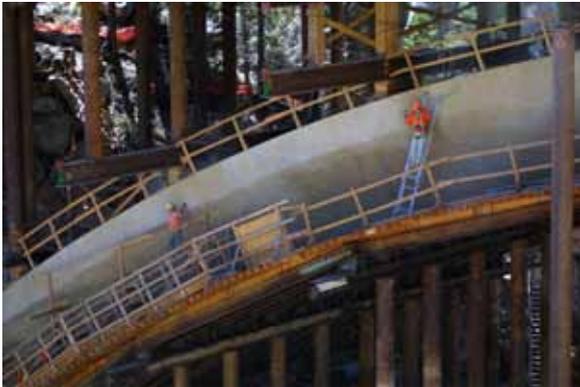
Finishing work proceeds on one of the concrete arches.
