# State Street Bridge Rehabilitation

**Careful planning retains substructures and arches of 83-year-old concrete bridge**

# Methods of Corrosion Prevention and Control in Concrete Bridges

# Preserving Lincoln's Heritage

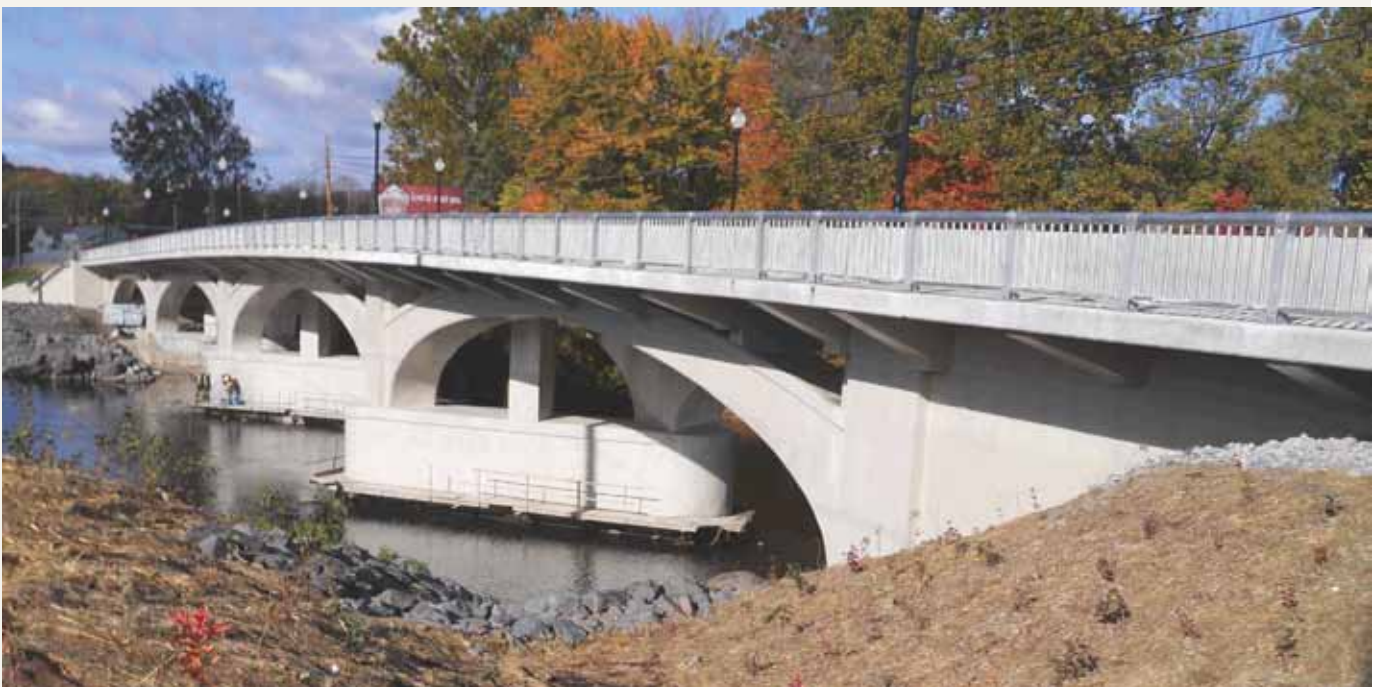
South elevation of the recently rehabilitated State Street Bridge over the Schuylkill River in Berks County, Pa. All photos: TranSystems.

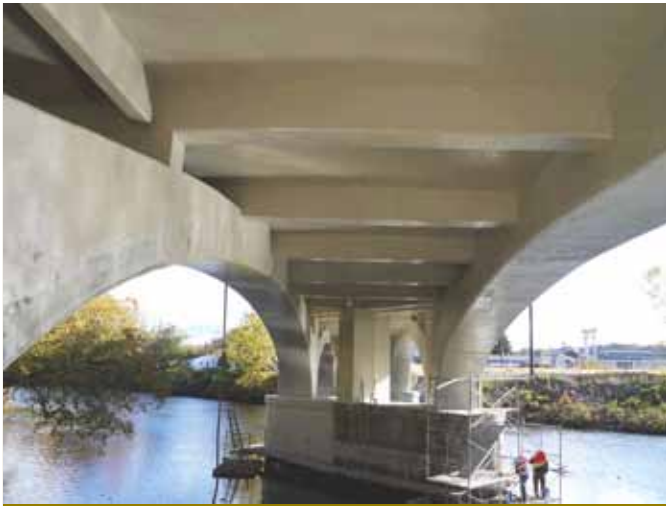
View of the underside of the rehabilitated bridge showing the original arches and the new cast-in-place concrete floor beams and deck.

pairs to match the existing architectural features of the bridge, and the partial removal and filling of the cellular abutments to support a standard pavement section. Shotcrete and formed concrete repairs were used for the work. Specified concrete compressive strength for the new deck and floor beams was 4000 psi. The general contractor was Allan A. Myers LP. TranSystems, a subconsultant to Whitney, Bailey, Cox and Magnani LLC, was responsible for the bridge repair design.

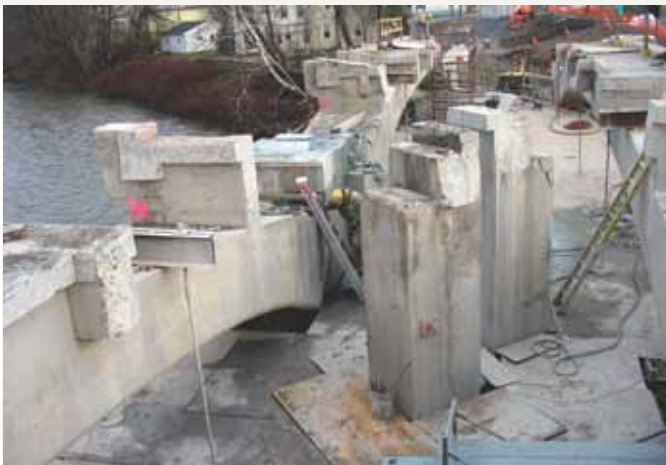
These were the components of the existing structure that were left in place after removal of the deck and floor beams.

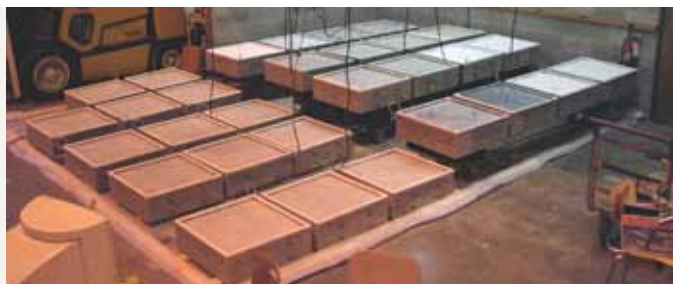
Thirty laboratory test specimens were subjected to 6 months of accelerated corrosion testing. Photo: University of Wisconsin-Milwaukee.

Thirty reinforced concrete laboratory specimens were subjected to 6 months of accelerated corrosion testing that consisted of wet/dry cycles of exposure to saltwater. The specimens also had the application of a constant electrical potential between their top and bottom mats of uncoated reinforcement. The conditions are used typically to significantly accelerate the corrosion process in reinforced concrete.

Sixteen of the specimens received a protective treatment prior to exposure to accelerated corrosion. The remaining 14 specimens were cast with mixed-in chlorides and subjected to patch repair treatments after 3 months of accelerated corrosion. After repairs, the group of 14 specimens was subjected to an additional 3 months of testing. Each treatment was applied to two specimens.

The specimens were evaluated with respect to corrosion currents, chloride ingress, half-cell potential readings, extent of cracking, rust staining, and condition of the reinforcing steel after the conclusion

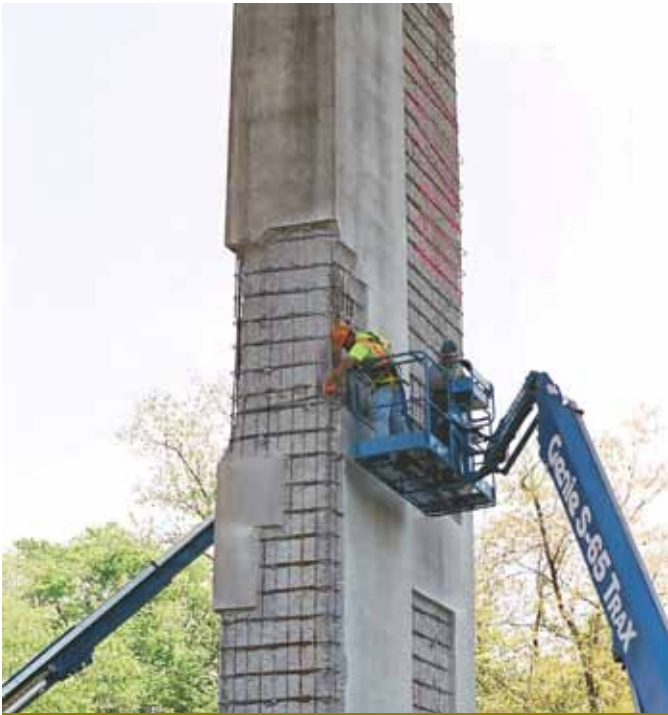
Shotcrete was used to repair the 86 piers on the 7122-ft-long Abraham Lincoln Memorial Bridge in LaSalle, Ill., the longest bridge in the state. Using shotcrete ensured contractors could visually check encapsulation of the reinforcing steel.

Shotcrete provided a variety of benefits, including the ability to remove and replace concrete in stages. On several severely deteriorated piers, 33% of the pier was repaired and remobilized when the shotcrete reached 70% of the required strength. The procedure was then repeated, eliminating destabilization concerns. The use of prebagged shotcrete also ensured freshly placed, consistent mixtures. Using air and water hoses placed over the side of the bridge also provided a safe procedure.

Construction time was shortened, as the shotcrete placement was completed the next day with sandblasting or high-pressure water blasting of the patch's edge. The shotcreting process also provided a visual encapsulation of the reinforcing steel, eliminating concerns about voids. Shotcrete curing with wet cotton mats also provided a superior finish.

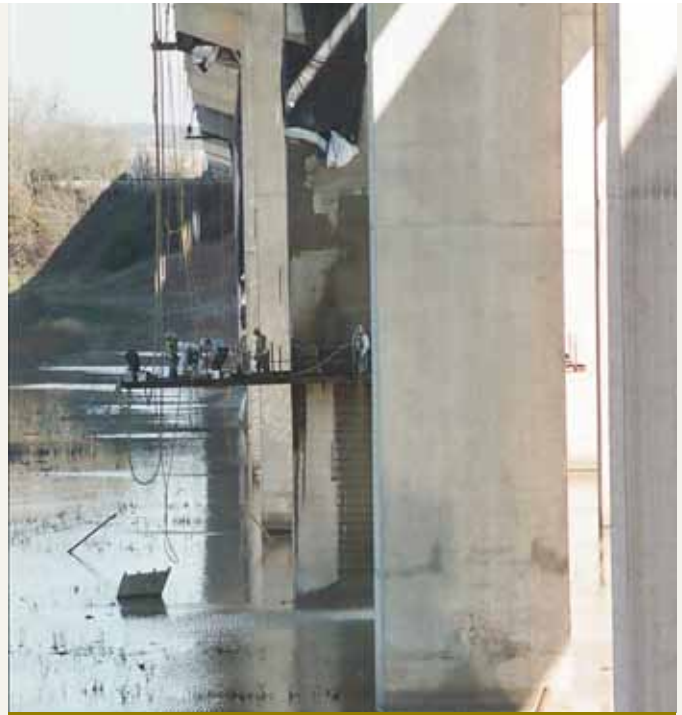
All work was completed from overhead, which provided less risk due to the ability to feed air and water hoses over the side rather than handling formwork.

Repairs were completed in two phases, with work on the southbound structure being followed by work on the northbound one. For land-based piers, 70-ft-tall boom-lifts were placed over the bridge's side with cranes. A detailed safety program was created to allow raising and lowering of platforms that were placed just below the deck. They were used at all finger-joint piers over the inaccessible areas. The concrete in the piers was removed past the first mat of reinforcing steel during which saw-cutting the edges and sandblasting with abrasive grit was performed, taking care to blast the saw-cut edges that were polished by the saw. The existing reinforcing bars were supplemented as necessary.

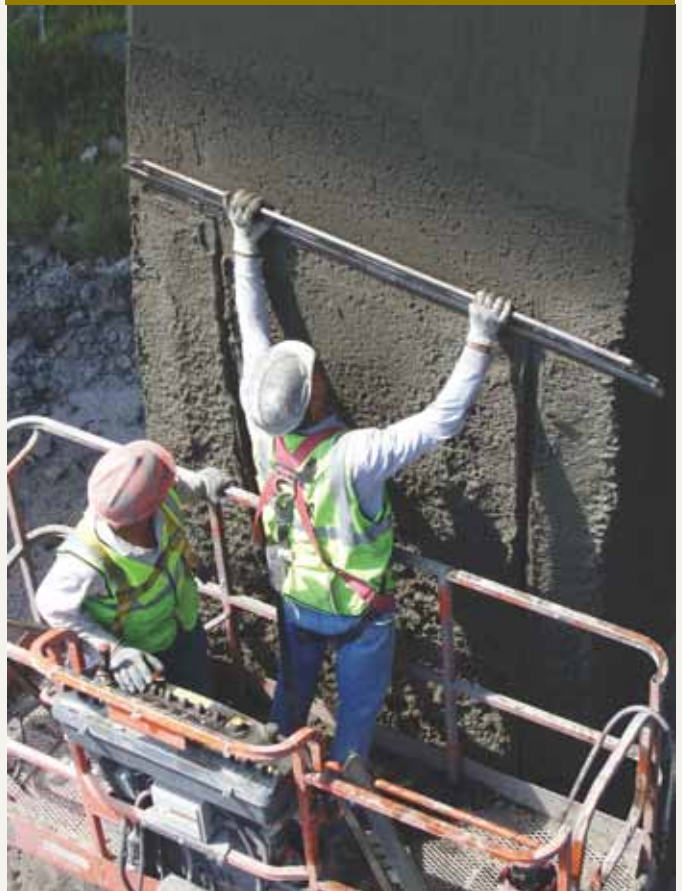
Concrete placement was eased with the use of shotcrete, which could be smoothed even in unreachable areas without having to maneuver forms. The work was performed by ACI-certified nozzlemen.
