**COUNTY / COLLIER COUNTY, FLORIDA**

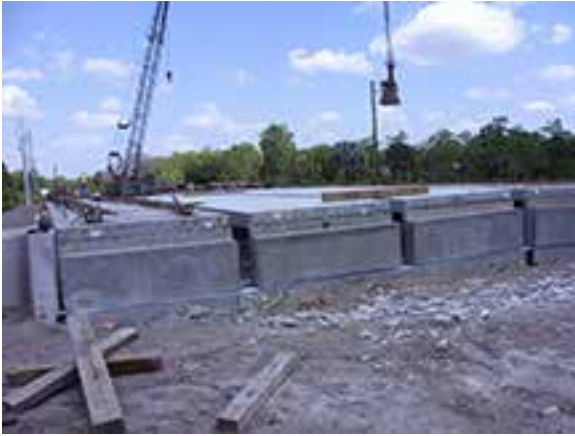
Looking east — west end of bridge — end diaphragms cast by second pour at the fabricator. All photos: Collier County, Fla.

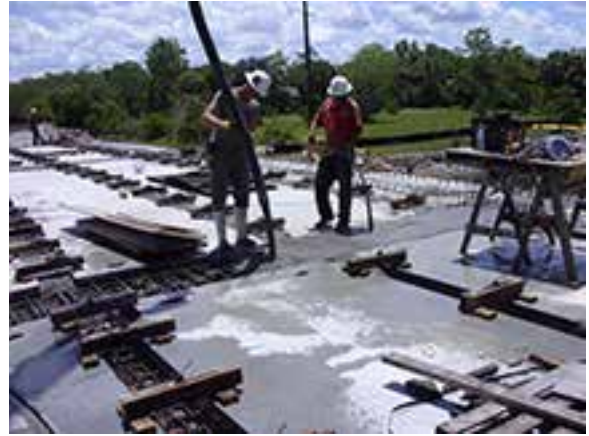
Transverse closure pour over intermediate bent.

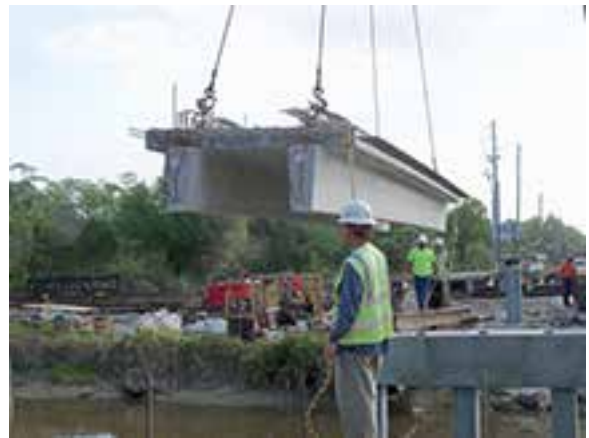
Florida double tee getting ready to set.

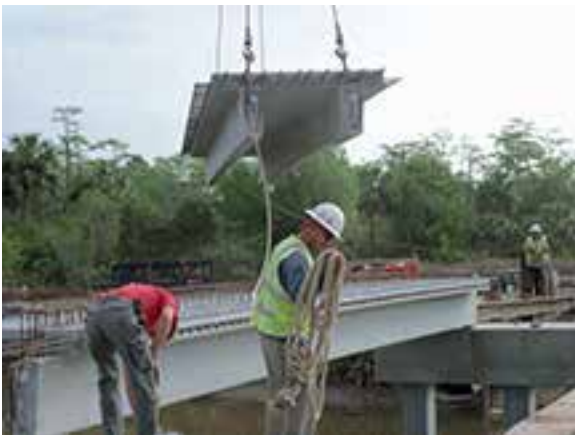
Typical precast prestressed modified Florida double tee being hoisted for placement.

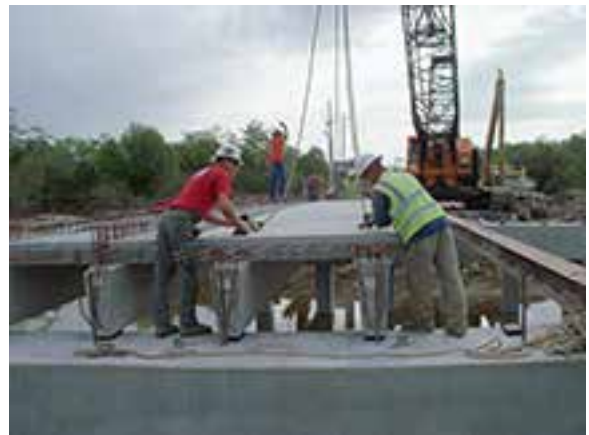
Setting the beams in place at intermediate bents No. 1&2 – releasing the lifting clamps after beam is in place.

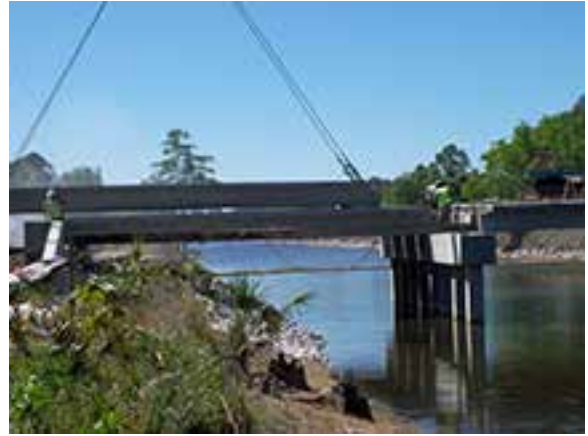
Beam installation between end bent No. 1 and intermediate bent No. 1.

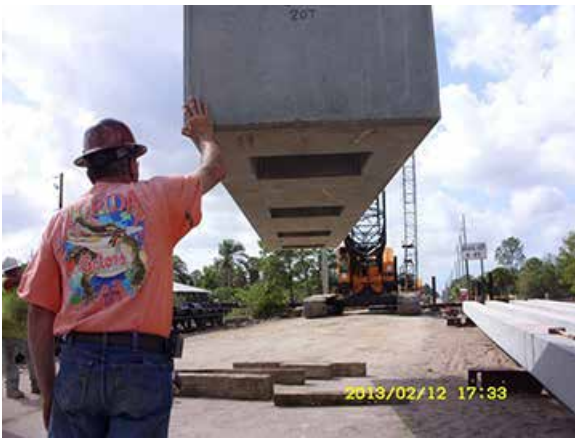
Precast pile cap being delivered to the site.

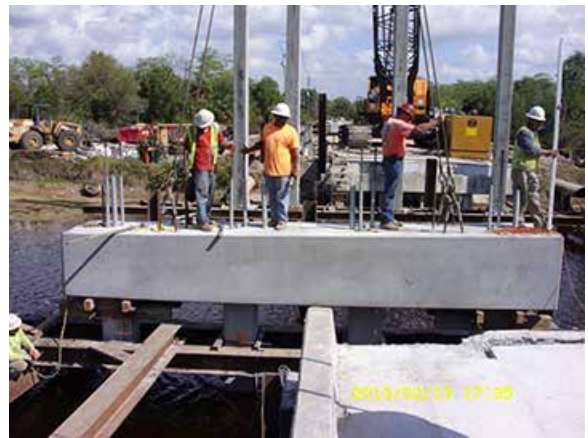
Bent erection and leveling — precast pile cap being checked for final grade before release from crane.

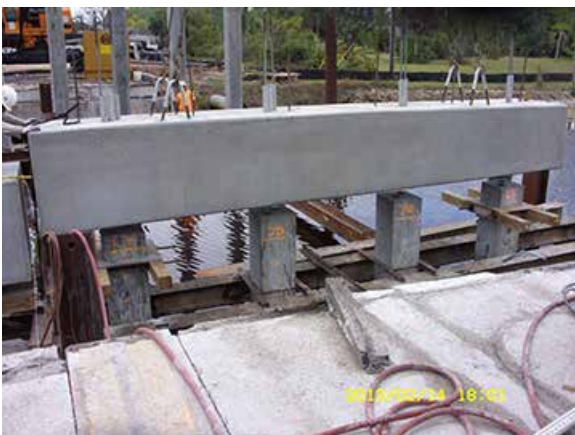
Setting bents — setting the pile cap on piles at intermediate bent No. 2.

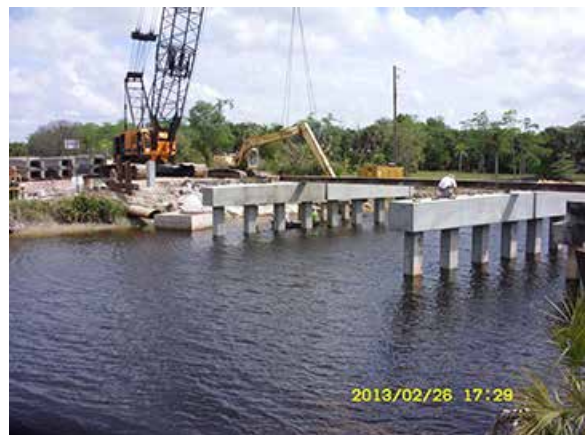
Final erection of intermediate bents — elastometric bearing pads being set.
