COUNTY / COLLIER COUNTY, FLORIDA

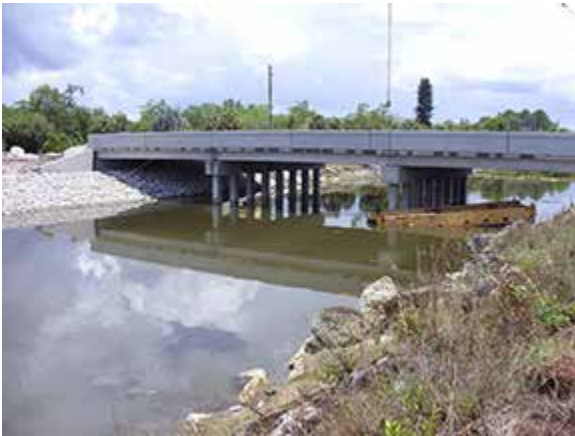
Profile view of bridge looking north.

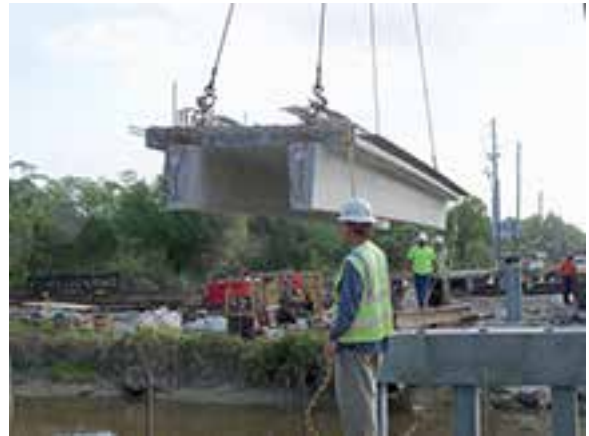
Florida double tee getting ready to set.

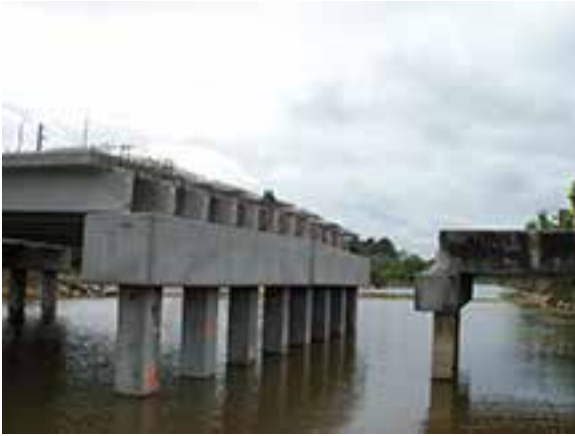
Contrast between new bridge on the left and existing bridge on the right.
