Restoring a Vital Link in Rhode Island

by **Bharat Patel, Vanasse Hangen Brustlin Inc.**

Rehabilitation of the Jacks Run Concrete Arch Bridge

by Daniel Wills,
MS Consultants Inc.

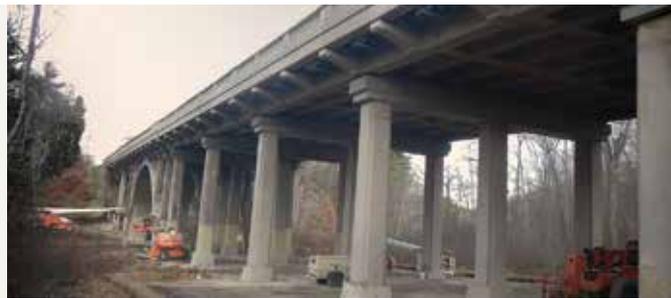
Underside view of the rehabilitated Stillwater Viaduct Bridge. Photo: Vanasse Hangen Brustlin Inc.

The existing, deteriorating superstructure was replaced with precast concrete stringers, pier caps, floor beams (at the arch span), fascia beams with cantilevered brackets, spandrel beams (at the arch span), and decorative bridge rail with spindles. The bridge deck is 8-in.-thick, cast-in-place concrete with a waterproofing membrane covered by a 3-in.-thick asphalt overlay. The new bridge incorporates all the historical elements of the originally constructed bridge.

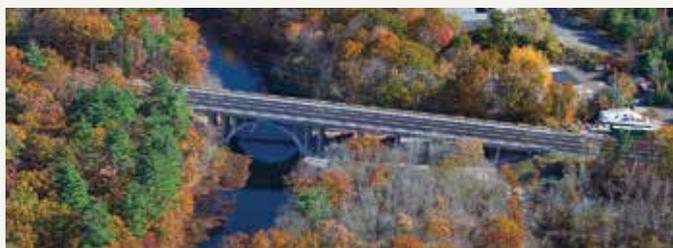
Aerial view of Stillwater Viaduct Bridge. Photo: Mark Flannary Photography.

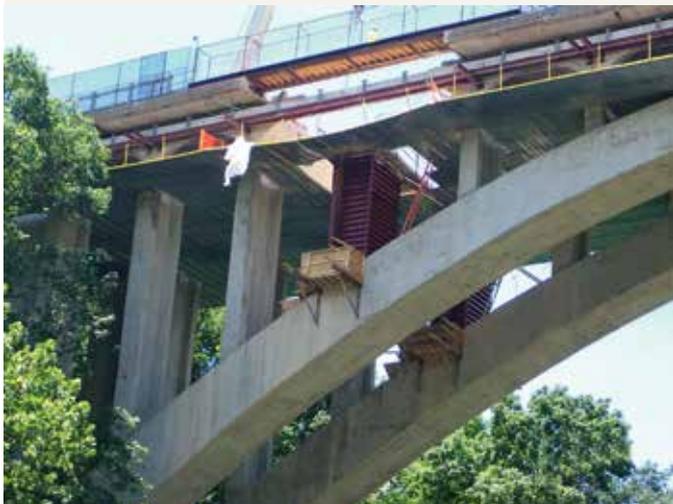
Reconstructing a new column during rehabilitation of the Jacks Run Bridge. Photo: MS Consultants Inc.

Due to extensive deterioration and high chloride content, it was determined that the entire deck and the floor beams, jack arches, abutment back walls, and columns adjacent to the expansion joints should be replaced. For the remaining concrete elements, an extensive program of repairing over 6000 ft² of spalls and delaminations was required.

To extend the life of the rehabilitated structure, measures were taken to mitigate corrosion. Galvanized reinforcement was used for the floor beams and columns at the expansion joints. The distance between the floor beams was increased and the sides of the floor beams were sealed with epoxy resin sealer. Also, two different types of galvanic anode corrosion protection systems were installed. For the concrete repair areas, zinc puck shaped anodes were placed around the perimeter of patches to prevent halo corrosion. In the larger elements being replaced, distributed anode rods were used. Both anode systems were designed for 25-year corrosion prevention.
