# Active Monitoring of the Transport of Long-Span Precast Concrete Girders

by Richard E. Lindenberg and Jonathan C. McGormley, Wiss, Janney, Elstner Associates Inc.

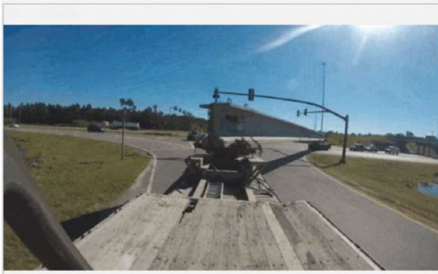
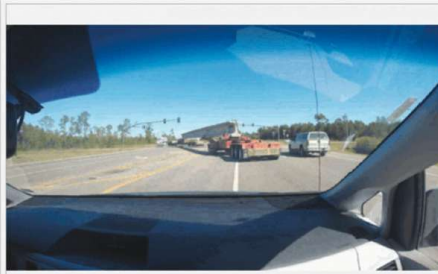
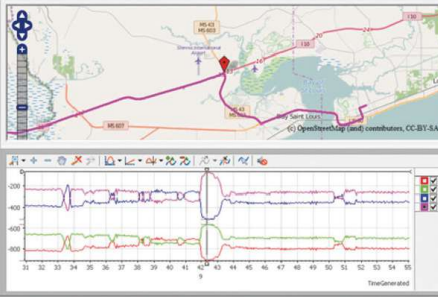
Data fusion of traditional strain plots, with synchronized time-lapse video, geolocation map, and interpolated three-dimensional sensor mapping.

Both girders traveled from Pass Christian, Miss., through Louisiana on Interstate 10 into Baton Rouge, La. From there, the transports deviated with one girder traveling to Alexandria, La., and the other to Lake Charles, La. For each girder, over 40 channels of instrumentation were collected at 100 Hz to record individual events along the route. Time-lapse video correlated with geolocation data allowed the research team to review events along the shipping route. The data were fused to correlate time lapse, geolocation, traditional time versus strain response, and sensor-mapped imagery.

A significant challenge of this research was to efficiently investigate many hours of collected data. The fused data was not intended to accurately identify critical stresses and girder position, but

rather was used to assist the investigators with the rapid interrogation of girder response while simultaneously observing time-lapse video correlated to events of interest, for example, turns and railroad tracks. The strain gage placement permitted peak responses to be captured during transport

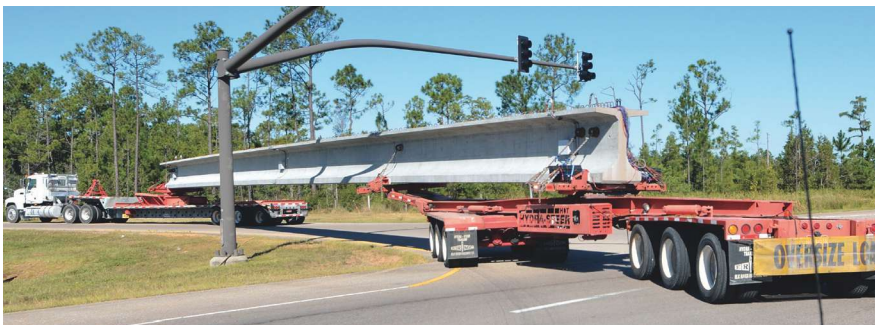
Girder turning onto an interstate ramp, an example of a significant event causing differential bending strain at the top flange of the girder.

cracking strains in both girders. Low-speed maneuvers, such as tight turns, produced the greatest tensile strains in both test girders during transport. Based on a review of these events, these strains were principally due to the lateral force introduced by the jeep tongue.

Accordingly, in many cases the girders experienced the highest tensile strains at the location of the jeep tongue, and not at midspan of the girder. Therefore, the force input by the jeep tongue strongly influenced the girder bending response. This force is a consequence of the driver's operation of the jeep, with no direct feedback to the driver on the magnitude of that force. This exceedance occurred several times for both girders during transport. The largest strain responses from standard transport activity occurred during low-speed maneuvers (less than 10 mph) that relied on the engaged jeep tongue to turn the rear bunk, such as the turn onto the interstate ramp. Post-transport inspection found no visually observable
