ROUTE 198 (DUTTON ROAD) OVER HARPER CREEK

STAGED SUPERSTRUCTURE REPLACEMENT USING LIGHTWEIGHT CONCRETE AIDS PROJECT GOALS

by Jeremy Schlusel, Caroline Hemp, and Timothy Beavers,
Whitman, Requardt & Associates LLP

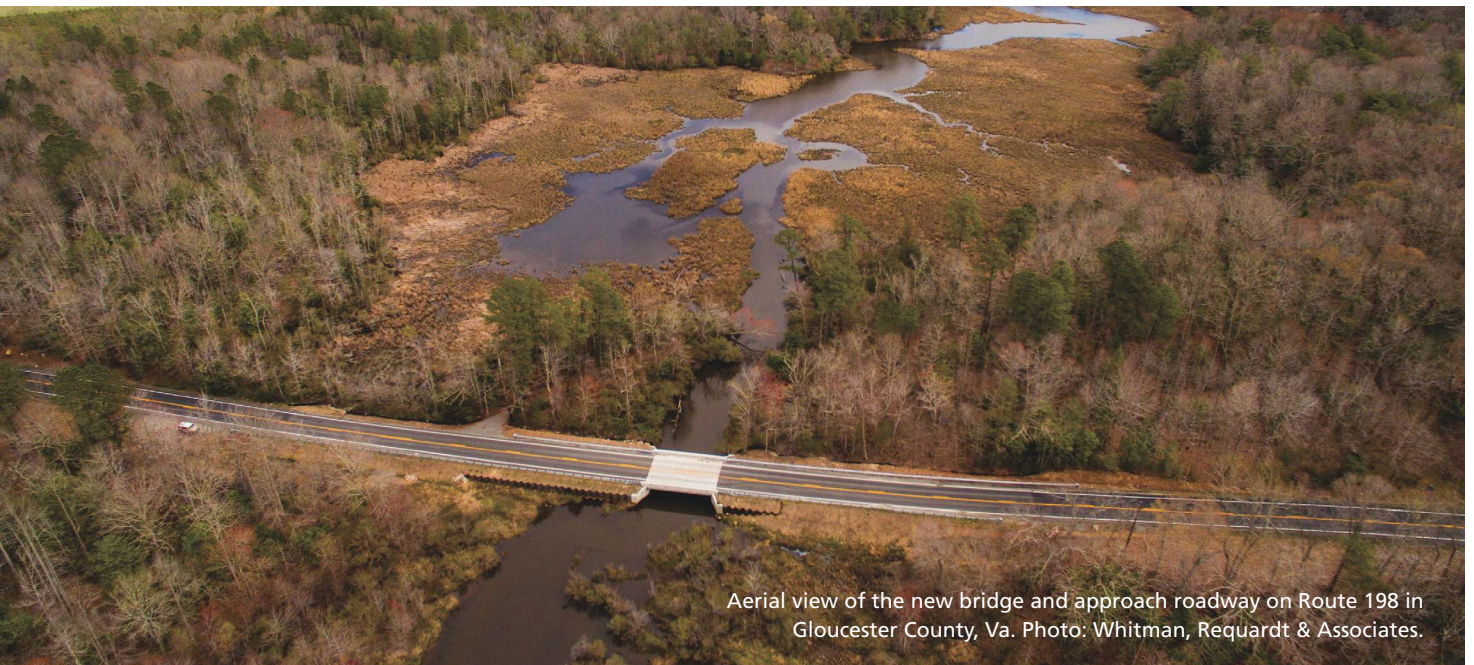
Aerial view of the new bridge and approach roadway on Route 198 in Gloucester County, Va. Photo: Whitman, Requardt & Associates.

The new superstructure configuration is 45 ft 2 in. from end-of-slab to end-of-slab and 32 ft 4 in. out-to-out of parapet. The bridge maintains the same horizontal alignment, and the vertical gradient was modified to be approximately 0.3% to ensure drainage. The final cross section consists of four 29-in.-deep prestressed, lightweight concrete bulb-tee beams spaced at 9 ft with an 8 1/2-in.-thick concrete deck. The bridge has a final curb-to-curb width of 30 ft, which provides two 12-ft-wide lanes with 3-ft-wide shoulders. An open-curbed, Kansas corral-type parapet was chosen to facilitate deck drainage and semi-integral backwalls were detailed at each end of the superstructure to make it a jointless structure. The existing abutments and wingwalls were modified to support the new superstructure width and bearing pad elevations.

In addition to the superstructure constraints, the project needed to accommodate the wider superstructure with only minor widening of the approach roadway. To achieve this widening without impacting the designated wetlands, marine-grade sheet-pile walls were designed and constructed. The sheet piles facilitated the approach roadway widening and grading that was necessary along the shoulders. The widening also slightly increased the work space for the contractor and enabled the project to maintain 11-ft lanes for the duration of the project.

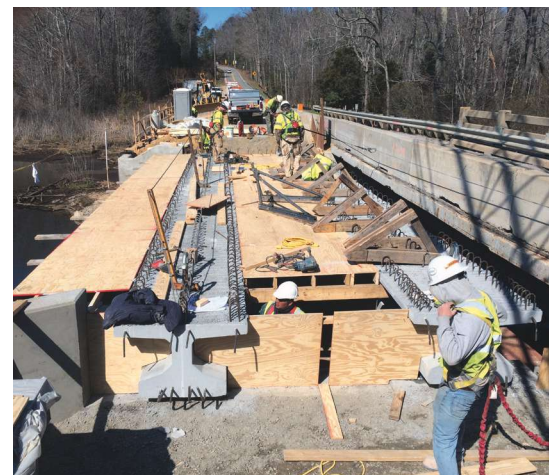
Two 29-in.-deep lightweight concrete bulb tees prior to deck placement. Photo: Virginia Department of Transportation.

Therefore, to minimize the dead load, the designers evaluated the use of various densities of lightweight concretes for both the bulb tees and the concrete deck. After discussions with VDOT and industry professionals, the bulb tees were designed using VDOT Class A5 lightweight concrete with a maximum density of 115 lb/ft³ and a minimum compressive strength at 28 days of 5 ksi. The beams were designed for a minimum compressive strength

STRUCTURAL COMPONENTS: Four lightweight concrete prestressed 29-in.-deep bulb-tee beams with an 8½-in.-thick cast-in-place lightweight concrete deck and a lightweight concrete semi-integral backwall and substructure modifications
