Long Key Bridge Pier Replacement

V-pier replacement at 12 expansion joints

by Dennis Fernandez, Florida Department of Transportation and Dr. Luis Vargas, Bolton Perez & Associates

LONG KEY BRIDGE PIER REPLACEMENT / MONROE COUNTY, FLORIDA

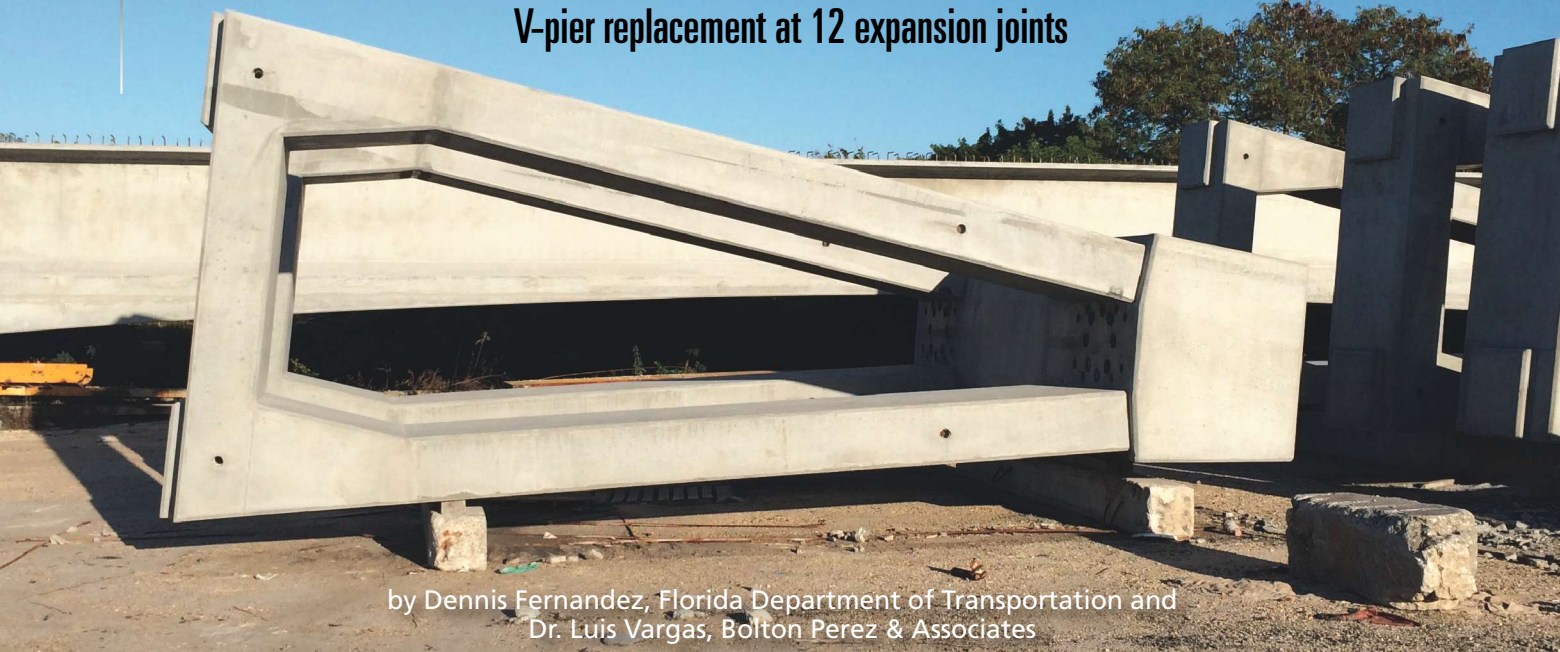
Precast concrete replacement pier in storage at precaster's facility in Tampa, Fla. Photo: Kurt Podoll, Standard Concrete.

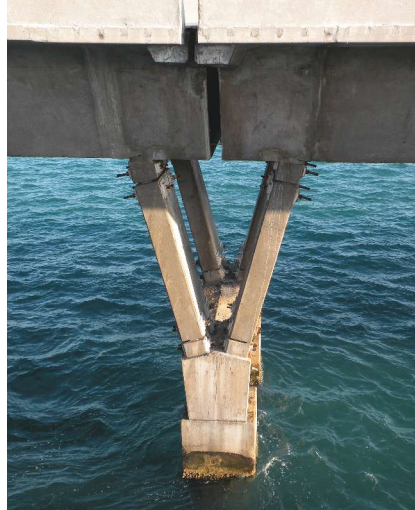
Side view of original V-piers with Freyssinet hinges at top and bottom. Photo: Luis Vargas.

Each pier foundation consists of two 42-in.-diameter concrete drilled shafts with cast-in-place caps that were connected by a precast concrete tie. Longitudinal movements of the bridge due to long-term deformation, thermal, and horizontal loads were accommodated by shear deformation of bearing pads at the bases of the interior V-piers. At the expansion joint locations, the V-pier legs are hinged at the top and bottom.

The 12 piers at the expansion joints were designed to accommodate the longitudinal expansion and contraction of the concrete segmental superstructure due to thermal fluctuations by allowing rotation about the Freyssinet concrete hinges. Somewhere during the design process, steel rods were added to pass through the center of the hinges. These rods effectively limited the rotation of the hinges, causing the piers to crack.

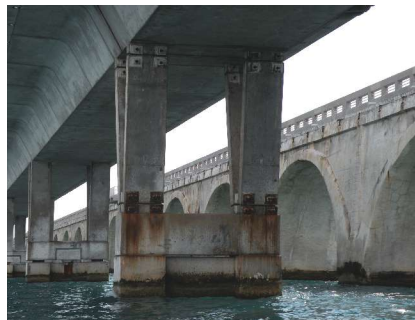
Photo of the existing V-pier with the 1908 arch structure in the background. The galvanized compression plates installed shortly after construction are visible. Photo: Luis Vargas.

These piers are located in an extremely aggressive (saltwater) environment. Water entered the cracks in the pier concrete causing deterioration and corrosion of the reinforcing steel in the vicinity of the hinges. The piers were subsequently reinforced by temporary

plates and external post-tensioning bars in order for the bridge to continue functioning. FDOT has been aware of the condition of the piers since 1990, and several unsuccessful attempts have been made over the years to fund the replacement of the 12 piers at the expansion joints.

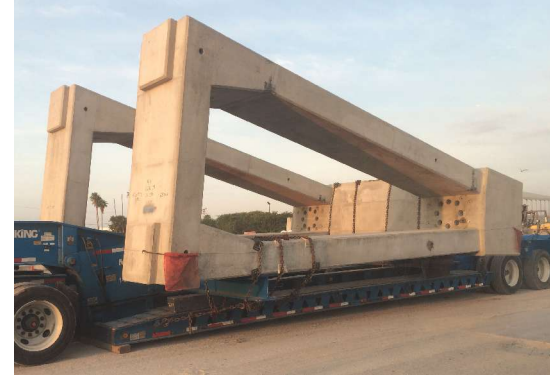
Precast concrete replacement pier ready for transportation from precaster's plant in Tampa, Fla. Photo: Kurt Podoll, Standard Concrete.

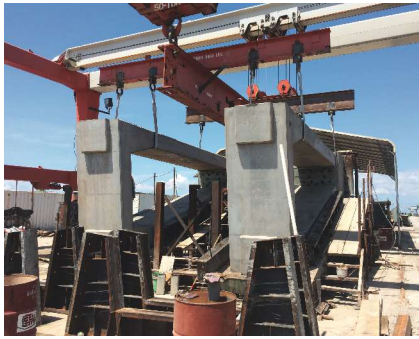
Special lifting and handling procedures were established. Photo: Kurt Podoll, Standard Concrete.

of the interior core forms and to use self-consolidating concrete. Lifting and handling procedures were established by the project team to meet the FDOT requirements to minimize cracking. These prefabricated elements were manufactured in Tampa, Fla., and shipped to the project site.

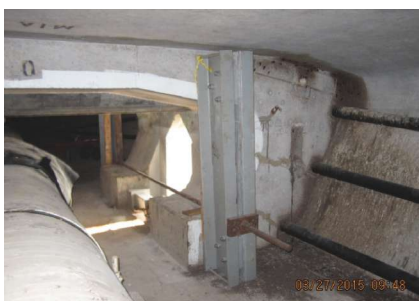
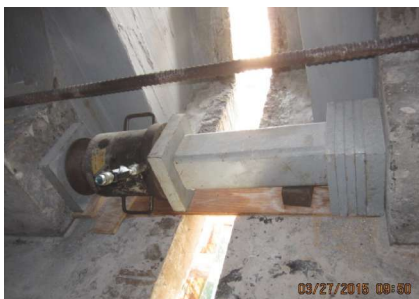
Temporary devices used to lock expansion joints during pier replacement. Photo: FDOT.

1. Install temporary drilled shafts.
2. Install the temporary support system.
3. Install stabilizing system to the existing V-pier.
4. Restrain expansion joint pier

segment of adjacent units with post-tensioning devices.

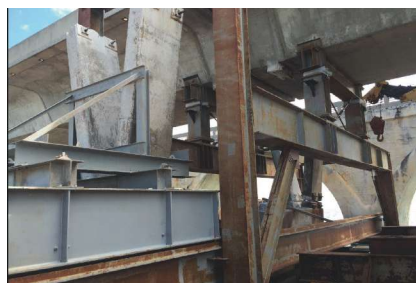
Temporary support system supporting spans as existing V-pier is being removed. Photo: FDOT.

The temporary support system (TSS), envisioned and engineered to support the box girder during the replacement of the V-piers, consisted of an innovative steel structure that was unique, safe, and efficient. It was designed with the characteristics of a permanent structure as it carried the bridge and traffic while the substructure was being replaced. The TSS was supported on temporary drilled shafts and included a sophisticated jacking and monitoring system to transfer all dead and live loads from the superstructure without perceptible displacements. As the replacement work was done within the ecologically sensitive Florida Keys National Marine Sanctuary, the TSS avoided special permitting requirements by being independent of the existing bridge (not

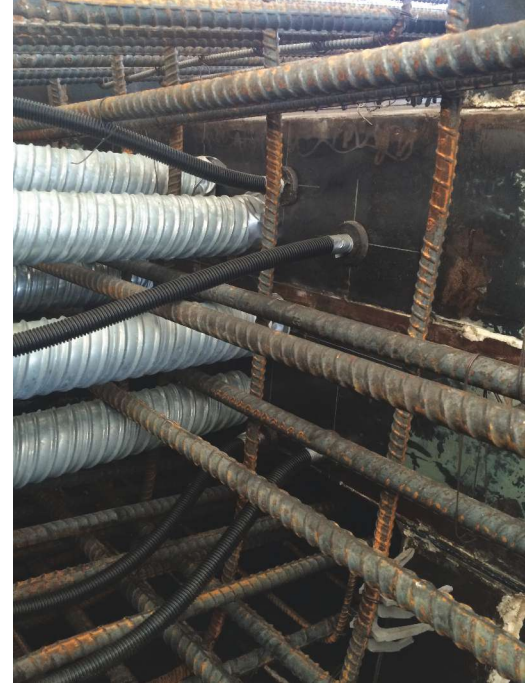
Reinforcing bar cage, grouting tubes, and steel duct for connection between drilled shaft and replacement pier. Photo: Kurt Podoll, Standard Concrete.

Elastomeric bearing pads located on top of the delta-frame support the segmental concrete box girder and accommodate lateral forces and longitudinal displacements. The new precast concrete V-pier has a pier cap, which is designed with a special moment connection (similar to other accelerated bridge construction [ABC] connections in high seismic areas) to the existing drilled shafts, providing continuity to the foundation similar to the original design.

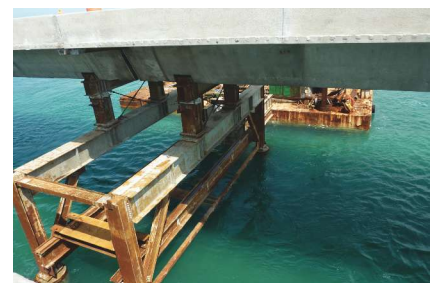
Temporary support system spanning between temporary outboard drilled shafts supporting the bridge after the V-pier has been removed. Photo: FDOT.

using the existing bridge for support). The TSS addressed several aspects of constructability: it was reusable, accommodated existing foundation and superstructure conditions, and allowed for all assembly and disassembly operations to be done above water.

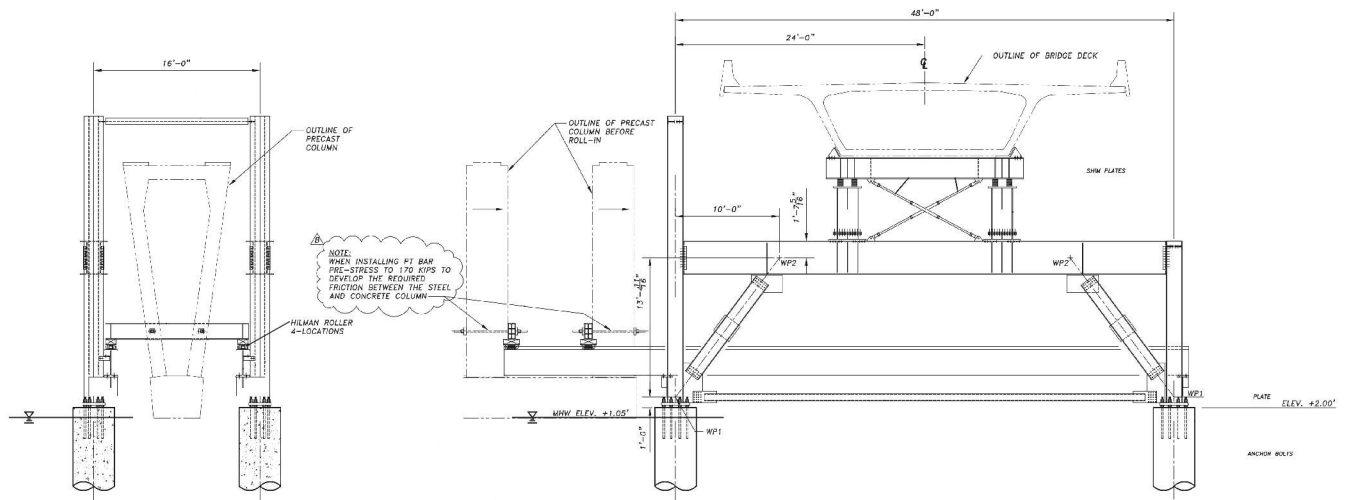
Shop drawing excerpt from temporary support system frame showing replacement scenario. Figure: A2B Engineering LLC.

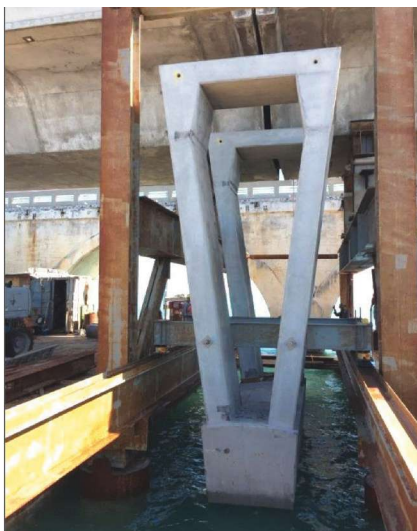
New pier seated in temporary support system and ready for side launch into permanent position. Photo: FDOT.

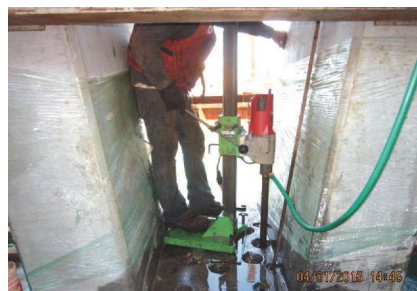
With the new V-pier in position, anchor holes were used as drilling template for establishing connections into drilled shaft. Photo: FDOT.

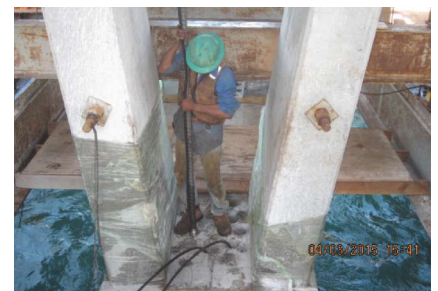
High-strength bar installation and cementitious grouting operations using ABC connection details. Photo: FDOT.

5. Preload jacking devices with 80% of jacking loads.
6. Monitor deflections and possible settlement for about 6 hours.
7. Jack the structure to transfer superstructure reactions to the temporary support system.
8. Saw cut or burn (or both) connections at the hinges (top and bottom).
9. Disconnect and remove the existing V-pier cap and footings by wire cutting at the top of existing drilled shafts.
10. Slide in and level the new V-pier.
11. Drill holes in the existing drilled shafts; install and grout steel bars.
12. Install bearing pads and retract jacks to transfer load to new pier.
