Preserving a Landmark: Lake Tillery Bridge Rehabilitation

With innovative construction techniques, a historic concrete arch bridge in a North Carolina National Forest was preserved

JAMES B. GARRISON BRIDGE (WESTBOUND) / ALBEMARLE, NORTH CAROLINA.

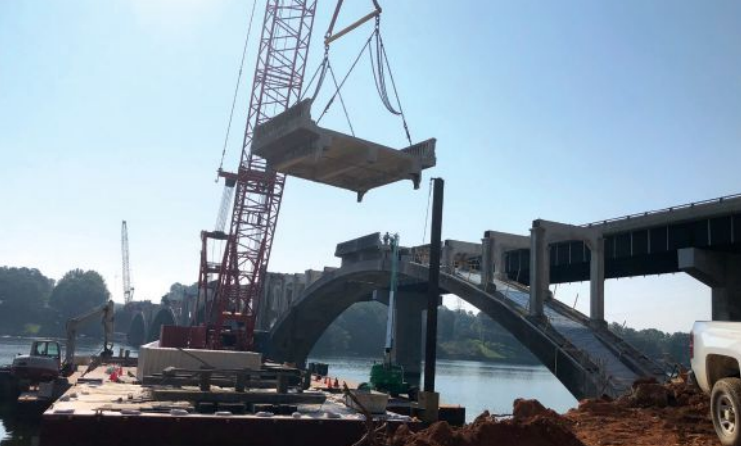
A section of the original bridge deck is removed from span C. Twenty strain gauges were installed in the existing arches to monitor stress and movement during demolition.

The design-build team began by evaluating the existing concrete arch bridge and original demolition sequence. The team proposed a new demolition sequence that kept the bridge in balance, removed leading-edge safety hazards (that is, worker fall hazards), and eliminated longitudinal saw cutting to prevent concrete slurry from entering the lake. The team collaborated with NCDOT and the engineer of record to come up with a new demolition sequence. The contractor then proceeded with removal of the concrete superstructure while leaving the four arch spans and the original piers intact. Because the original bridge arches were to remain

and become the foundation of the new bridge, it was imperative to closely monitor the structure for movement after every step to ensure that the substructure and arches did not exceed allowable stress levels. Twenty strain gauges were installed in the existing arches to monitor the stress and movement during demolition.

The contractor essentially took the structure apart piece by piece, using a 60-in. saw to cut transversely through the concrete sections, while avoiding longitudinal cuts. Taking the complicated geometry and stability of the existing bridge into consideration, the team developed and implemented key

alternative construction sequences that maintained the stability of the structure throughout all stages of construction. The strain gauge measurements were diligently and continuously monitored and recorded. The revised sequence and precise demolition methods resulted in stress and movement levels of the arches well below the allowable limits.

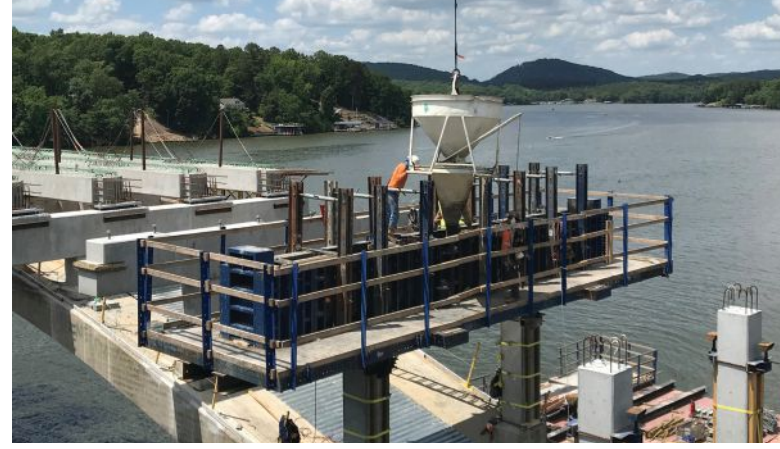
Cast-in-place concrete cap construction.

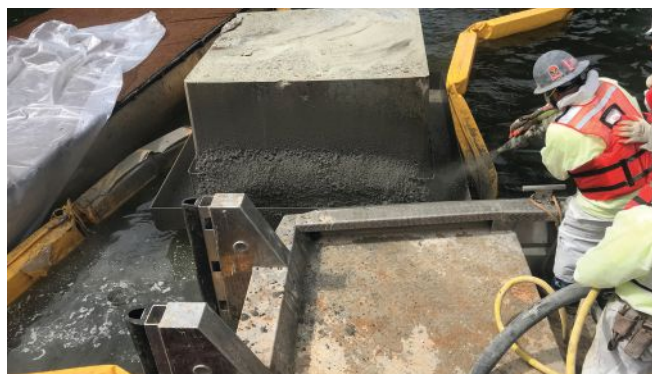
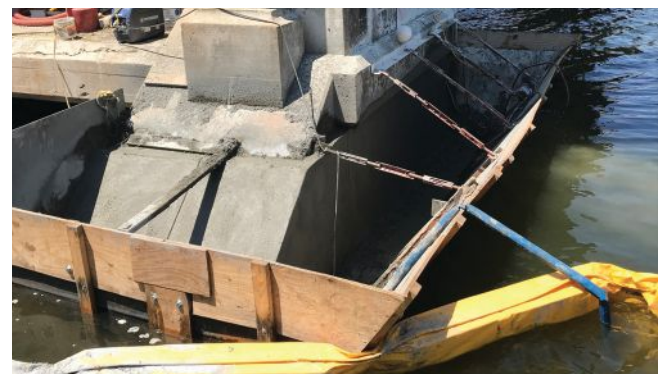
A protective layer of concrete was installed at all existing piers to protect and reinforce the area most susceptible to erosion from the fluctuating water levels. The cofferdam system provided access for crews to apply the shotcrete protection. The left photo shows the shotcrete application, and the right photo shows the finished product.

Both bridges required underwater structural encasements of the existing substructure to extend the life of the piers. A protective layer of concrete was installed to all existing piers from the base of new construction to 4 ft below the normal pool waterline to protect and reinforce the area most susceptible to erosion from the fluctuating water levels. This effort required placing concrete 6 ft underwater.

The project team worked together to find an effective installation procedure that would minimize the impact to the waterway. The contractor designed a steel cofferdam that was attached to

each pier on both bridges and could be lowered to a level below the area that needed repairs. The cofferdam was sized to allow workers room to install the protection after dewatering. This operation was performed instead of a challenging underwater grouting operation, which would have been difficult to vent adequately given the site's constraints. This revision provided a safer work environment and resulted in a better product when completed. Instead of using traditional concrete formwork, a diving crew used injection ports to construct a sacrificial shotcrete layer within the cofferdam. After pumping out the cofferdam, the crew could work in that space to apply the final shotcrete protection to the piers in the dry.

Slag concrete was used for the substructure repairs below the waterline.

Slag cement is a durable solution for protecting the structural integrity of the original bridge arches that is less susceptible to an alkali-silica reaction, which results in flakes falling off into the water over time. Slag cement also held the slump longer, made the mixture more workable, and was easier to place using long boom lines.

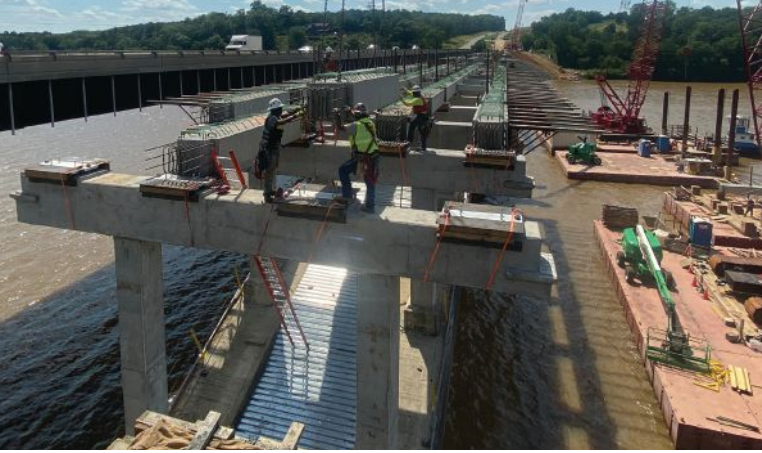
New precast concrete box beams are erected in span F. Note the continuity reinforcement detail at the beam end, the common bearing under the continuity diaphragm, and the epoxy-coated reinforcement that will be cast into the composite deck.

The existing superstructure was replaced with prestressed concrete spandrel box beams that were 3 ft × 3 ft and 20-ft 7-in. or 14-ft 10-in. long, depending on the cap spacing. Each beam contained reinforcement that extended from the beam ends, which allowed the beams to be set and connected with a cast-in-place diaphragm to create a continuous beam across the span.

Partial-depth prestressed concrete deck panels were placed to span transversely between the beams. The 3.5-in.-thick panels were 4 ft × 6 ft 8 in. and served as a work surface and formwork for the cast-in-place concrete bridge deck.

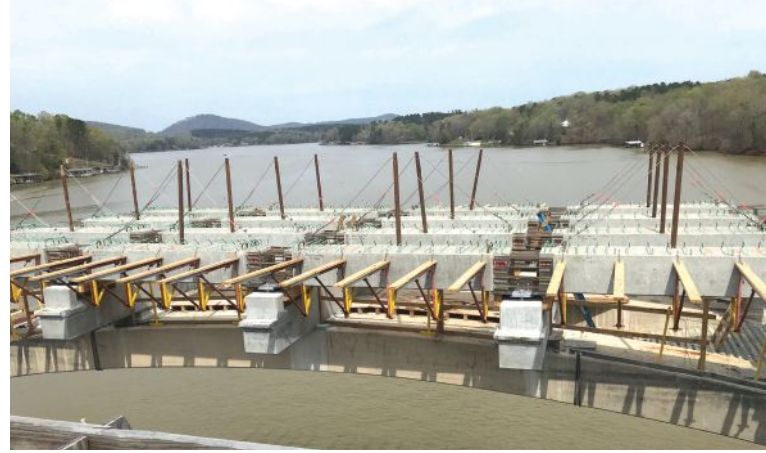
Prestressed concrete box beams are placed and await the cast-in-place concrete continuity diaphragms.

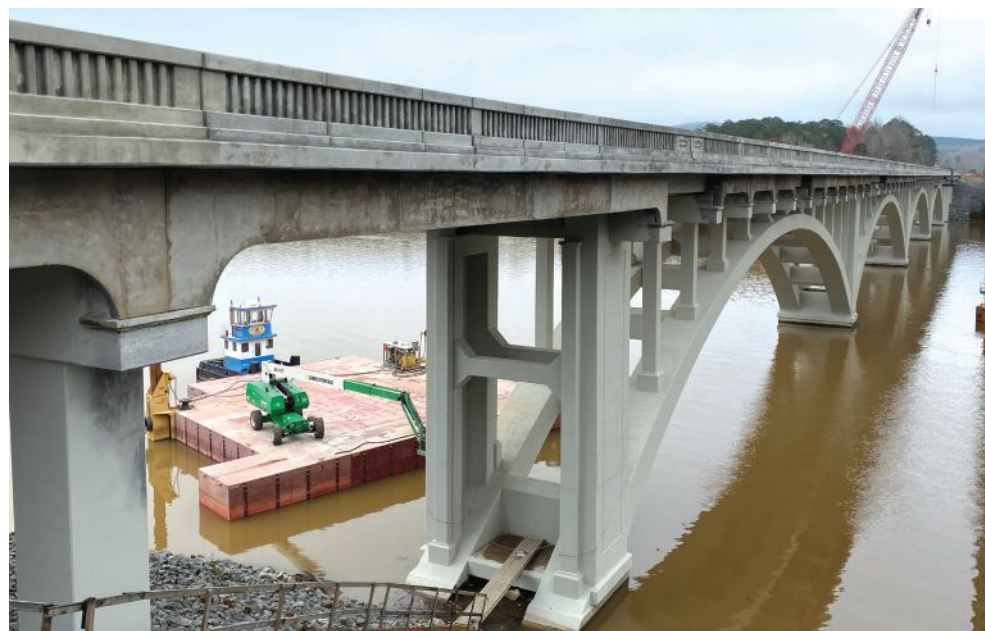
Precast concrete fascia panels were used to preserve the historic aesthetics of the original arch structure.

Another unique feature of the bridge was the barrier railing, which was designed to preserve the architectural intricacy of the existing structure. The concrete barrier was cast in place using custom barrier wall forms to achieve the exact spacing and appearance of the “church windows” that span the length of the bridge. Because NCDOT specified a Class II surface finish on the concrete barrier, full-time grinding and patching crews were required to ensure the final product met expectations. This

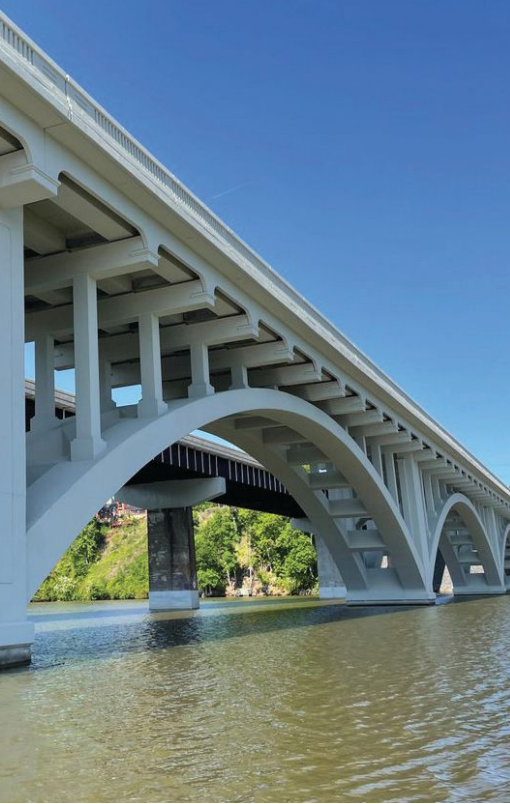
The completed project maintains the historic character of the original structure while extending the service life of the bridge for many more years.

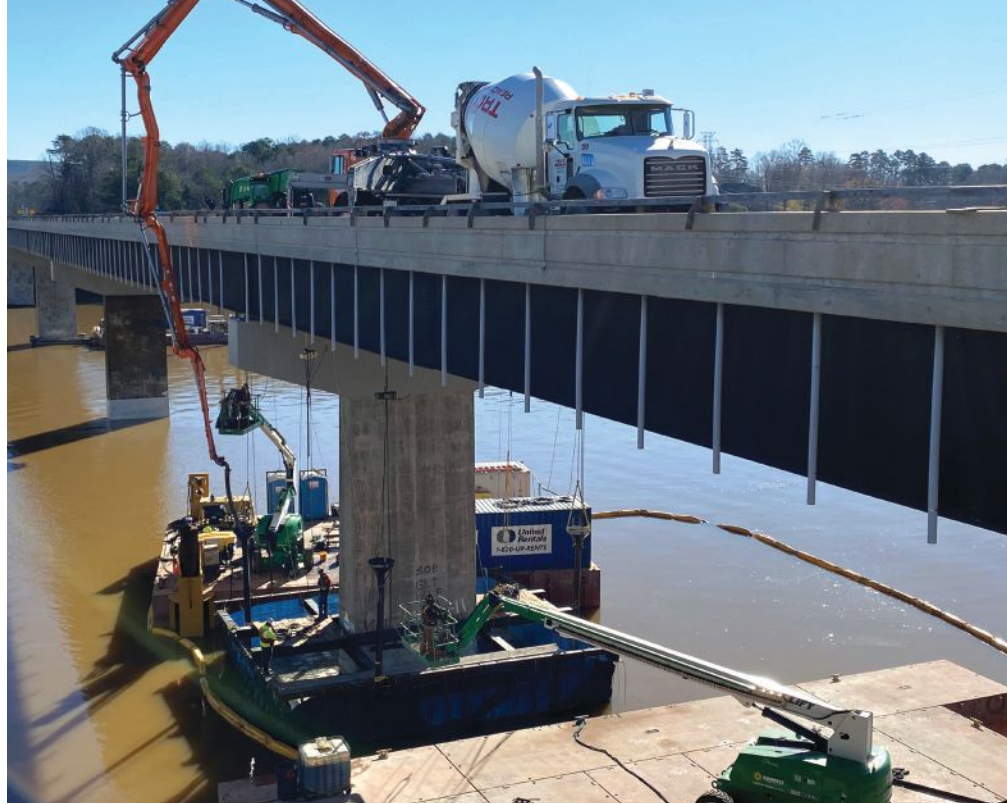
Another issue that was unforeseen due to limited access to the eastbound bridge during the preconstruction phase was the discovery of an improperly constructed footing for one of the piers. Because of the flow of the river, the pier was gradually moving out of position. A 2-ft-thick protective layer of reinforced concrete was designed to be cast in place around the pier footing more than 20 ft below the waterline to resolve the issue. An innovative solution to accomplish the repair was developed using reinforced geotextile fabric for the formwork; this solution ensured that the project schedule was maintained and access in the waterway was provided (see the Creative Concrete Construction article on page 53 for details).

The parallel bridge required a protective layer of 2-ft-thick reinforced concrete to be cast in place around one pier footing more than 20 ft below the waterline. More than 200 yd³ of concrete were placed underwater by tremie for this repair—a process that took 16 hours of continuous pumping from the deck of the bridge.

More than 200 yd³ of concrete were placed at the pier—a process that took 16 hours of continuous pumping to complete. The sheer quantity of concrete placed, plus the logistics of bringing in all the trucks and pumping the concrete, made this a unique aspect of the project.
