Extending the Life of Concrete Segmental Bridges

by Chris Davis, Scott Greenhaus, and Bob Sward, Structural Technologies; Craig Finley and Jerry Pfunter, Finley Engineering Group

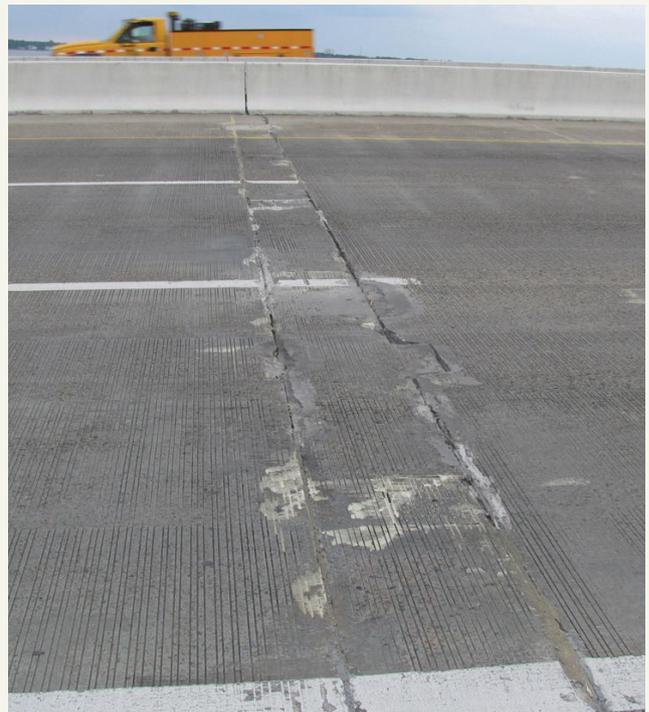
A precast concrete segmental bridge with a joint opening extending the full depth of the deck. The spalling is due to a lack of prestressing across the joint and issues with the top-slab dimensional proportions. Photo: Finley Engineering Group.

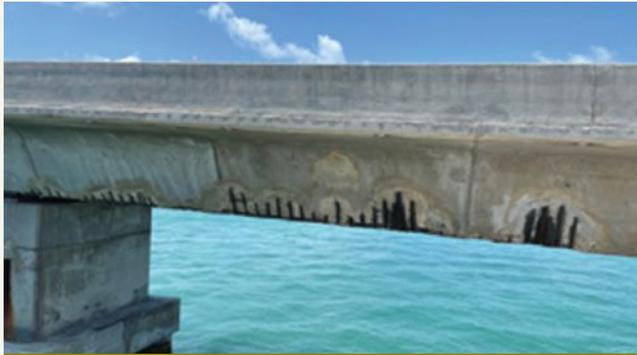
A precast concrete segmental bridge with loss of concrete cover and reinforcement cross-sectional area due to corrosion of reinforcement after approximately 45 years of service and exposure to a saltwater environment. Photo: Finley Engineering Group.

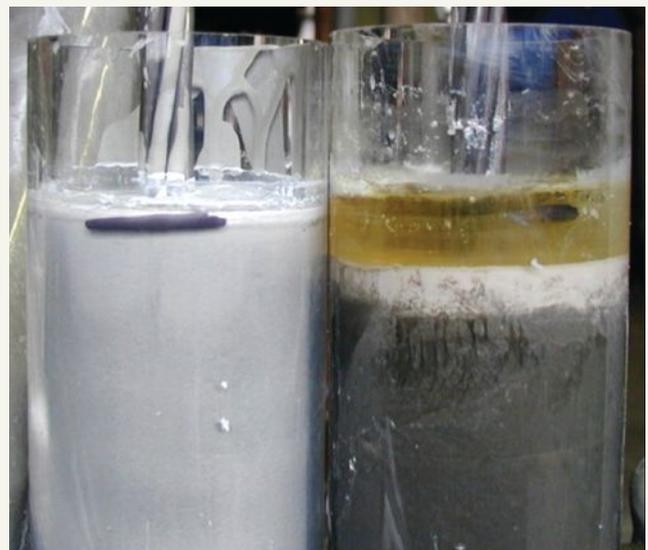
Comparison of grout column samples. The sample on the right exhibits bleed water segregation; the sample on the left is a nonbleeding, nonsegregating grout. Photo: Structural Technologies.

Throughout the 1980s and 1990s, cement, water, and expansive admixtures were part of the standard formula for post-tensioning grouts. These grouts have proven to be susceptible to bleed water at high points and post-tensioning anchorages, resulting in voids in tendon ducts at critical locations. This situation gained attention in 2000 when several external tendons on the Mid-Bay Bridge in Okaloosa County, Fla., failed.¹ The investigation into this event, as well as others, has led to a better understanding of grout rheology, mixing, placing, and duct system detailing requirements. Subsequent improvements in the grouting process and duct systems have been developed and implemented.

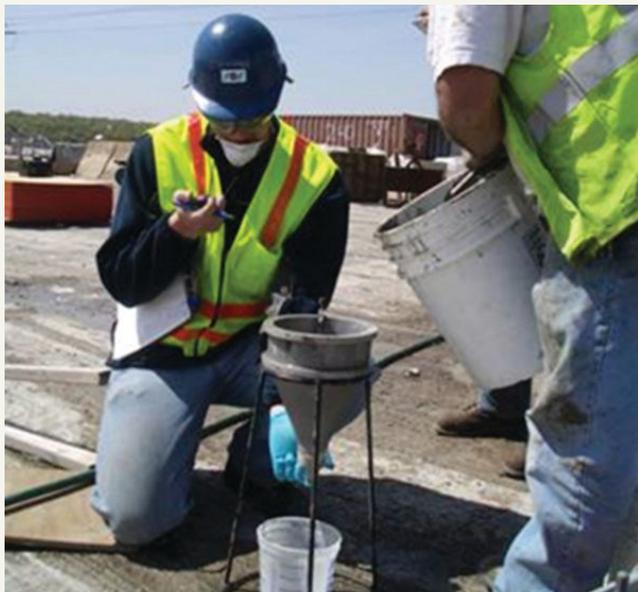
Post-tensioning system details and procedures, quality assessment, quality control, and technician training and certification requirements have all contributed to more successful and reliable tendon grouting. Photo: Structural Technologies.

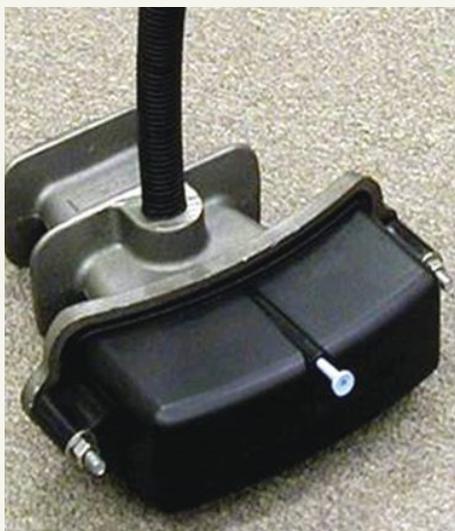
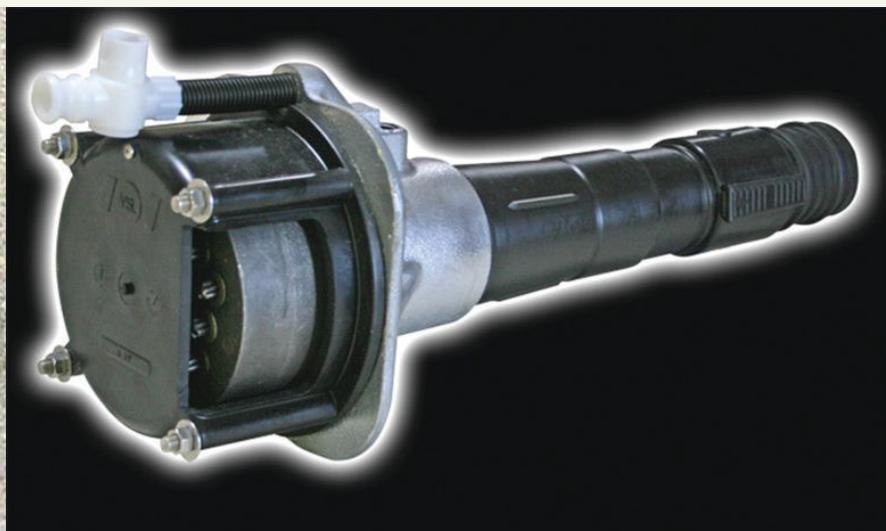
Corrosion-resistant tendon anchorage systems: anchorage for slab tendon (left) and multistrand tendon anchorage with cutaway of grout cap (right). Photos: Structural Technologies.

Special attention should be given to construction and expansion joints as well as closure pours. If the expansion joints are open or the joint seals fail, water can infiltrate the joint and deteriorate the adjacent prestressing steel and anchorages, particularly where the end anchorages are not adequately protected.

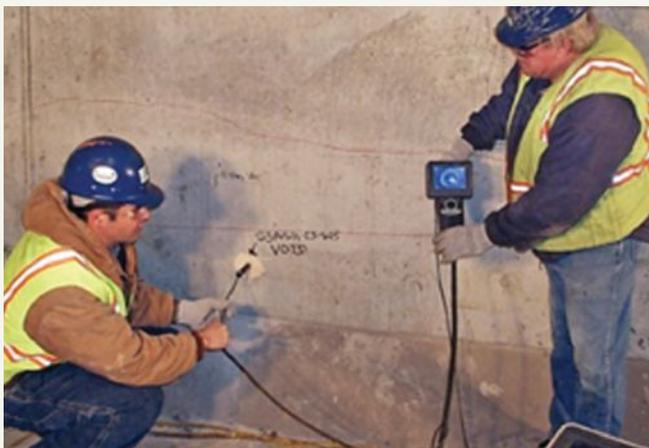
Inspection of a void in a grouted post-tensioning duct using a borescope. Photo: Structural Technologies.

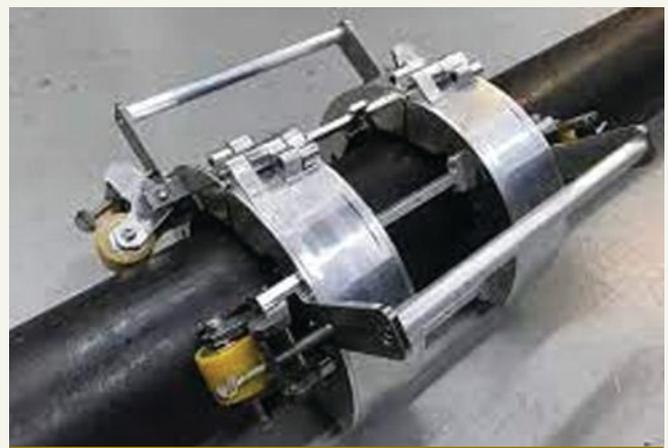
Magnetic flux leakage technology being used on an external tendon to detect section loss and wire breaks in post-tensioning strands. Photo: Infrastructure Preservation Corporation.

- **Electromagnetic investigation:** Magnetic flux leakage (MFL) subjects the steel tendon to a strong magnetic field to determine the extent of corrosion and/or wire breaks in a post-tensioning tendon. At locations where there is section loss or wire breaks, the magnetic field in the tendon is disturbed and is recorded by sensors. This technique can be used on external tendons and stay cables but is generally not applicable for internal tendons.
