Harbor River Bridge Replacement

by Lynda Monroe, Infrastructure Consulting & Engineering PLLC

HARBOR RIVER BRIDGE REPLACEMENT / BEAUFORT COUNTY, SOUTH CAROLINA

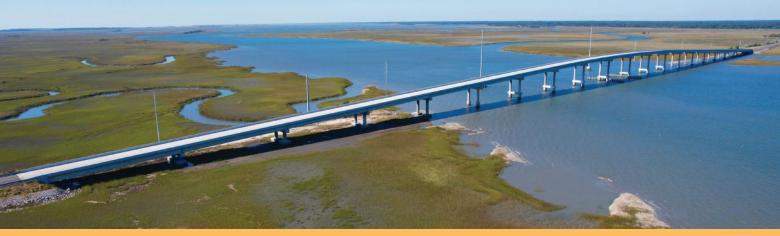
The new 3340-ft-long Harbor River Bridge carries U.S. Route 21 over environmentally sensitive habitat. Photo: Kaze Aerial Production.

The size of the replacement bridge makes it a focal point for the local community and completely transforms the landscape of the surrounding area. The structure spans a significant distance over environmentally sensitive salt marshes and a tidal river from St. Helena Island to Harbor Island. The layout of the bridge was established to satisfy the required vertical clearance over the 90-ft-wide navigational channel (65-ft minimum vertical clearance from the mean higher high-tide elevation to the low chord), and to meet the existing roadway using a maximum grade of 4%. The total bridge length is 3340 ft, and the maximum height is approximately 120 ft from the top of the deck to the bottom of the river at its highest point.

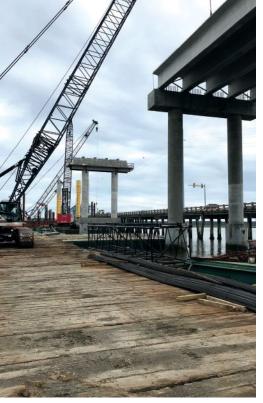
Sectional barges were used for construction access and to place the prestressed concrete beams. The prestressed concrete beams and piles were delivered to the project site either by barge or truck. Photo: United Infrastructure Group Inc.

To further minimize work in the salt marshes, footings supported by 24-in. prestressed concrete piles were selected for the interior bents outside of the channel limits. Crews constructed these marsh bents from temporary causeways, using sectional barges that could be removed without long-term damage to the marsh ecosystem. Floating barges were used for much of the bridge construction access. Crews used either trucks or barges to deliver the prestressed concrete piles and beams to the site, depending on their location in the final structure.
