Advances in Stress Wave Scanning of Decks and Pavements

Yajai Tinkey, Ph.D., PE¹, Larry D. Olson, PE² Patrick Miller³, PE and Matthew Hergert⁴

^{1,2,4,4}*Olson Engineering, Inc., Wheat Ridge, CO*

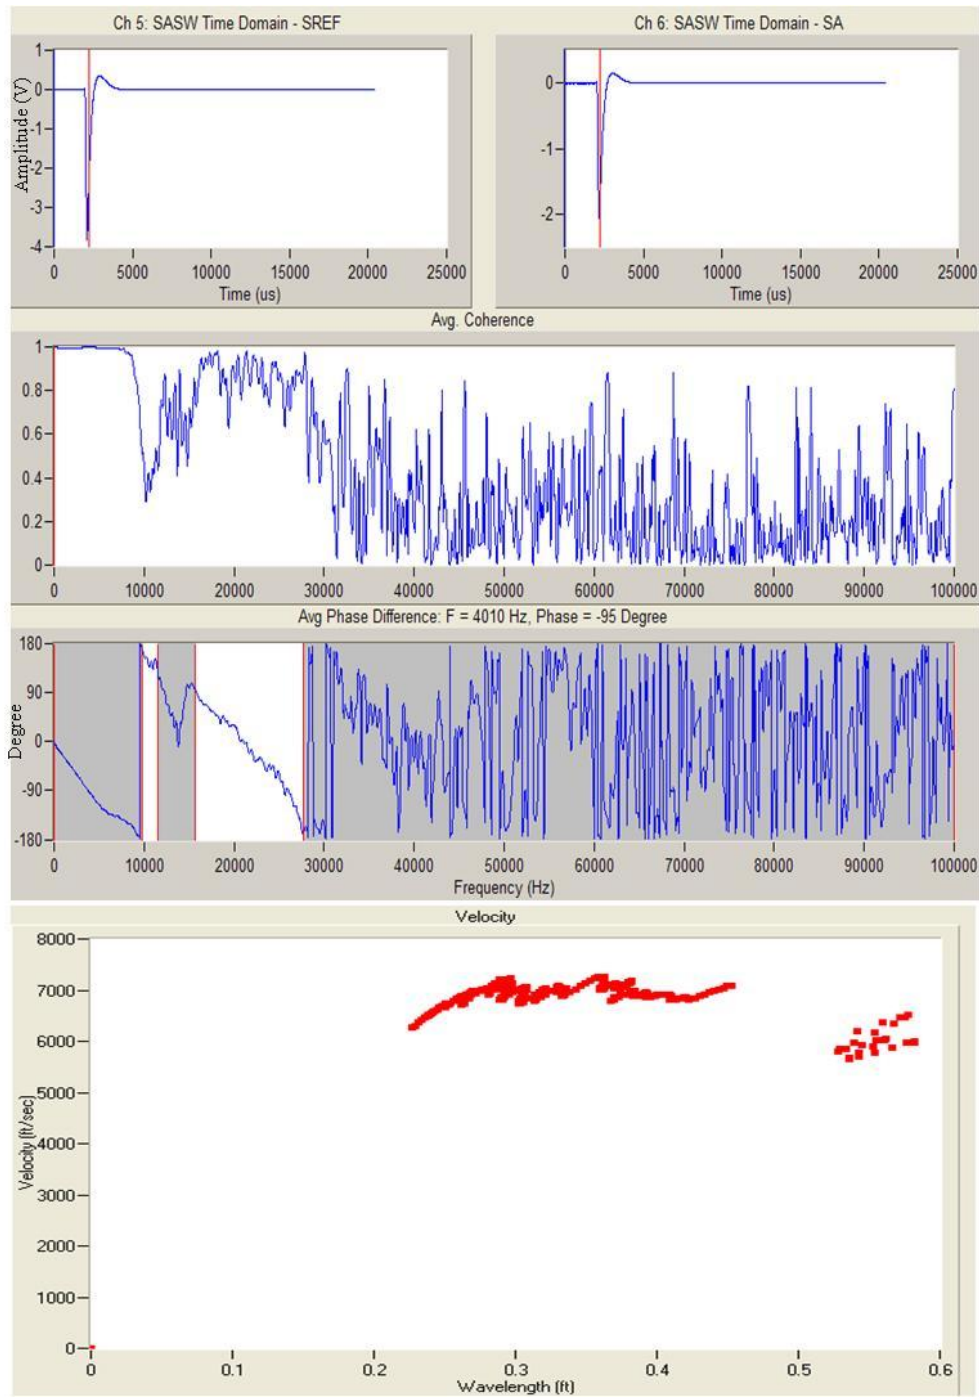
Figure 1 – SASW Data Processing from Non-contact Microphones

For the SASW tests, two microphones of the same kind were used as non-contact transducers. The distance between the two microphones was 4 inches (10.1 cm) and a solenoid impactor was used as an impact source. The microphones were mounted 3 inches (7.6 cm) above the concrete slab and the source was located between 8 and 18 inches (20.3 and 45.7 cm) away from the closest microphone. Good quality SASW data (top trace in Figure 1)

with a good coherence up to 10,000 Hz (2nd trace from top in Figure 1) was captured by both microphones. Note that the SASW data shown in Figure 1 were exponentially windowed after the large amplitude surface wave pulse traveled by them to eliminate other wave vibration modes. The surface wave velocity can be calculated from the phase plot (3rd trace from top in Figure 1) as a function of wavelength (velocity = frequency x wavelength (7)). The surface wave velocity is calculated to be approximately 7,000 ft/sec uniformly from wavelengths of 0.2 to 0.4 ft (6.1 to 12.1 cm) as seen in the last trace in Figure 1 which showed good agreement with the results from contacting displacement transducers.

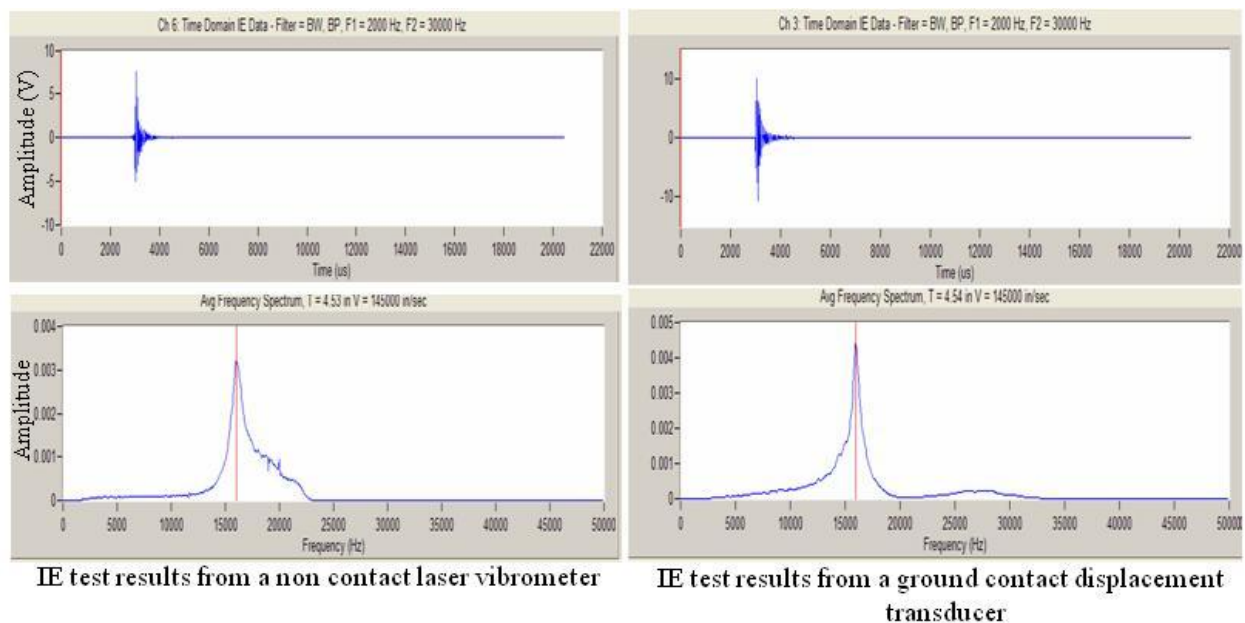
Figure 2 – Comparison of IE Data from a Non-contact Laser Vibrometer and Ground Contact Displacement Transducer on a 4.5 inch (11.4 cm) thick Concrete Slab-on-Ground

Non-contact Laser Vibrometers.. Laser vibrometers measure vibration using the Doppler shift effect and generally have a wide frequency range and excellent vibration resolution which are well suited to indoor laboratory testing. In addition the laser vibrometer has an ability to measure high vibration frequencies (up to 100 kHz depending on the unit) which make it suitable to measure surface waves in materials (16). A significant drawback of laser vibrometers is their cost, which typically ranges from \$10,000 – \$50,000 for a single receiver. Abraham et al. performed a successful study in which an extreme number of repetitive surface wave tests were performed on a variety of concrete samples using a laser vibrometer receiver mounted on a semiautonomous robot (17). The laser vibrometer has also been successfully implemented as a receiver for impact echo testing on concrete structures (18 and 19). In this preliminary experimental study, a laser vibrometer unit was rented from Polytec, Inc. The maximum Doppler frequency that the unit can acquire is 22 kHz. In this experiment, both a laser vibrometer and an accelerometer transducer were used as receivers. The laser vibrometer was attached to a tripod 40 inches (101.6 cm) above the tested concrete slab. A small Allen wrench was used as an impact source. In this case, a normal concrete velocity of 12,000 ft/sec was used to calculate the IE thickness. The left traces of Figure 2 show the IE data from the laser vibrometer on a 4.5 inch (11.4 cm) thick concrete slab and the right traces of Figure 2 show the IE data from the displacement transducer on an adjacent location. The top traces of Figure 2 are the time domain IE data and the bottom traces are the linear spectrum of the time domain data. Review of Figure 2 shows that the results from the laser vibrometer are as good in quality as the data from a displacement transducer.

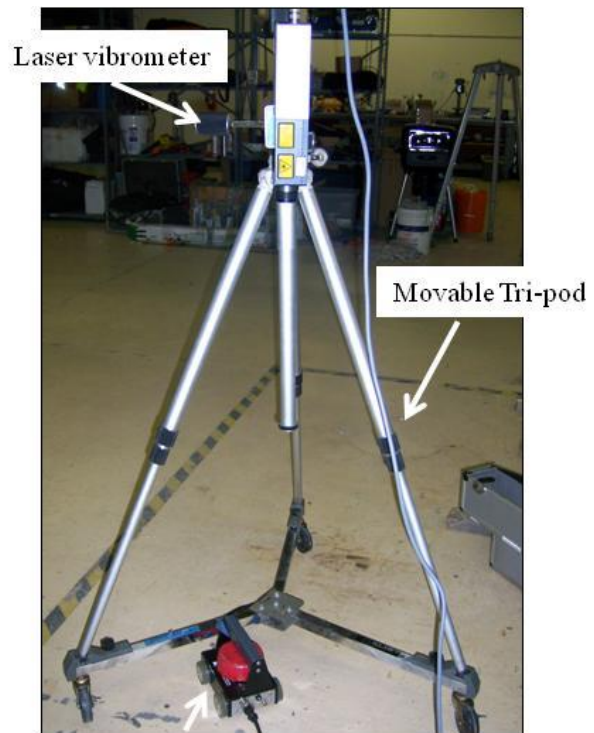
An automatic solenoid impactor (within the Impact Echo Scanner device) attached to the frame of the tri-pod

Figure 3 – Test Setup for Impact Echo Scanning

The only rolling contact transducers used commercially in IE tests is the rolling displacement transducer for Impact Echo Scanning. The rolling Impact Echo Scanner (IES) was first conceived by the second author in the 1990's (20) and is based on the IE method (5 and 6). To expedite the IE testing process, an Impact Echo Scanning (IES) device has been developed with a rolling transducer assembly incorporating multiple sensors, attached underneath the test unit. When the test unit is rolled across the testing surface, an optocoupler on the central wheel keeps track of the distance. This unit is calibrated to impact and record data at intervals of nominally 1 inch (2.54 cm). If the concrete surface is smooth, a coupling agent between the rolling transducer and test specimen is not required. However, if the concrete surface is rough, water can be used as a liquid couplant. A comparison of the impact-echo scanner and the point by point impact-echo unit is shown in Figure 4. Typical scanning time for a line of 157 inch (4 m), approximately 150 points, is 60 s with a resolution of 1 inch (2.54 cm) along a scan line.

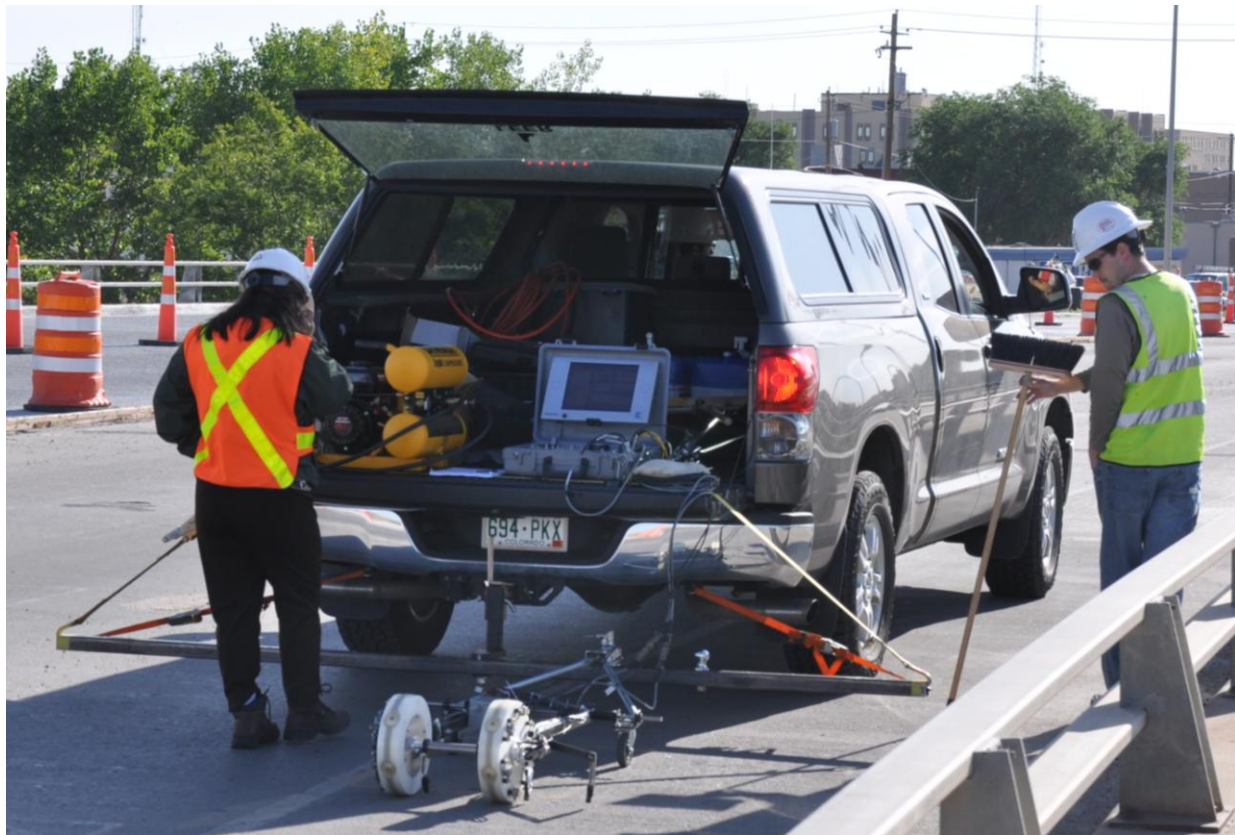
Figure 7 – Prototype Vehicle Mounted Bridge Deck Scanner (BDS) on 1st Street Bridge in Casper

A steel beam was attached to the towing hitch of the vehicle in the transverse direction as shown in Figure 7. The beam had trailer ball hitches at 1 foot spacings and would allow test runs to be performed at any 1 ft (30.48 cm) interval location across a lane. An example BDS-IE scan line test result is presented in Figure 8 (from a new bridge). Similar data sets were combined to produce the BDS-IE results plots discussed later herein for the 1st Street Bridge which had delaminations. The BDS unit has also been towed by had across bridge decks using a cart.

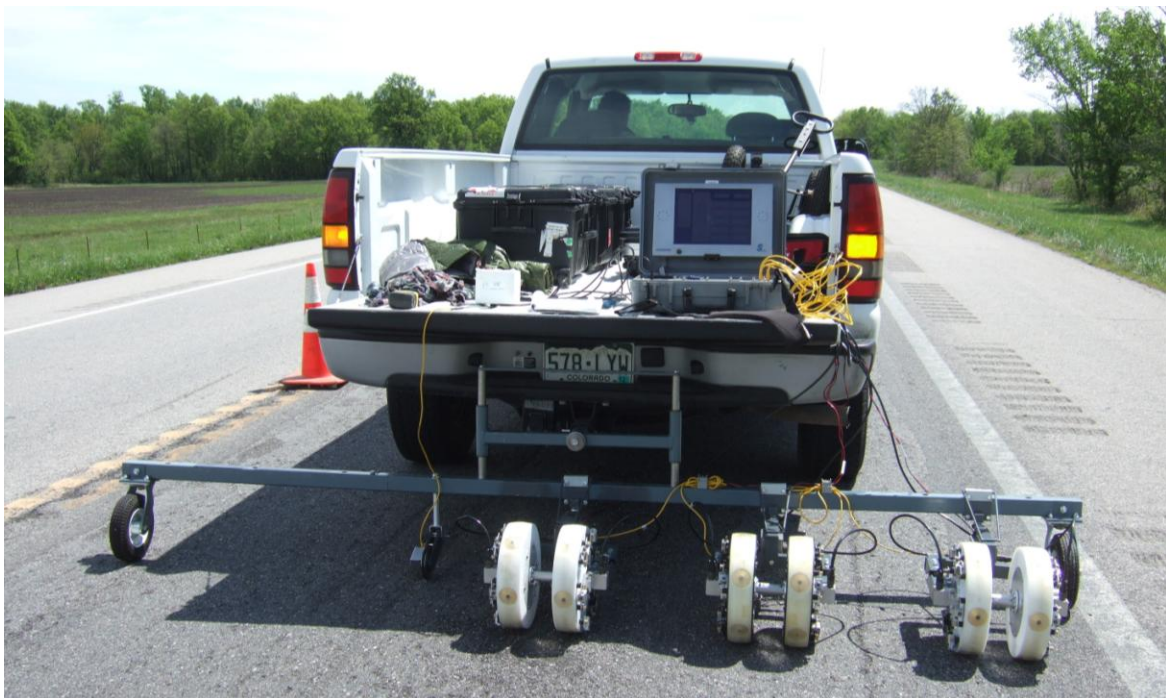
Figure 11 – Bridge Deck Scanner on Kansas Asphalt Pavement site with 3 pairs of wheels spaced 0.5 ft (0.15 mm) apart for combined Impact Echo and Spectral Analysis of Surface Waves scanning.

Application of Bridge Deck Scanner to Asphalt Pavement Delaminations. The initial research involved evaluation of both laboratory and full-scale pavement sections with constructed delaminations at the NCAT laboratory and test track at Auburn, Alabama. Based on this research, Impact Echo and Spectral Analysis of Surface Waves scanning with the BDS showed sufficient promise that the technology was selected for further evaluation in the second field phase of the project and the BDS was expanded from 1 pair of wheels to 3 pairs of wheels. The BDS was subsequently evaluated with the 3 wheel pairs at the NCAT test track and asphalt highway pavements in Florida and Kansas (shown on the Kansas pavement below in Figure 11). The wheels were spaced at 0.5 ft (0.15 m) apart for combined IE/SASW testing and shifted across the rear of the truck to test a whole lane in 2 passes.
