PCI Advisory on I-Girder Stability during Handling and Construction

by Chris D. Hill, John S. Dick and Maher K. Tadros

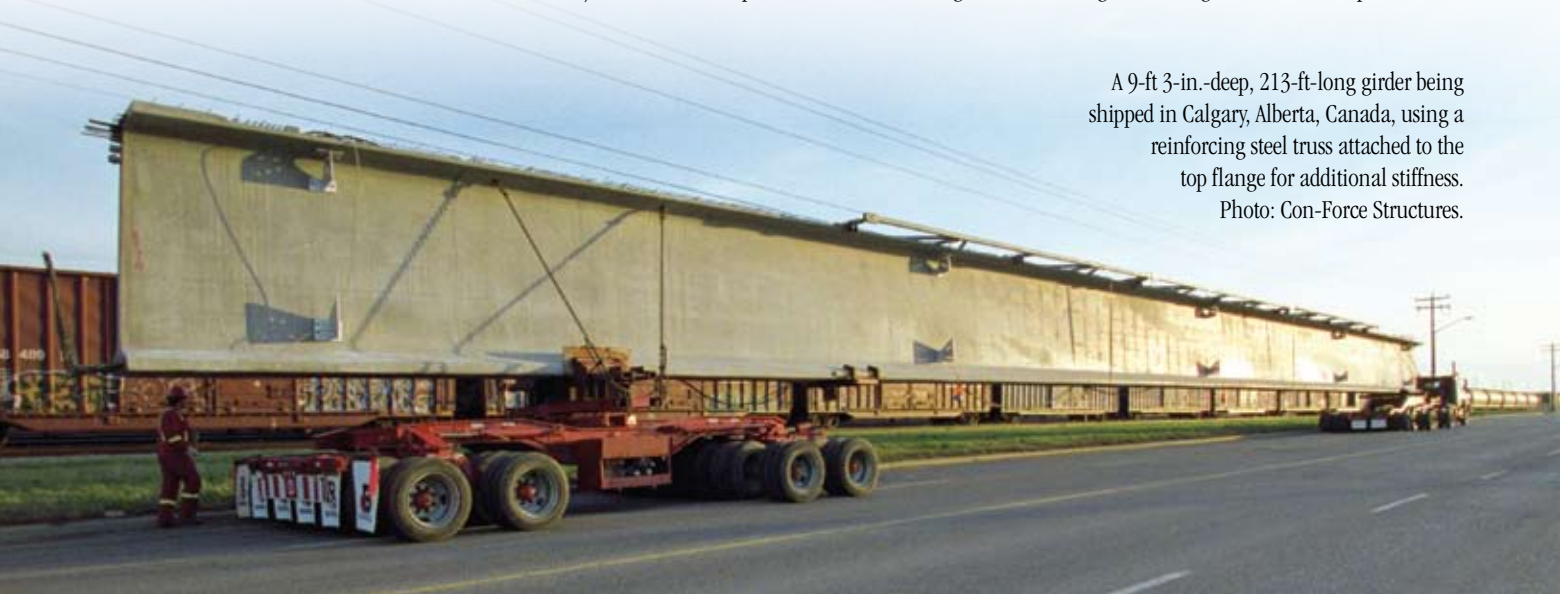
A 9-ft 3-in.-deep, 213-ft-long girder being shipped in Calgary, Alberta, Canada, using a reinforcing steel truss attached to the top flange for additional stiffness.

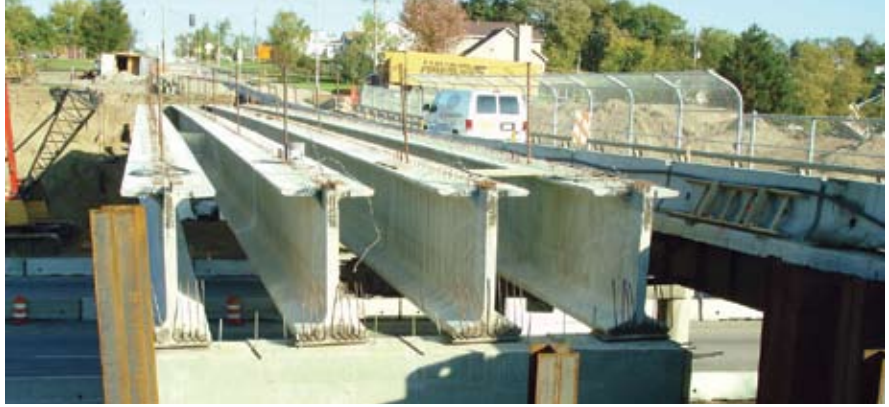
An NU2000 (6-ft 7-in.-deep), 183-ft-long girder used for the construction of the Riverview Road Bridge over I-80 in Omaha, Neb. The bearing pads are 36 in. wide, 8 in. long and 1 7/8 in. thick. The wide, thin, pads provide stable support for these long girders. This bridge has steel mid-span diaphragms but no diaphragms on the piers. Photo: Coreslab Structures (OMAHA) Inc.

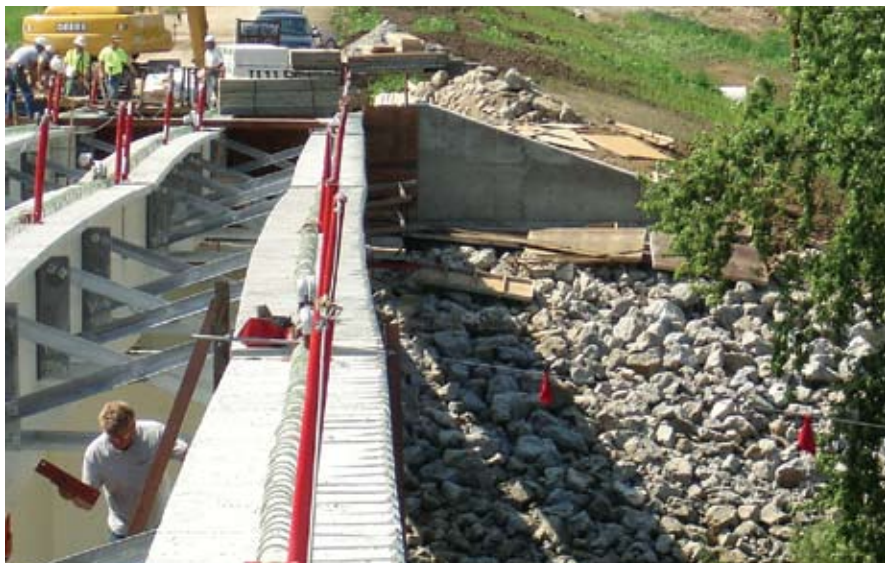
This photo shows long-term sweep. The LTS was subsequently removed by straightening, plumbing beam ends, and reattaching cross bracing to the straightened girders.

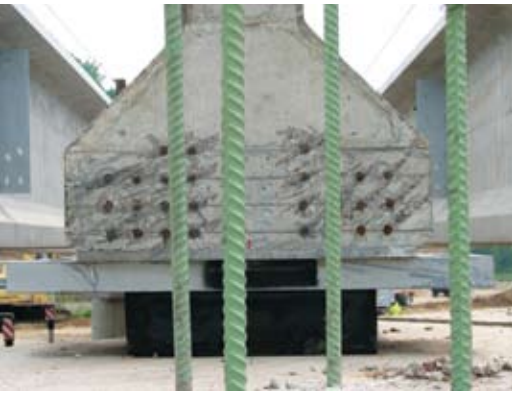
Example of a narrow, tall bearing pad that must be given attention by all project stakeholders and avoided by designers.

When a girder is placed on a narrow bearing and not exactly centered, slight eccentricity would create significant lateral stress about the girder's weak axis, and significant additional LTS. This situation would be magnified if the girder web were not plumb.
