Creative Patches Save McCullough Bridge

Cedar Lane Bridge over Rockville Pike

Route 76 Bridge over Lake Taneycomo

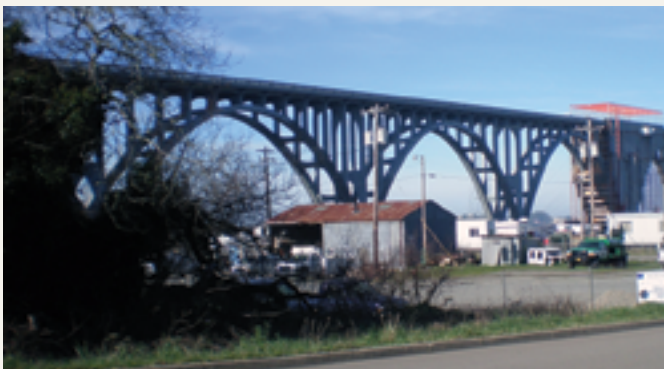
The Conde B. McCullough Bridge on Highway 101 at Coos Bay, Ore. Photo: International Concrete Repair Institute and BASF Corp.

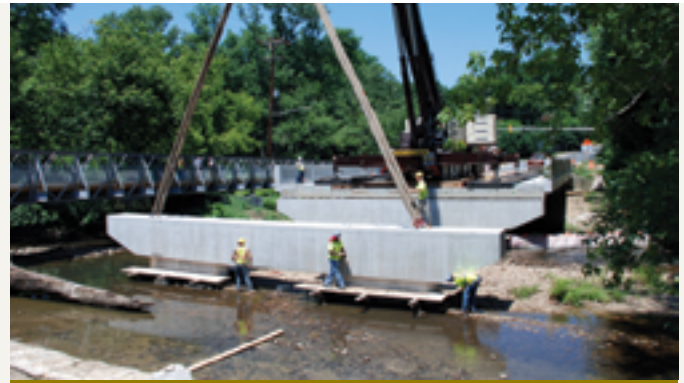
Erection of precast concrete pier caps. All photos: Newcrete Products.

The structure was assembled by first setting, and vertically post-tensioning, the pier caps and abutment caps to the existing pier stubs utilizing 1-in.-diameter, epoxy-coated, high-strength, threaded bars. These bars conformed to ASTM A722, Grade 150, Type II and were tensioned to 54 kips. The adjacent box beams were then placed and transversely post-tensioned using 1¼-in.-diameter, Grade 150, hot-dipped, galvanized, ASTM A722 threaded bars, which were tensioned to 120 kips. A 5-in.-thick, cast-in-place, concrete overlay on the roadway and a 4-in.-thick concrete overlay on the sidewalk completed the structure.

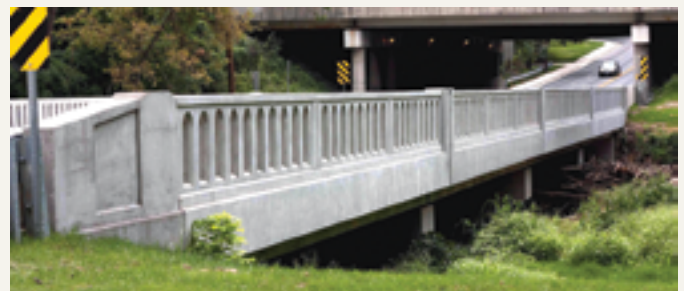
Completed bridge.

Planned and orchestrated for success, the removal and replacement construction was completed in 51 days, 19 days ahead of schedule. The application of accelerated bridge construction techniques, using precast, prestressed concrete structural components provided an economical solution, met the schedule, and produced the desirable end results of this truly unique project. ▲

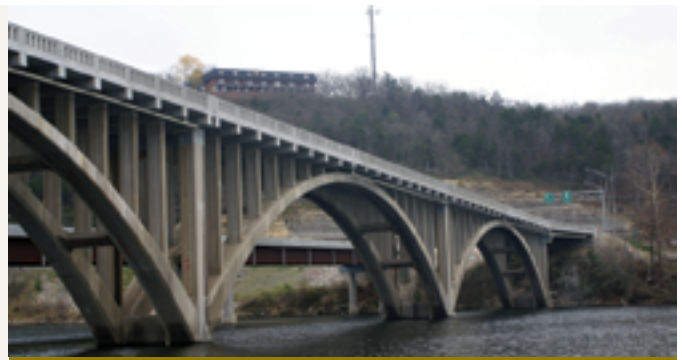
Photo of the completed bridge. All photos: Kevin Skibiski, Horner & Shifrin.

Existing concrete spandrel beams were spaced at 10.5 ft along the length of the arch spans. The existing beams were cast on concrete spandrel columns that carry the load to the arches. To speed and simplify construction, new precast, reinforced concrete spandrel beams were used. The beams had pockets cast in them to allow the existing column reinforcement to be re-used in the connection detail.

Spandrel beams were set on a bed of epoxy on top of the existing columns. The epoxy acted both as a leveling pad and joint sealant around the exterior of the reinforced connection. The pockets were then filled with grout. Once the process was mastered, the contractor was able to complete the work quickly, saving months of construction time.

Challenges included casting the grout pockets and handling the beams because of the reduced cross section at the grout pockets. Ninety-five beams were required, each approximately 32 ft long with a 2-ft-square cross section. The tops of the beams were sloped 2% transverse to the roadway to provide a better fit-up of the partial depth, precast, prestressed concrete deck panels.

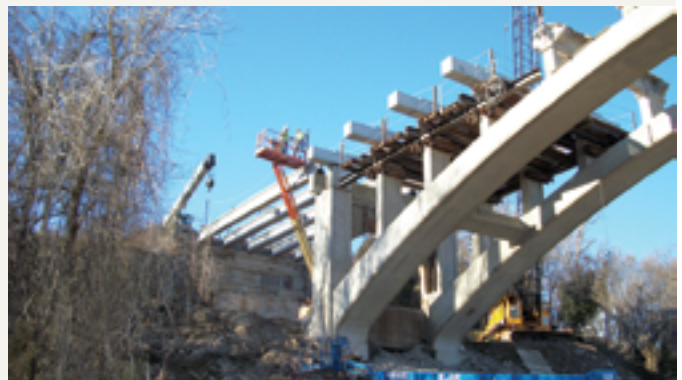
Precast spandrel beams were placed on top of the existing columns.
