PROJECT

RECONSTRUCTION

of the Ohio & Erie Canal Aqueduct Over Tinkers Creek

by Anthony Borrelli, Bergmann Associates

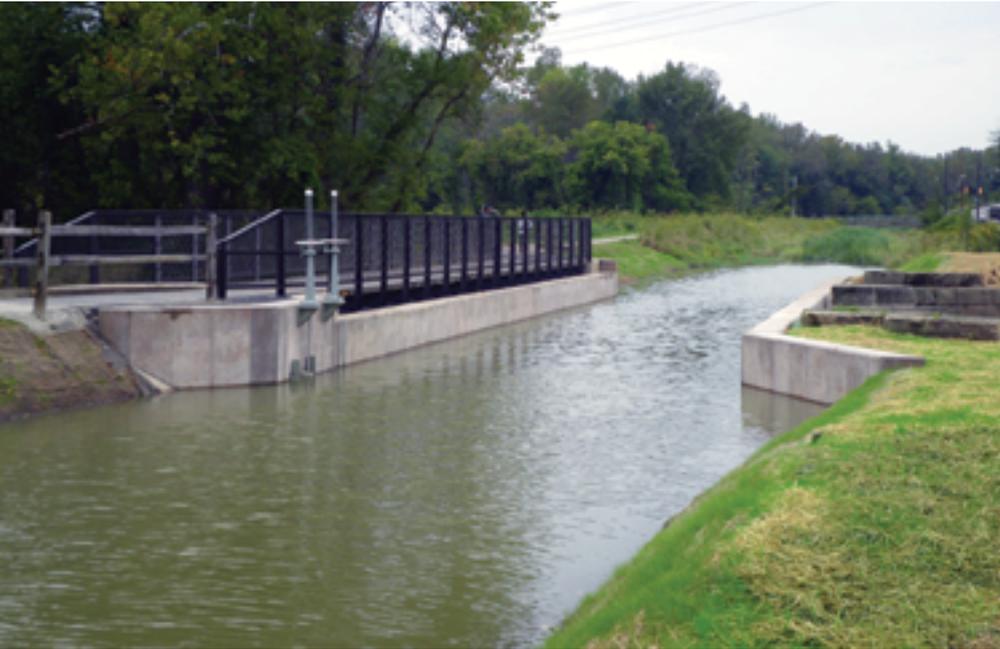
View of the re-watered Ohio & Erie Canal across Tinkers Creek. Manually operated sluice gates in the wall of the transition structure allow for regulation of canal water levels. Photo: Bergmann Associates.

The original aqueduct featured two, 4 by 4 ft “waste gates” in the downstream sidewall of the timber trough. These gates provided National Park Service staff with the ability to regulate the water levels in the canal, either after a flood event or for maintenance purposes. Replicating such large gate openings in the through girders would have compromised the structure’s capacity.

Rather, two 2-ft-square, manually operated sluice gates were provided in the side wall of the southern transition structure and discharge into

3-ft-diameter, outfall pipes, buried behind the existing stone abutments, out-letting downstream to Tinkers Creek.

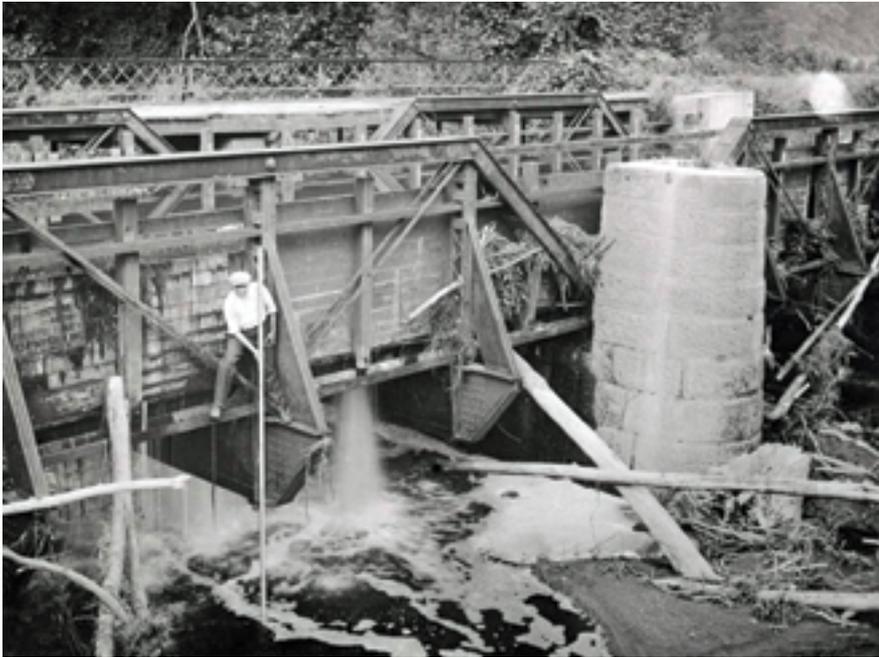
The 1905 aqueduct structure consisted of a two-span truss supporting a timber trough. Note the low freeboard to Tinkers Creek and significant debris accumulation. Photo: National Park Service.

As a result, on-going maintenance has been needed through the years. The aqueduct has been relocated, rehabilitated, and replaced several times, most notably in 1905 when a two-span iron truss supporting a timber plank trough was installed on the original masonry pier and abutments.

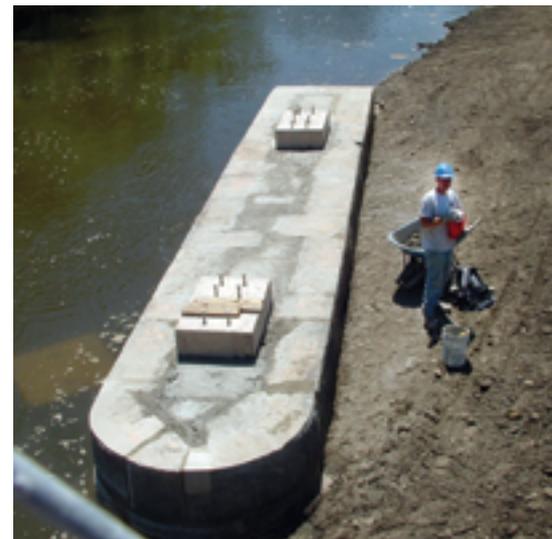
Center pier masonry reconstructed to just below the bottom of the aqueduct trough. Note the two concrete columns cast inside the pier that support the bearings for the new trough. Photo: Bergmann Associates.

Twin 4 by 3 ft concrete columns extending up from the pier footing were cast inside the core of the stone pier to support the stainless steel and elastomeric bearings that carry the aqueduct trough. This provided an entirely new load carrying system and avoided loading the sandstone masonry.

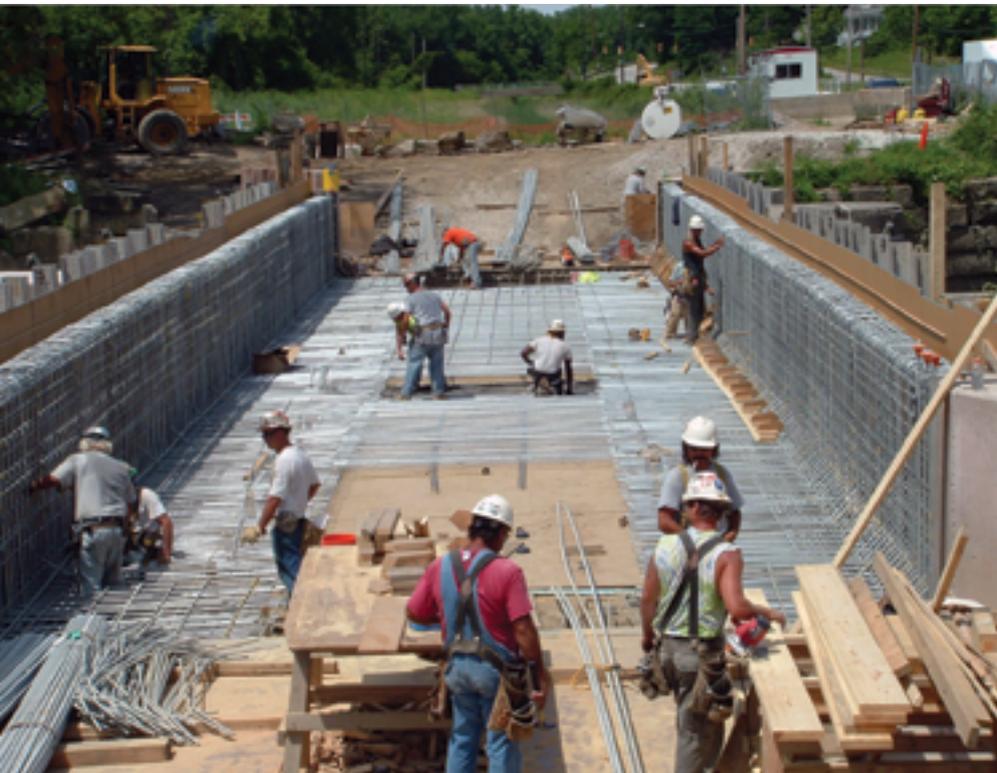
Placement of the galvanized reinforcement for the new trough floor slab and through girder sidewalls. Photo: Bergmann Associates.

The specified compressive strength of all the concrete was 4 ksi and featured an integral color admixture consistent with other newly constructed concrete structures in the park. For added durability, galvanized reinforcement was used throughout the structure.

The new aqueduct consists of a 96-ft-long, two-span through girder and floor slab system continuous over the center pier. The original aqueduct cross section was considered to be a historic feature that had to be maintained. Through girders, 1 ft 8 in. thick and 7 ft 2 in. deep, make up the sidewalls of the trough, and a 1-ft 6-in.-thick concrete slab spans 21 ft 11 in. between the girders making up the aqueduct floor.

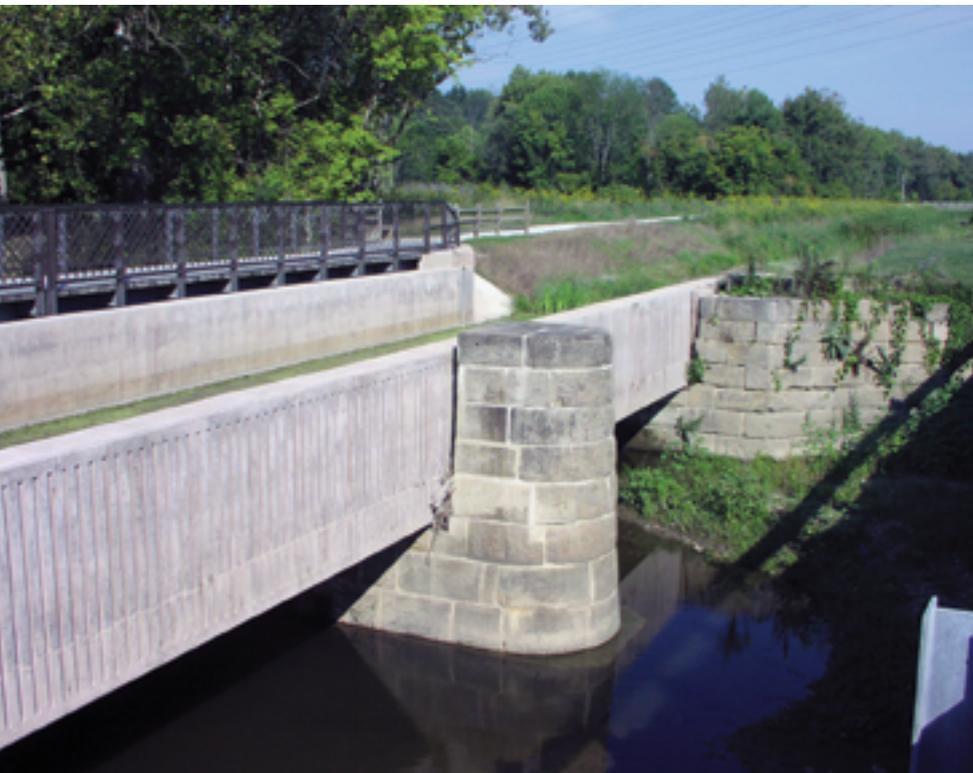
Elevation view of the new aqueduct and fully reconstructed masonry pier. Photo: Henry G. Russell Inc.

The existing 44-ft-long masonry pier was significantly deteriorated including cracked and dislodged stones, missing mortar joints, heavy vegetation growth, and settlement at the upstream end. The 112 ashlar sandstone blocks making up the pier were completely dismantled and the pier fully reconstructed as part of the project.

Various labor-intensive hand repair techniques were used to restore the historic stonework including re-tooling the exposed stone faces that featured a bush-hammered surface with smooth window pane margins, “dutchman” repairs consisting of piecing in new corners of chipped stones, and full replacement of the individual stones in some cases.
