# Post-Tensioning Grouts: Challenges and a Path Forward

by Reggie Holt, Federal Highway Administration

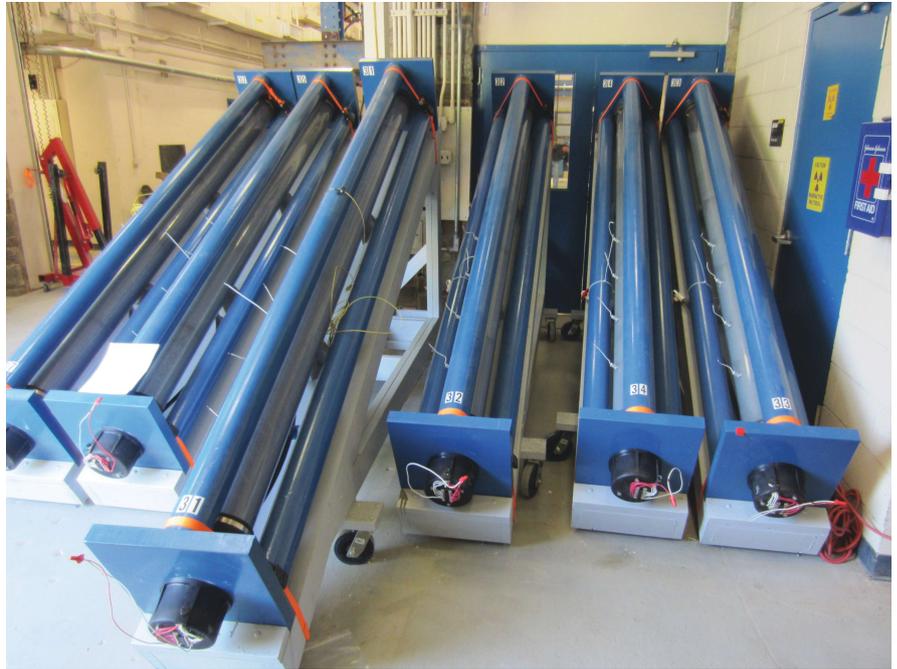
*Post-tensioning tendon corrosion testing on stressed tendons. Photo: FHWA Turner Fairbank Research Center.*

Subsequent to the identification of this issue, Sika and Federal Highway Administration (FHWA) each started independent efforts to collect chloride data, identify end users, and perform research to determine the long-term performance of PT strand exposed to high levels

of chloride. Results from these efforts were used to develop an FHWA technical advisory (TA) on assessing and managing the long-term performance of post-tensioned bridges having tendons installed with grout containing elevated levels of chloride ([www.fhwa.dot.gov/bridge/t514033.pdf](http://www.fhwa.dot.gov/bridge/t514033.pdf)). This TA, released in November 2013, provides guidance on identifying SikaGrout 300PT end-users, assessing PT tendon service life risks, as well as recommended management practices.

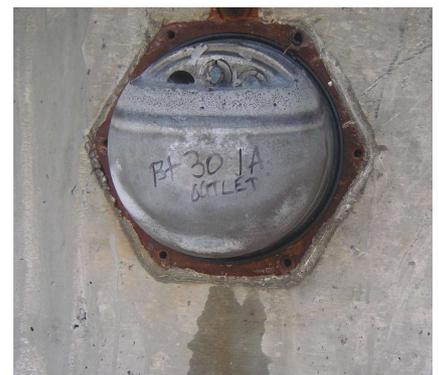
*Segregated grout at post-tensioning tendon end anchorage. Soft grout is located in upper layer. Photo: Texas Department of Transportation.*

A second issue deals with segregation of prepackaged, thixotropic PT grouts during or immediately after the grouting of PT ducts. PT grouts commonly used in the United States have sporadically been observed to exhibit this condition. When it forms, the grout matrix is typically separated into three common layers, with a top layer of soft (putty-like) grout, a middle layer of friable grout, and a lower layer of hard grout. The upper soft layer in segregated grout is highly corrosive and is therefore of

great concern. Segregated grout formations are typically isolated to tendon high point and anchorage locations with volumes generally varying from minimal to filling the upper third of the of the PT duct along a limited length

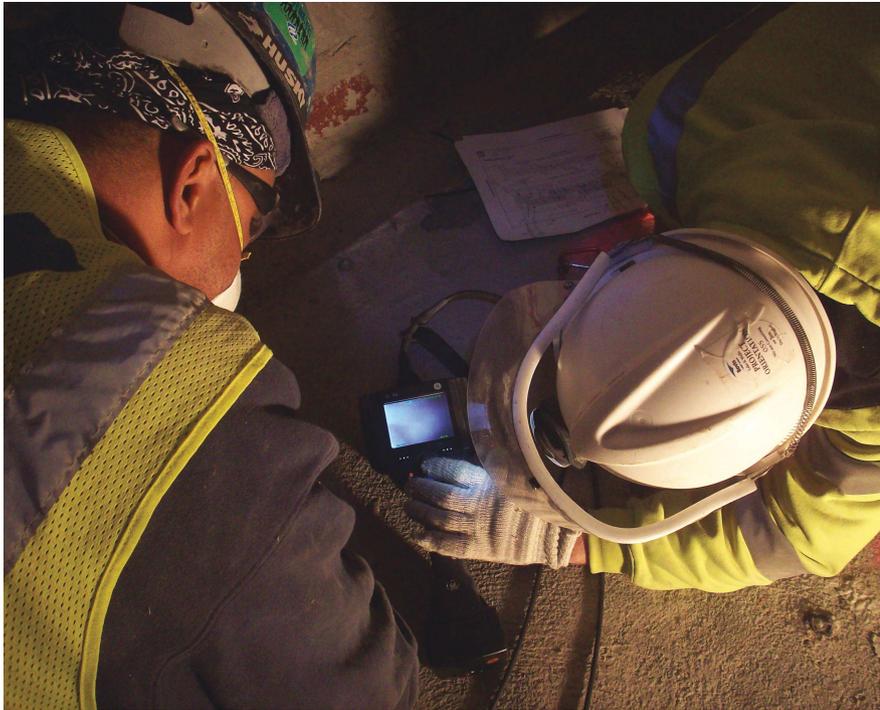
Inspectors visually examining a post-tensioning tendon using a boroscope. Photo: Structural/VSL.

The PTI M55.1-12 *Specification for Grouting of Post-Tensioned Structures* was recently updated to address concerns with grout segregation and strengthen its bleed water provisions.<sup>1</sup> In addition, extra care should be taken before tendon grouting to ensure that excess water is not inadvertently introduced into the PT grout from residual water in the grout mixer, conveyance, or duct. Because segregated grout formation is typically isolated to tendon high points and anchorages, post-

grouting inspections at these locations are highly recommended. More information is needed to fully understand segregated grout; however, following the above requirements and recommendations should both greatly reduce the occurrence of segregated grout and provide a means to identify segregated grout during bridge construction when it occurs.
