# I-5 Skagit River Bridge Collapse and Rapid Replacement

by Tom Baker, Dr. Bijan Khaleghi, Todd Harrison, Patrick Fuller, and Rich Zeldenrust, Washington State Department of Transportation

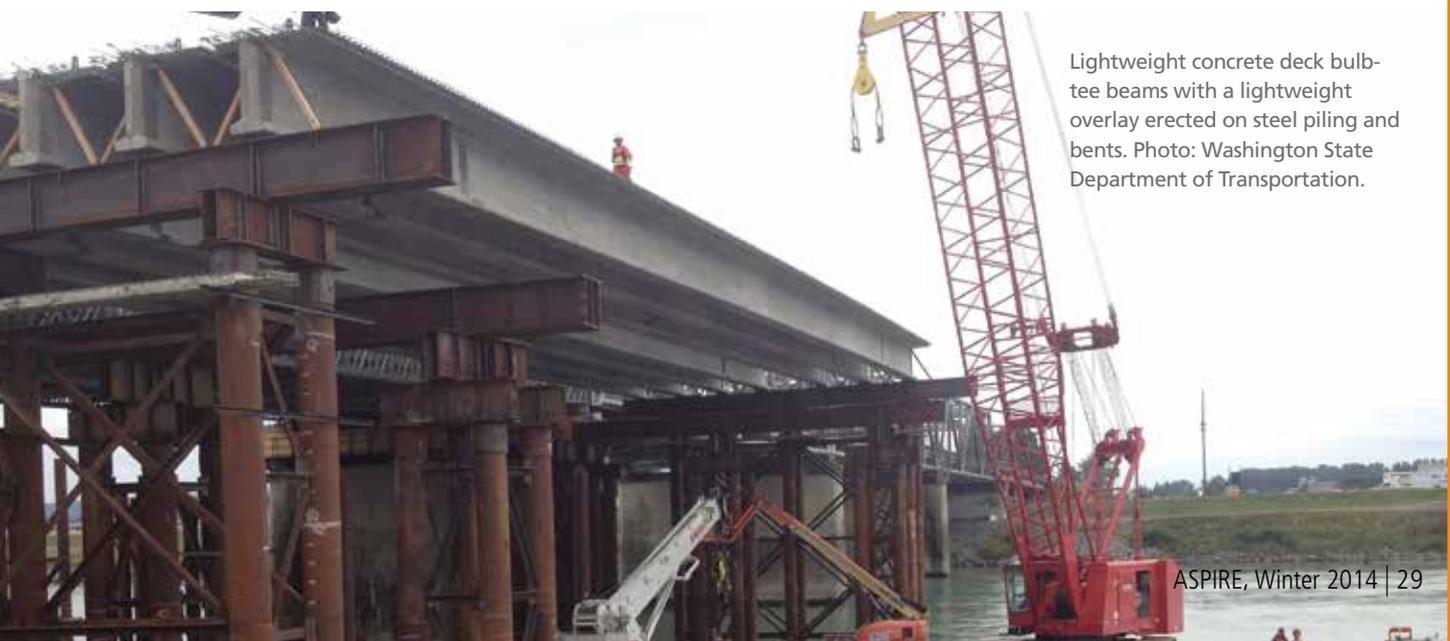
Lightweight concrete deck bulb-tee beams with a lightweight overlay erected on steel piling and bents. Photo: Washington State Department of Transportation.

The permanent superstructure was constructed on steel piling and bents, just downstream of the temporary spans. The girders were set using a 500-ton crane on the river's dike and a 200-ton crane on a barge system. The crane picks were quite detailed. Each pick required 19 specific moves, including passing the end of the girder from the dike crane to the barge crane, tucking the girder under the boom of the barge crane—while re-ballasting the barge system—and finally re-ballasting the barge as the girder was placed on the temporary bents.

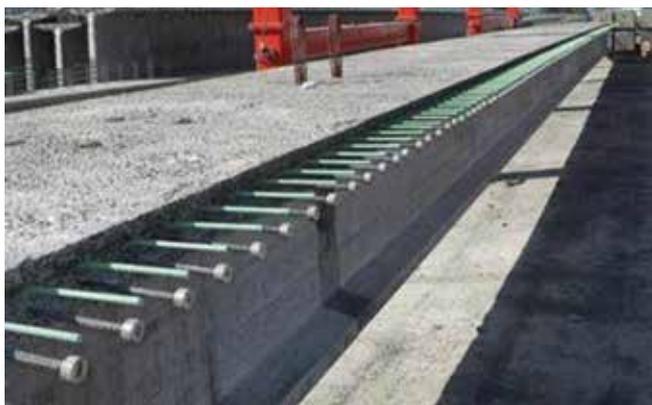
Lightweight deck bulb-tee girders in the casting yard. Photo: Washington State Department of Transportation.

The WSDOT plan to reconstruct the I-5 Skagit River Bridge consisted of constructing the permanent replacement span using accelerated bridge construction techniques. The 160-ft-long permanent replacement span, composed of 65-in.-deep deck bulb-tee girders made of lightweight concrete with

a silica fume concrete overlay, was built adjacent to the bridge and its temporary spans.

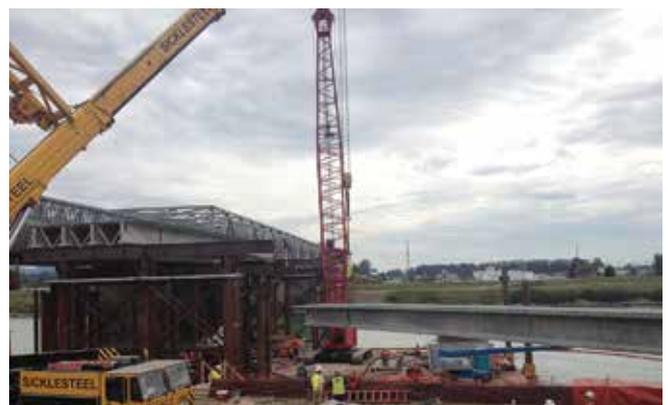
Erection of girders with a 500-ton crane on the river dike and a 200-ton crane on the barge. Photo: Washington State Department of Transportation.

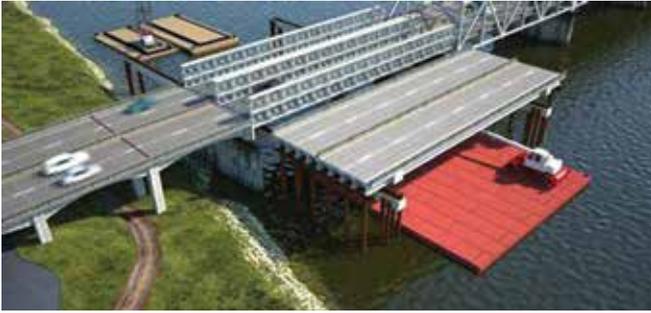
Location of replacement span during construction. Rendering: Parsons Brinckerhoff.

Separate rows of piling and bents were built to support a rail system that would be used to slide the temporary spans out, and slide the new span into place.

A vertical and horizontal jacking system was concurrently installed using a rail system supported by temporary piling and bents. To complete the installation of the new span, first the temporary spans were lifted off the existing substructure and slid off onto the temporary bents upstream of the bridge. The new span was moved upstream in a similar fashion, with the exception that it needed to be shifted ½ in. longitudinally to fit into place.

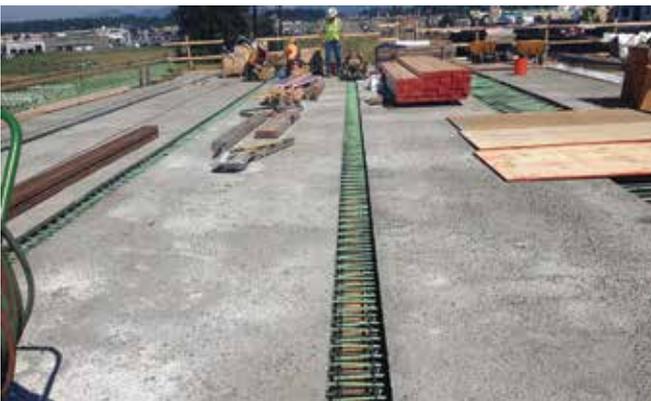
Deck closure reinforcement. Photo: Washington State Department of Transportation.

To complete the bridge, the girders were tied together with end diaphragms and closure concrete placements between the girders. This was followed by casting the traffic barrier and a 1.5-in.-thick silica fume deck overlay. Separate, intermediate diaphragms acting as jacking beams were also installed using reinforced cast-in-place concrete.
