Post-Tensioned Tendon Grouting on the St. Croix River Crossing

by Paul Kivisto, Minnesota Department of Transportation, and Paul Towell and Jeff Cavallin, Parsons Transportation Group

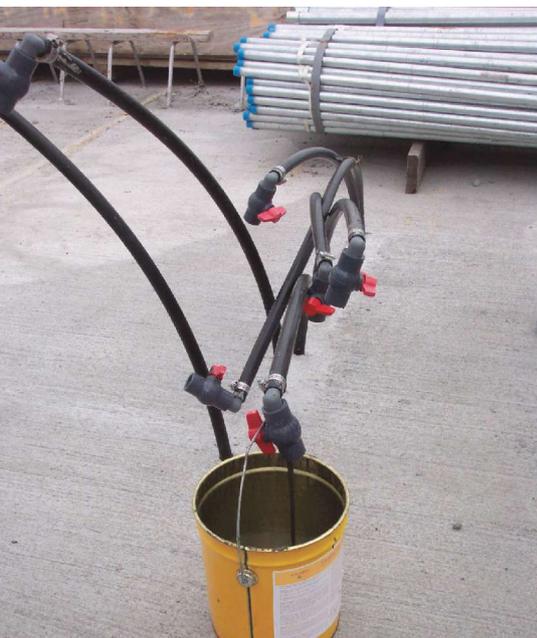
Preparing to inspect grout at grout vents.

force. Post-grouting inspection of tendon anchorage caps and inlet/outlet vents was performed for each tendon to confirm complete and successful grout filling of the tendons, and there were only a few isolated instances of incomplete grouting or voiding. Once identified, these minor areas were repaired using either gravity-fed or vacuum grouting procedures.

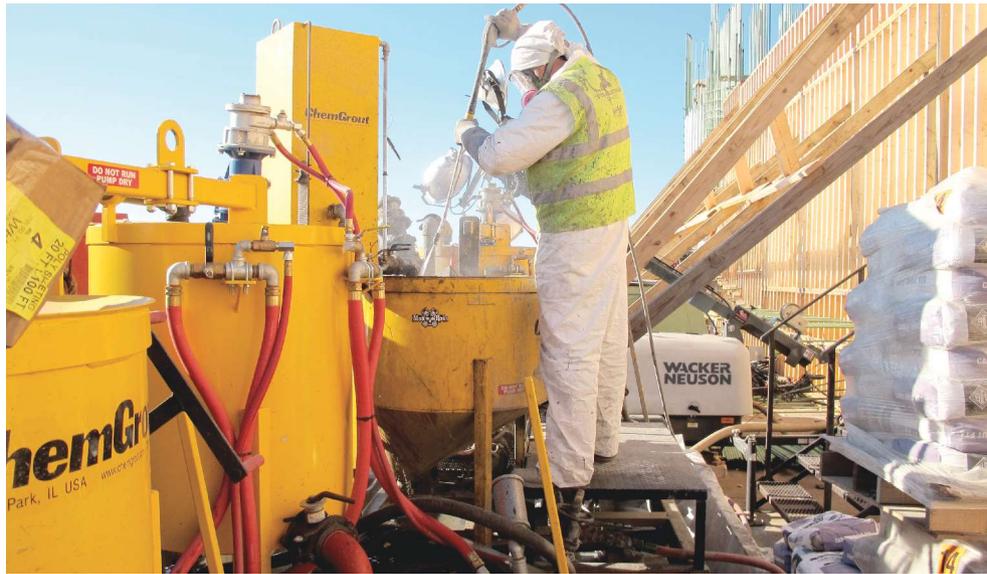
Grout being batched in a colloidal mixer. Photo: Paul Kivisto, Minnesota Department of Transportation.

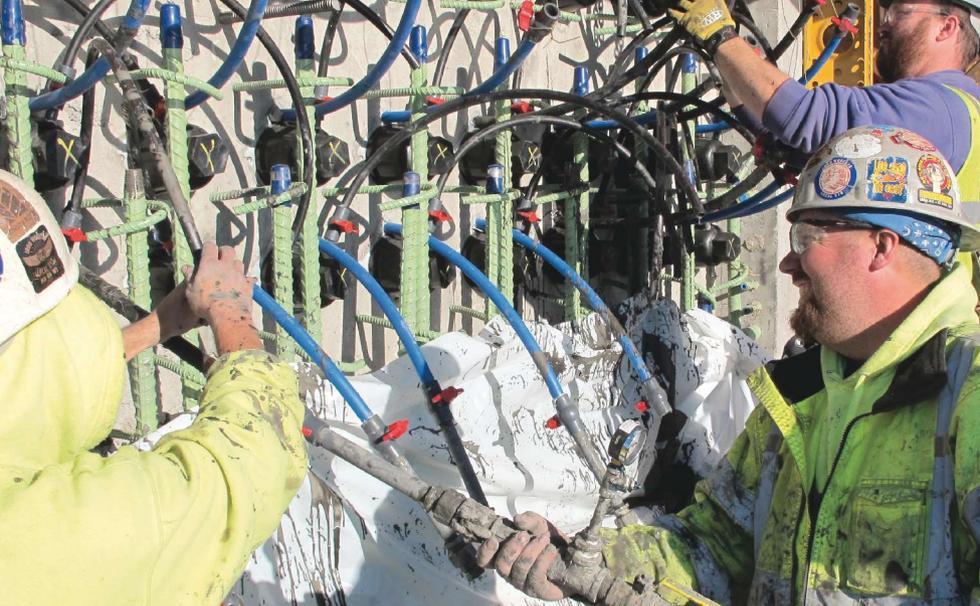
Grout being pumped into the ducts at the crossbeam in the extradosed spans (the crossbeam connects two columns of a pier). The crew is grouting the post-tensioned bars that extend across the width of the crossbeam (about a 16-ft-long bar). Photo: Paul Kivisto, Minnesota Department of Transportation.

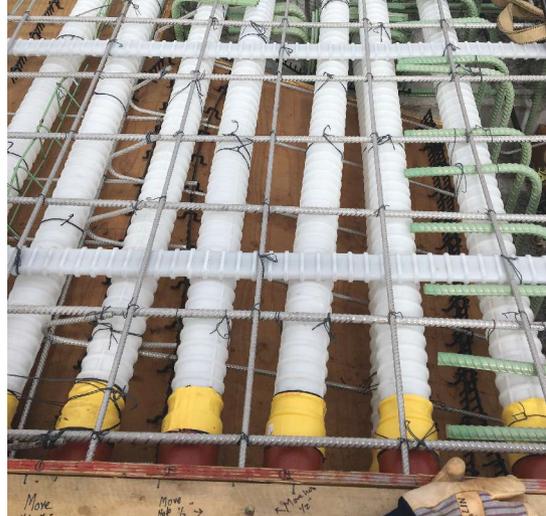
A cast-in-place pier table segment on an approach bridge. The round longitudinal post-tensioning ducts are 4 in. in diameter, and the flat transverse post-tensioning ducts are 1 in. by 3 in. Photo: Parsons Transportation Group.

The bridge's precast concrete segments and cast-in-place concrete box girders are post-tensioned with tendons ranging from 19 to 31 strands in 4- to 5-in.-diameter ducts. The river pier crossbeams were post-tensioned with 52 strand tendons in 6-in.-diameter ducts. Transverse deck tendons consist of four strands in 1-in. by 3-in. rectangular plastic ducts. For grouting, LAJV used grout plants consisting of double-tank colloidal mixers, which ensured proper mixing. Some grouting was done on transverse deck tendons in the casting yard; however, most grouting was done on the erected structure. Crews typically had an approved grouting supervisor, plus two workers at the mixing plant, as well as one worker at the inlet and one at the outlet. A quality control (QC) representative for LAJV and the MnDOT/construction engineering inspection (CEI) quality assurance (QA) staff monitored the grouting operations to ensure

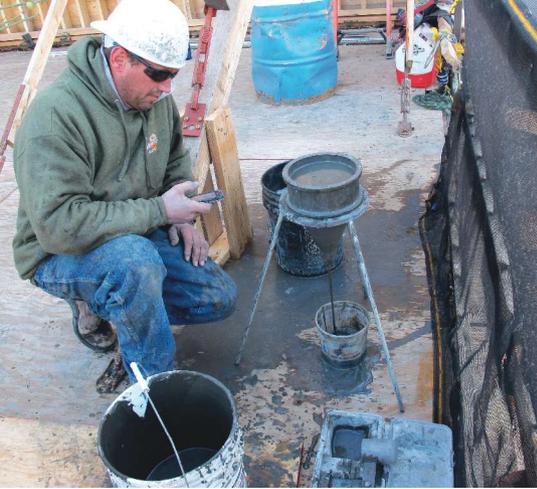
A modified flow cone test was required to be performed for every 2 yd³ of grout or every 2 hours. Photo: Paul Kivisto, Minnesota Department of Transportation.

Standard testing was required for all grout applications to ensure that the grout as prepackaged, mixed, and as placed in the ducts met requirements for temperature, fluidity, strength, wet density, control of bleed, and chloride ion content. Standard field production test methods included modified flow cone, mud balance, and Schupack¹ pressure bleed testing. Field test frequencies were as follows:

- Mud balance at outlet for every tendon with five or more strands and every fourth tendon with four strands or less
- Modified flow cone for every 2 yd³ of grout or every 2 hours
- Pressure bleed test and grout cube samples per each grouting operation
