THE CONCRETE BRIDGE MAGAZINE

SPRING 2019

Gerald Desmond Bridge *Long Beach, California*

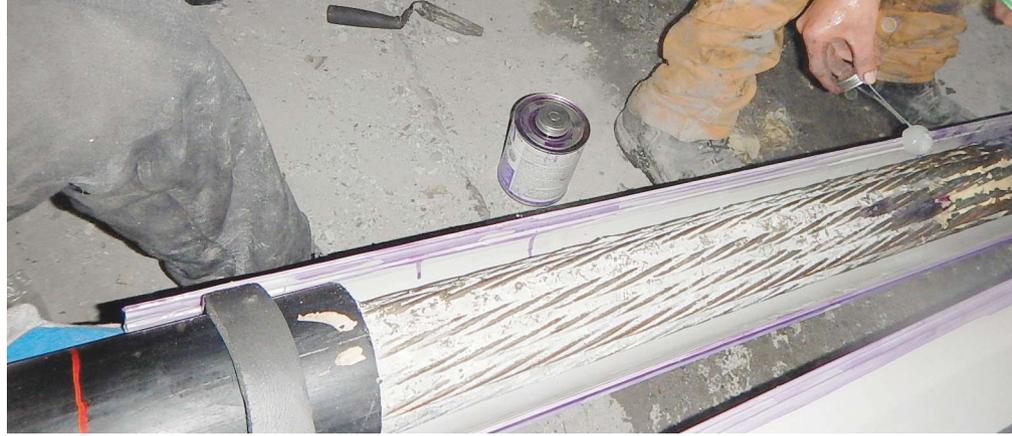
Installation of a split-duct system for permanent repair of external tendons for the Y Interchange project in San Antonio, Tex.

For external ducts that had incurred major damage over the years through splitting or cracking, DSI designed and installed a special split-duct system for permanent repair. Gaining access inside the precast concrete segments was a major challenge, Caravello notes. It was done from beneath the segments through integrated hatches, which were often located directly above heavy traffic areas, requiring traffic control and night

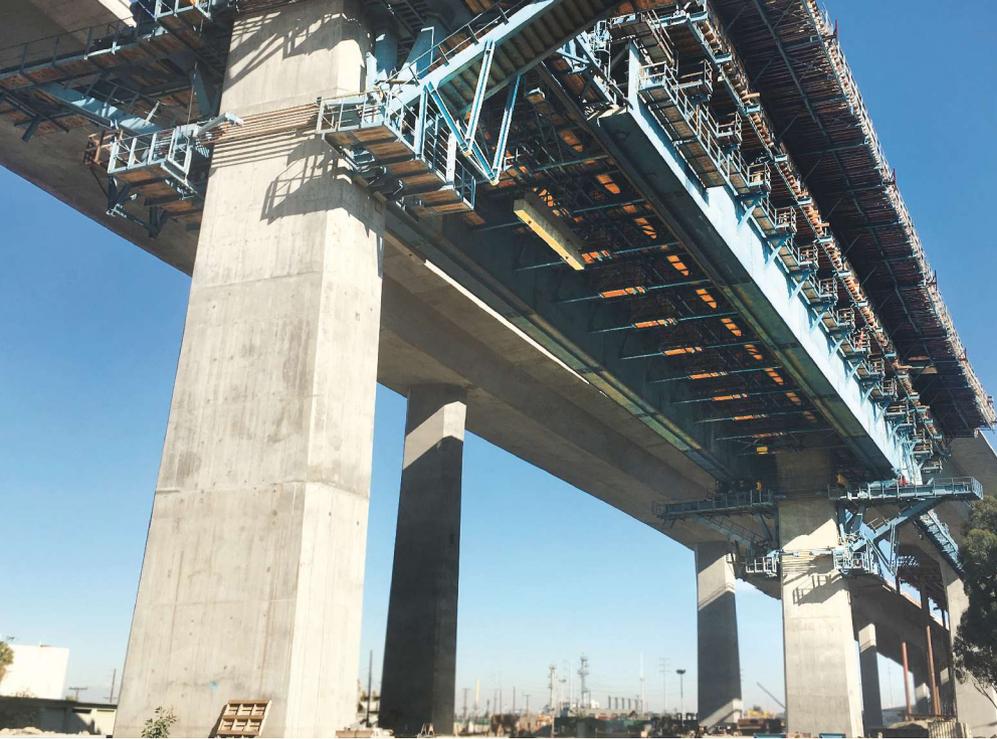
DYWIDAG-Systems International is providing longitudinal and transverse post-tensioning for the cast-in-place segmental box girder approach spans for the 5134-ft-long Gerald Desmond Bridge in Long Beach, Calif. The spans are being constructed using a movable scaffolding system, its first use in the state.

For example, DSI is providing longitudinal and transverse post-tensioning for the cast-in-place segmental box-girder approach spans for the 5134-ft-long Gerald Desmond Bridge in Long Beach, Calif. This bridge is currently under construction and will be, when completed, the second-highest cable-stayed bridge in the United States. The spans are being

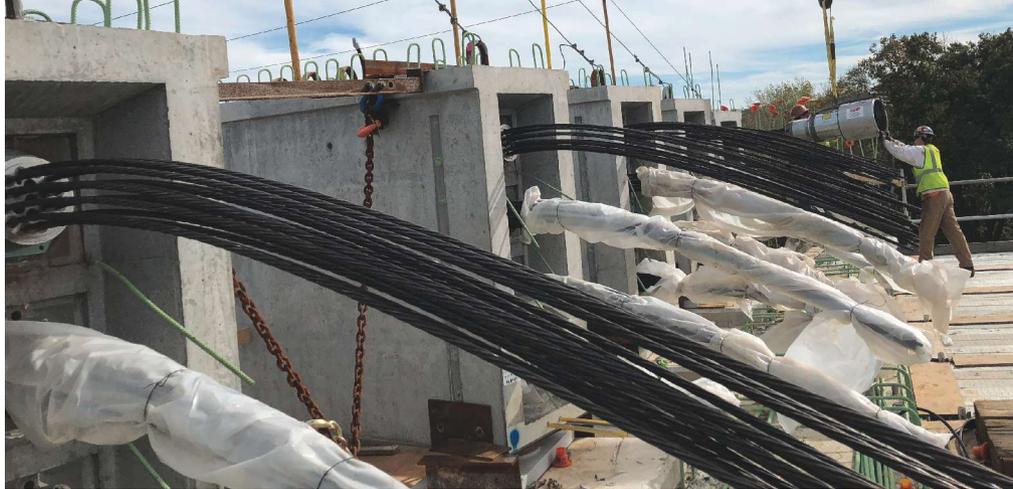
Post-tensioning strands have been installed and tensioning operations are underway for the main spliced-girder unit on the Coplay-Northampton Bridge between the Pennsylvania boroughs of Coplay and Northampton.

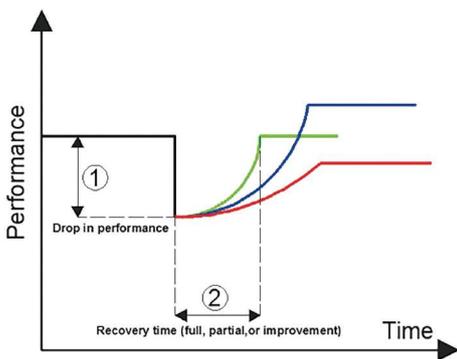
Figure 1. Resilience has two parts—initial response to a damaging event (the drop in performance) and recovery time. All Figures: Dr. Jeremy Gregory.

Resilience, an important element of sustainability, can be quantifiably measured in two stages, response and recovery (**Fig. 1**). First, we assess the system’s immediate response to an event. For example, let’s imagine that a city experiences a hurricane. Before the storm arrives, the city operates at peak performance, as indicated by parameters like economic productivity, transportation efficiency, and so on. As the storm ensues, the city’s performance will drop because of economic inactivity, disabled infrastructure, and other damages. The extent of the drop in performance is the first measure of resilience—a smaller reduction in performance indicates greater resilience. The second measure of resilience is the time to recovery to a performance level that may be lower than, the same as, or higher than the performance level before the disaster. A rapid and strong recovery signifies effective resilience.

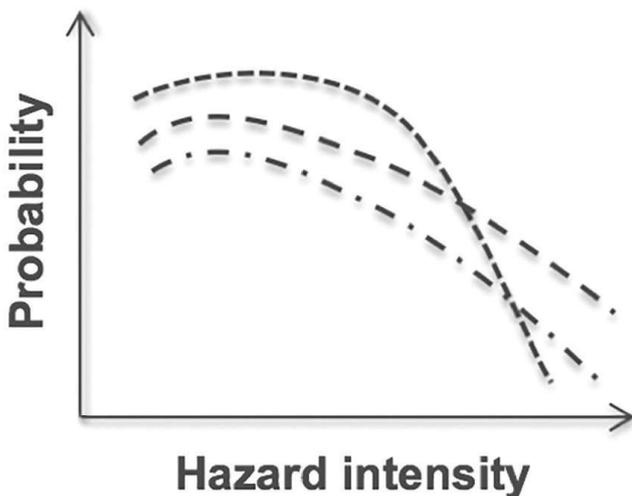
Figure 2. A generic hazard curve.

The crux of this model is the probability curve, which allows us to analyze the uncertainties of disaster and predict outcomes. Using government and other scientific data, we can generate a probability curve that estimates the likelihood of a hazard in a given location. We refer to this as a *hazard curve* (**Fig. 2**).

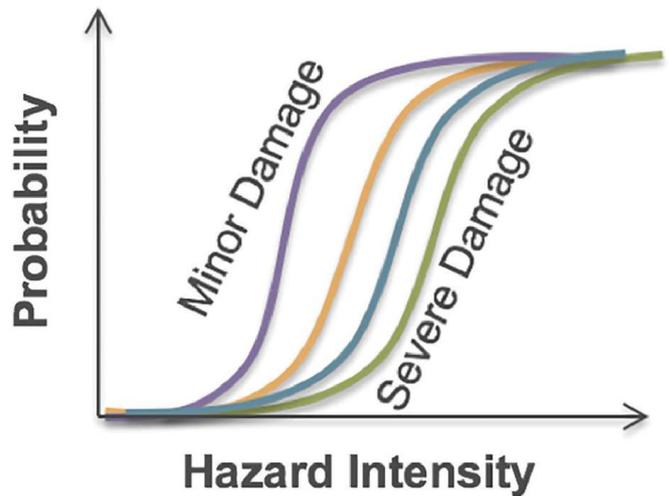
Figure 3. A generic fragility curve.

The hazard curve’s counterpart in resilience analyses is the *fragility curve* (**Fig. 3**), which estimates the damage a hazard will inflict on a structure. To generate fragility curves, we employ a technique inspired by molecular dynamics. We model the integrity of a structure’s components like we would the bonds of atoms. This methodology allows us to efficiently estimate the effects of hazard-induced loads on these components. What makes this technique unique is its versatility and precision. Whereas conventional models of building fragility approximate

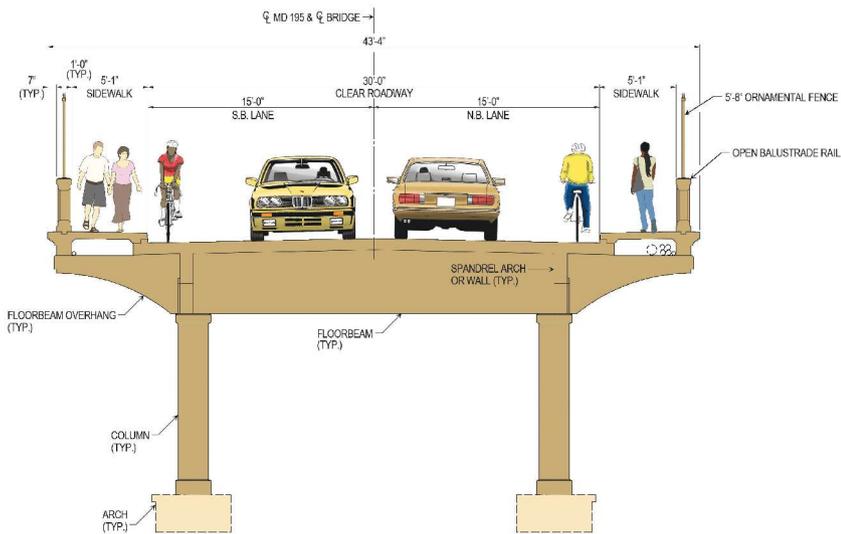
Rendering of proposed bridge section shows roadway with space for bicycles and sidewalks for pedestrians. Figure: Maryland Department of Transportation, State Highway Administration.

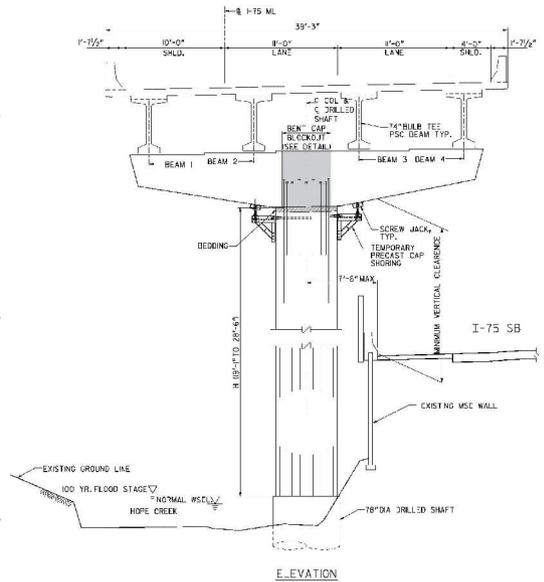
Cross section of a 3300-ft-long bridge adjacent and parallel to southbound Interstate 75, the existing retaining wall, and wetlands. Figure: Parsons.

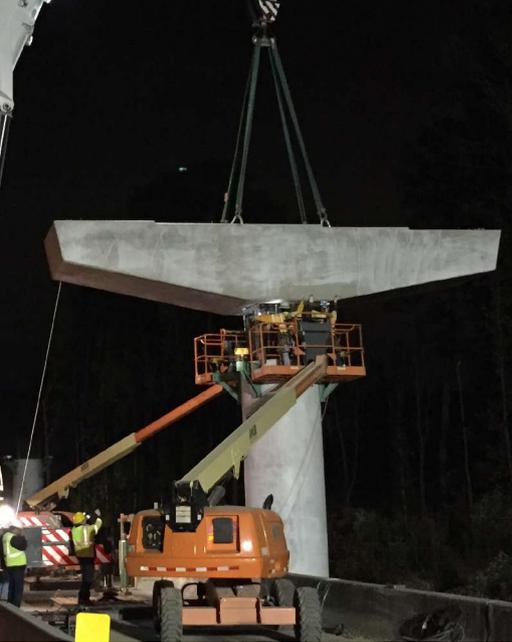
Erection of a precast concrete pier cap from the adjacent Interstate 75 shoulder. Photo: Northwest Express Roadbuilders.

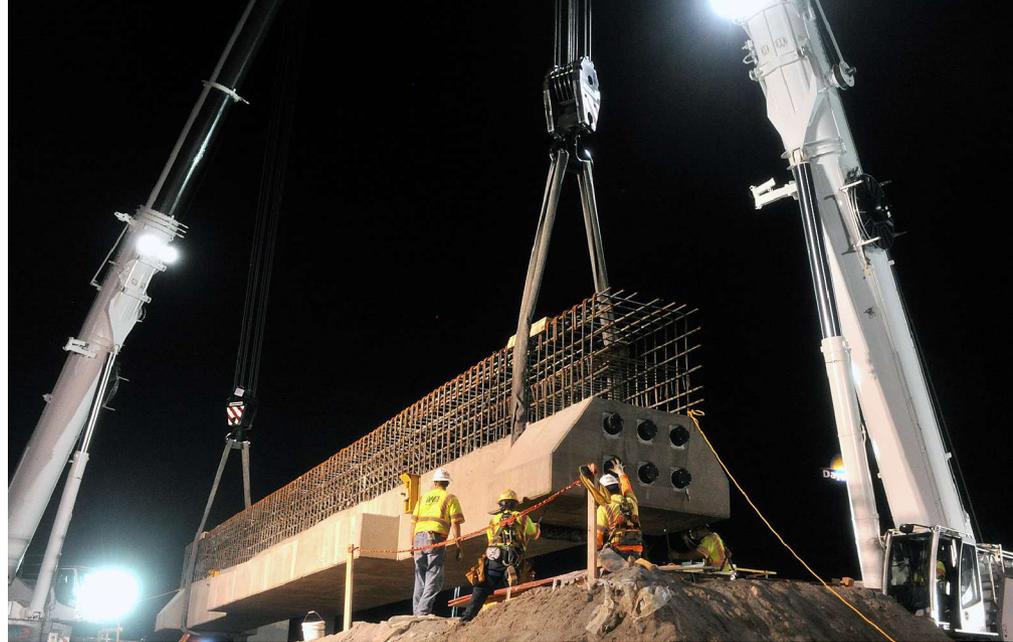
Lifting the post-tensioned precast concrete portion of a straddle bent cap from the fill embankment. The top of the embankment was constructed at the same slope as the final cap geometry to control the geometry of the formwork and post-tensioning ducts. The bottom segment of the cap was cast on the ground and lifted into place after post-tensioning. The top portion of the cap was then cast in place. Photo: Northwest Express Roadbuilders.

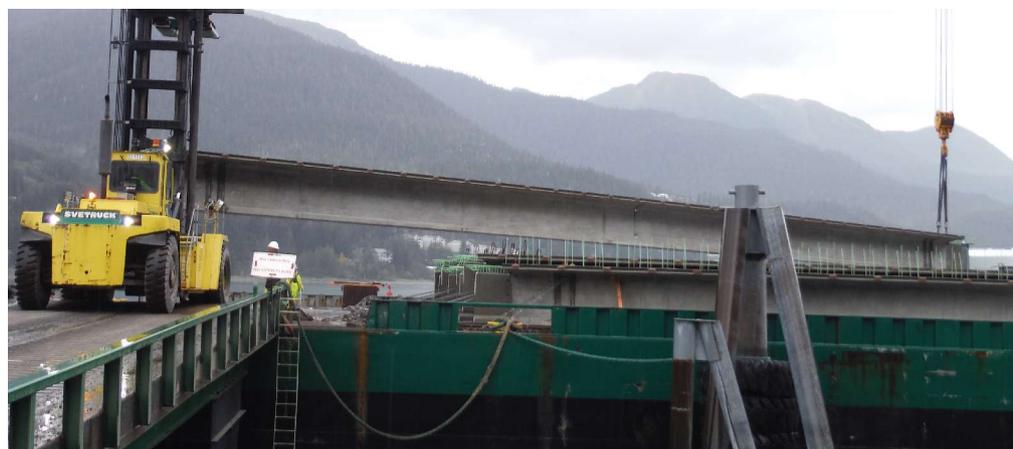
Installing the precast, prestressed concrete decked bulb-tee girders during nighttime construction. During the summer in Alaska, there is still daylight or twilight during “nighttime” construction.

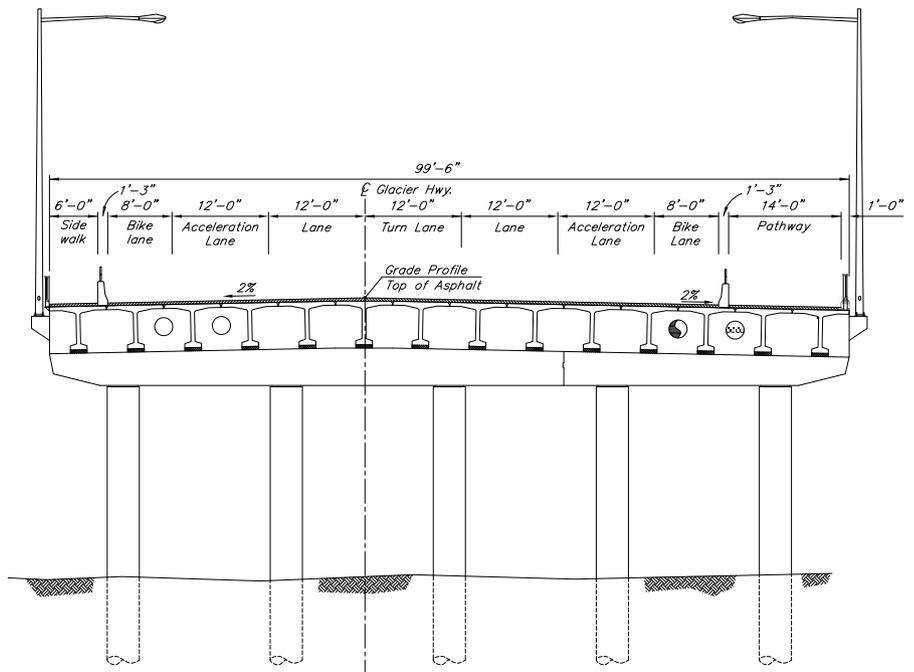
Typical section of the precast, prestressed concrete decked bulb-tee girder superstructure that is supported on reinforced-concrete-filled steel pipe pile extension bents.

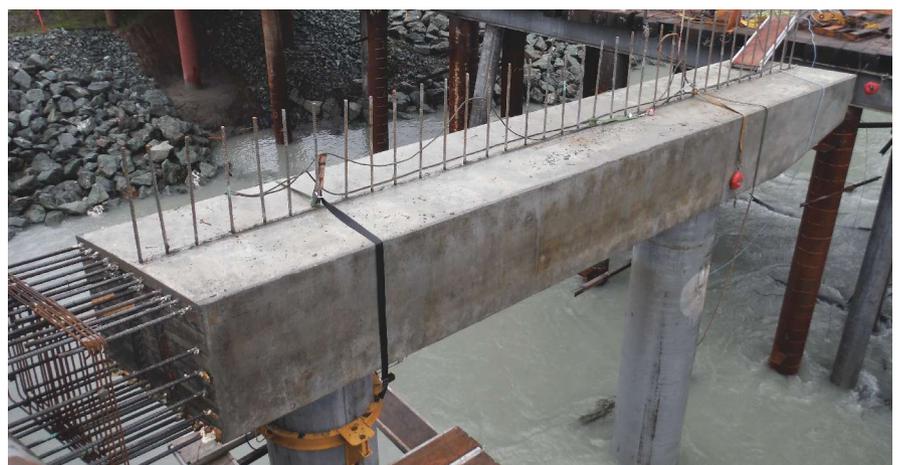
Completed first-stage pier using reinforced-concrete-filled steel pipe piles with reinforcement extended from top of cap to engage the diaphragm between girders.

pipe pile extension substructures (piles typically range from 2 to 4 ft in diameter for conventional bridges). Because this type of substructure does not require cofferdams, it can be built in less time than more traditional, pile-supported footings. The steel pipe acts as a stay-in-place form for the reinforced-concrete core and is included in the cross-sectional capacity of the members. The upper lengths of the pipe (exposed length and 10 ft below the minimum streambed surface) are hot-dip galvanized. AKDOT&PF requires the use of steel pipes that comply with either the American Petroleum Institute (API) 5L PSL2 X52 or ASTM A709 Grade 50T3 fabricated to API 2B or AKDOT&PF spiral (helical) weld specifications to provide superior seismic performance. Research performed at North Carolina State University developed strain limits of reinforced-concrete-filled steel tubes (RCFSTs) associated with the onset of pipe wall buckling and fracture (for more information, see the Concrete Bridge Technology article on RCFSTs in this issue of *ASPIRE*® on page 32). These composite concrete-steel sections are stiffer, stronger, and more ductile than conventional reinforced concrete or hollow steel members and are better able to accommodate large lateral demands from ice, earthquakes, and vehicle collisions.

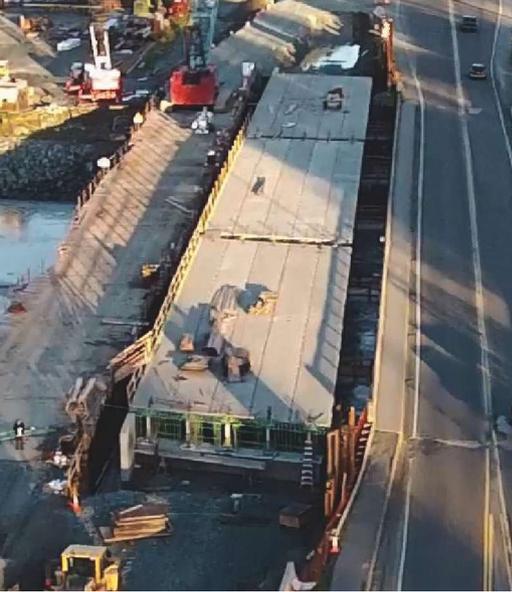
Aerial view of the bridge with the first stage of construction nearly complete; the work trestle is on the left, and the old bridge is on the right.

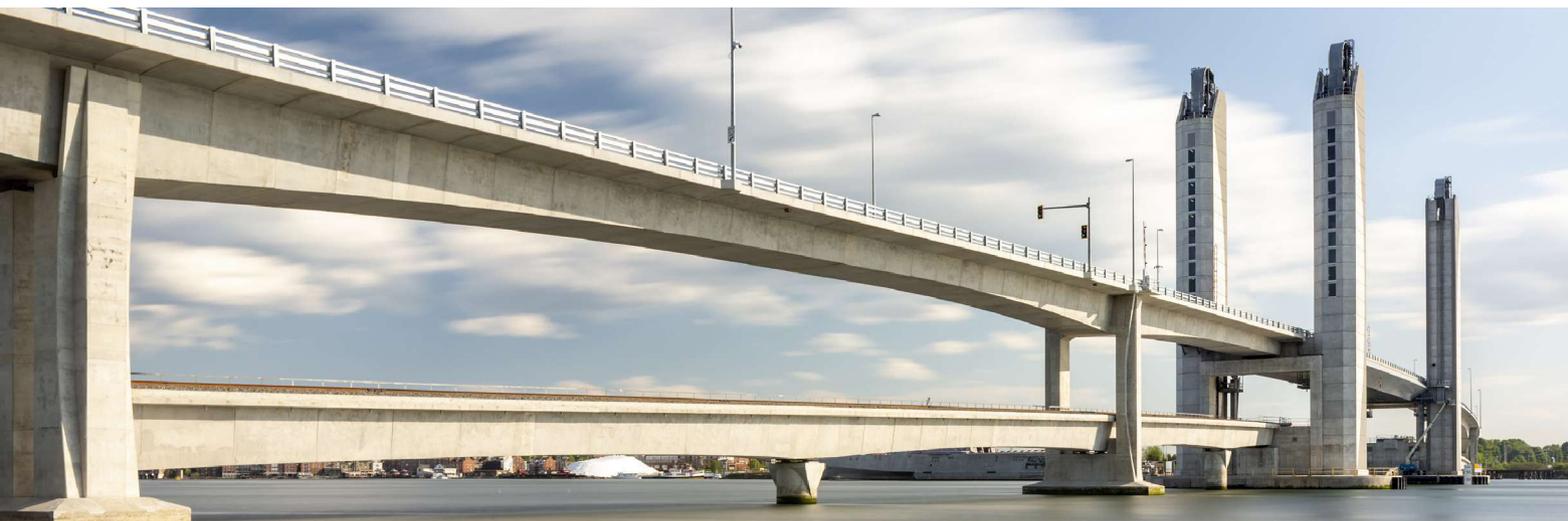
The new Sarah Mildred Long Bridge between Maine and New Hampshire over the Piscataqua River features twin segmental-concrete approach spans in a stacked configuration leading to a single-deck, hybrid movable span at the bridge's center. Photo: FIGG Engineering Group.

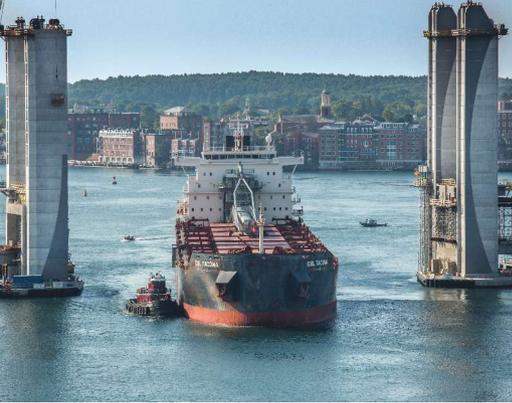
A ship passing through the movable span during construction shows the added width for maritime traffic and the size of ship that needs to be accommodated. Photo: Maine Department of Transportation.

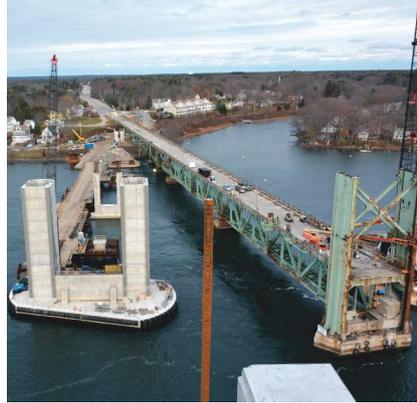
A new alignment was created for the replacement bridge, reducing the crossing skew to 15 degrees for approaching ships. Photo: Maine Department of Transportation.

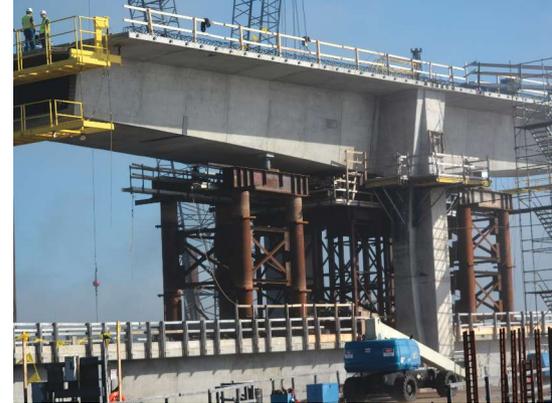
The upper vehicular spans feature precast concrete segmental box girders with depths varying between 8 and 13.5 ft and base widths varying from 15 to 16.75 ft. Photo: Maine Department of Transportation.

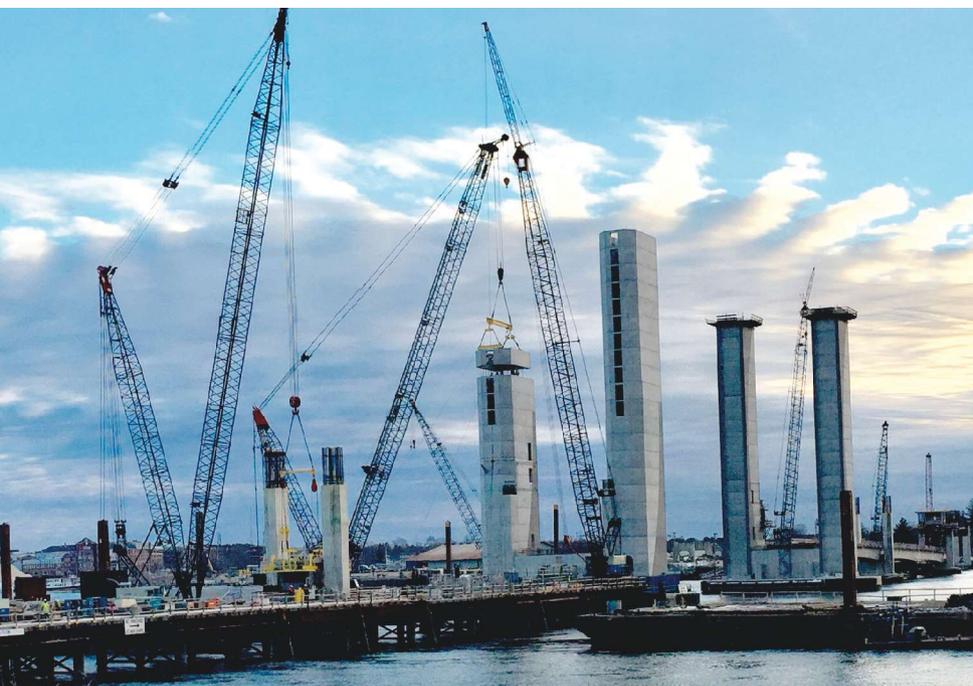
Each lift tower consists of 21 precast concrete segments cast at the project site using match-casting procedures. Photo: Maine Department of Transportation.

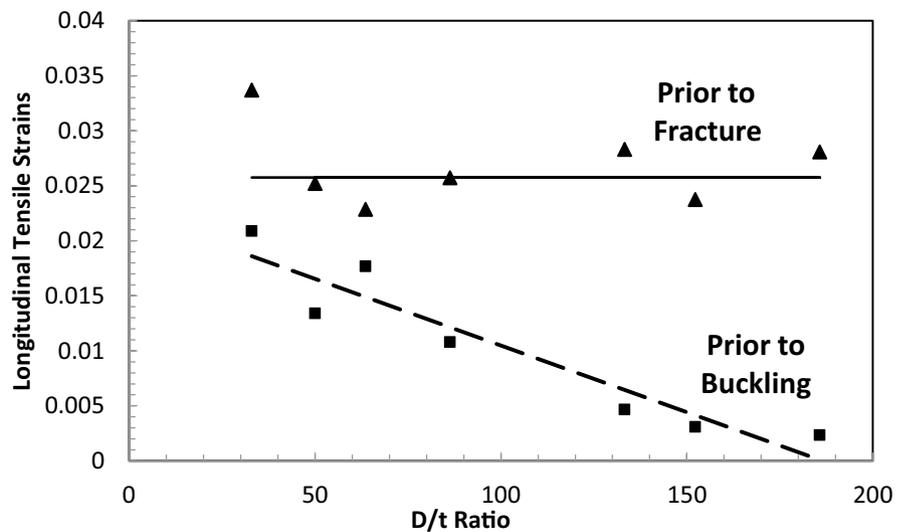
Strain limit states as a function of tube diameter/wall thickness ratio (D/t). Figure: Nicole Brown.

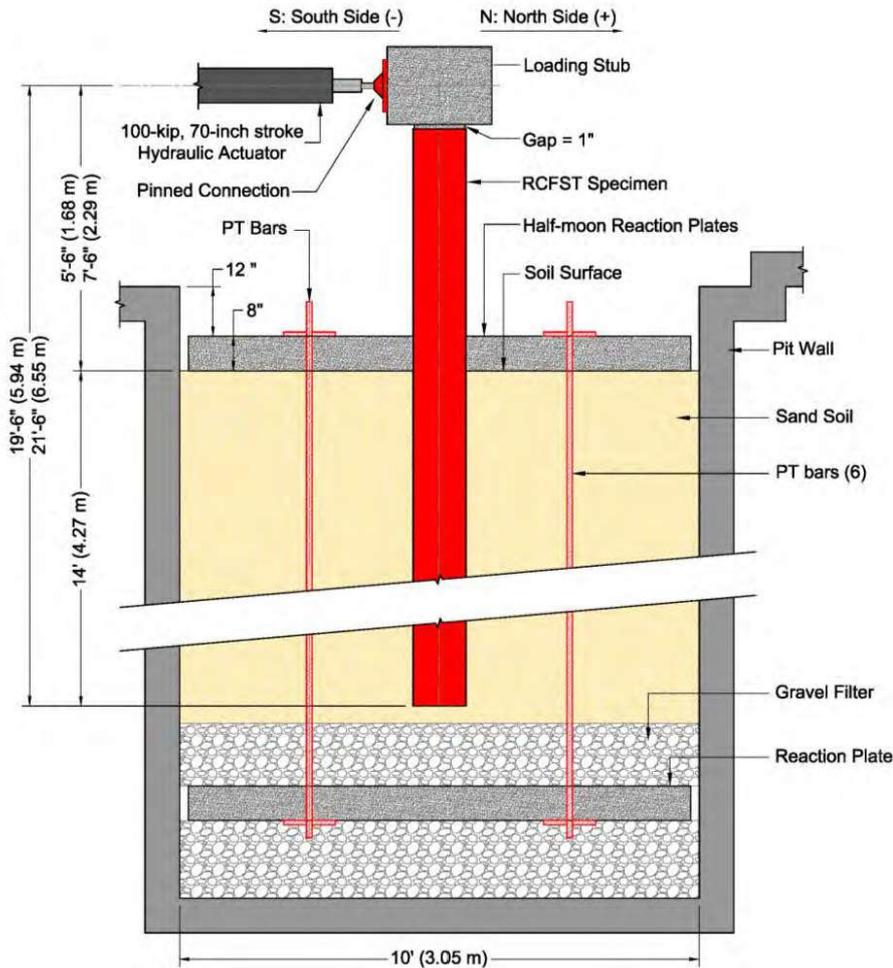
Test setup to model reinforced-concrete-filled steel tubes in soil. Figure: Diego Aguirre.

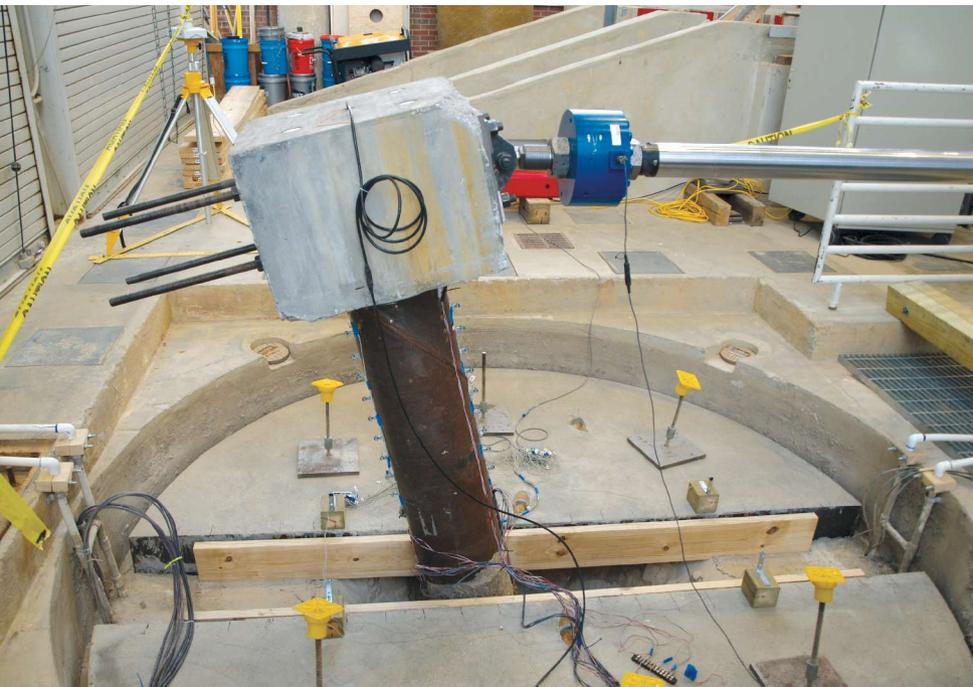
Deformation of reinforced-concrete-filled steel tube during test in soil. Photo: Diego Aguirre.

guidelines have been developed for RCFST seismic design. Recommendations have included strain limits, plastic hinge lengths, and analysis methods.

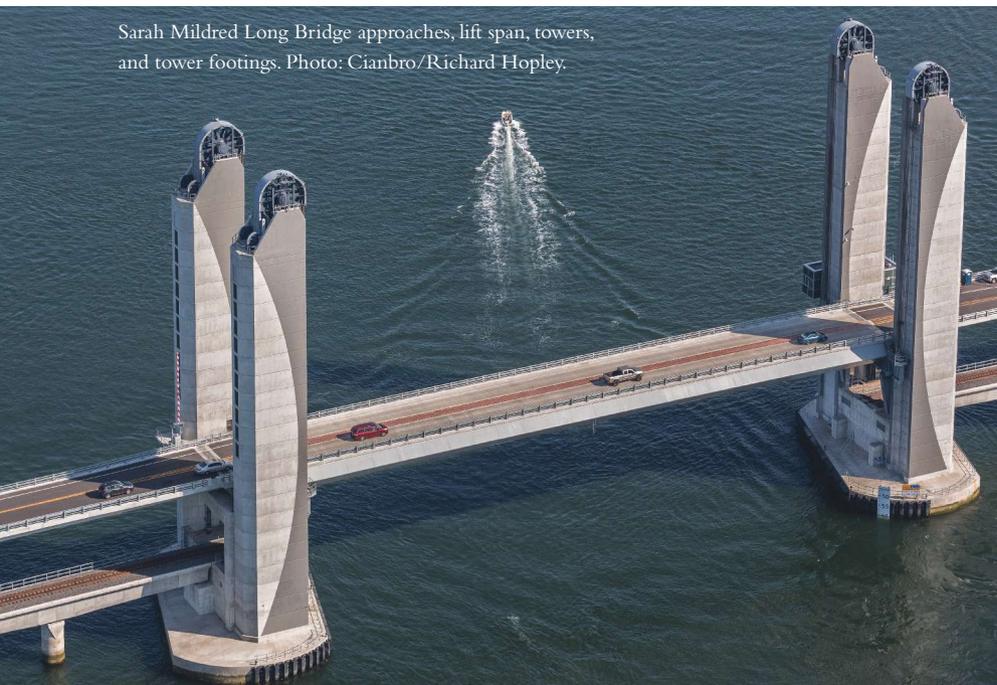
Sarah Mildred Long Bridge approaches, lift span, towers, and tower footings. Photo: Cianbro/Richard Hopley.

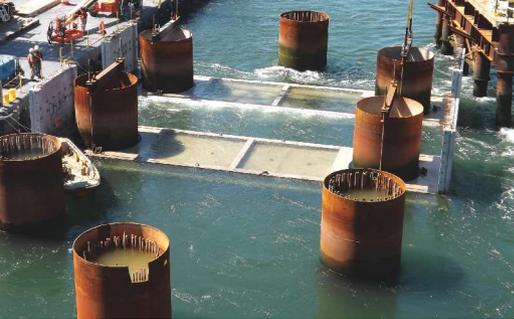
Installation of the drilled-shaft units. Photo: Cianbro.

Each precast concrete segmental tub, one for each tower, was composed of nine segments: five drilled-shaft units and four fill units. The drilled-shaft units used strongbacks with hangers to support the segments from the top of the drilled shafts. For erection, the fill

units were placed between the drilled-shaft units and were supported by an integral ledge cast into the drilled-shaft units. The drilled-shaft segments could be precisely located in elevation and plan by using threaded hangers and horizontal alignment fixtures cast into the concrete around the penetrations for the drilled shafts. The horizontal alignment fixtures also stabilized the segments from the pressure of the water current. A $\frac{3}{4}$ in. space between segments provided erection tolerance and space to grout and seal between segments. Grade 75, 1-in.-diameter sleeved all-thread bolts were spaced at 18 in. along the entire length of the joint between segments. Each all-thread bolt was post-tensioned to 30 kip after the joints were grouted, allowing the entire load of the fill unit (weight of first lift of concrete plus dead load of the fill

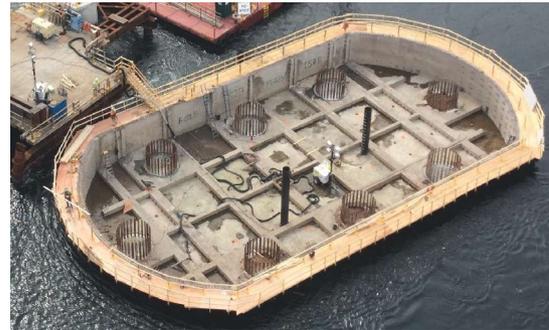
The dewatered tub with the drilled shafts visible. The work platform has been attached to the top of the tub. Photo: Cianbro.

The success of the system depended on the connection of the tub to the drilled shafts. The connection was required to transfer large uplift forces from the dewatered tub as well as the loads imposed from concrete placement. The design shear load transferred to each drilled shaft was 850 kip. A grouted shear key design, typically used in the offshore oil industry, provided the necessary capacity. The connection was designed using grouted pile-to-structure connection criteria from the American Petroleum Institute's *Recommended Practice 2A-WSD*.¹ Installing forms for grouting

before a segment was set allowed the divers to grout the connection from the top. High-strength (8 ksi), structural underwater concrete, with washout additives, provided the required strength in a timely manner in the cold river water.

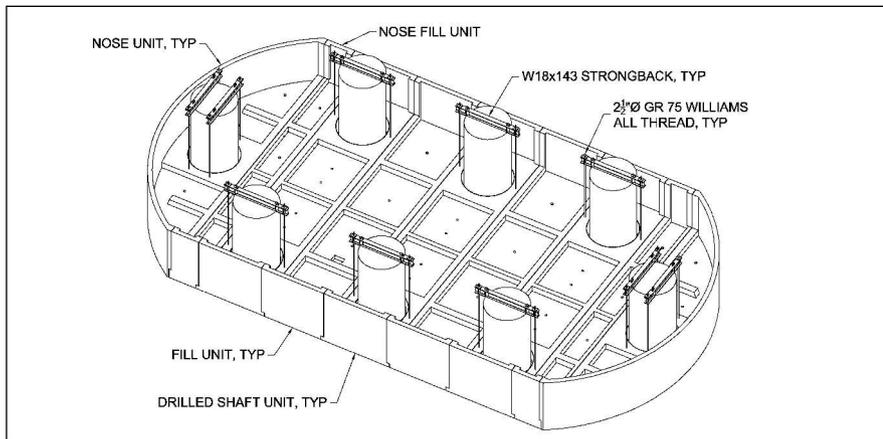
The precast concrete segmental tub. The use of sand-lightweight concrete for the segments allowed the tub to be installed using readily available equipment. Figure: Cianbro.

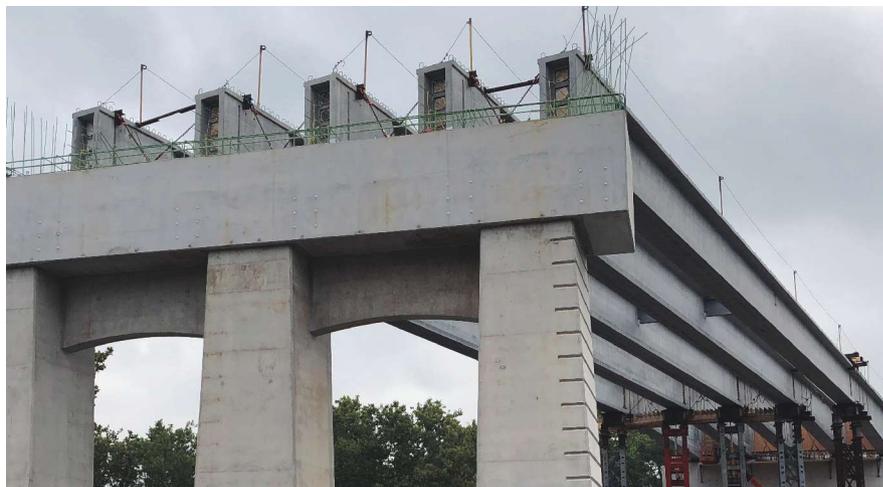
The main unit of the Copley-Northampton Bridge consists of a 540-ft-long, three-span section over the Lehigh River. The superstructure consists of five prestressed concrete PA bulb tees, which were spliced and post-tensioned. All Photos: Dr. Clay Naito.

Approval Guideline¹)-approved anchors. An EIT was installed as the top tendon (of four) in each of the five girders. "The EITs provide the highest level of corrosion protection possible, as they isolate the strands completely so no electrical path exists from the strand to the structural concrete for corrosion to develop," Salvadori explains.

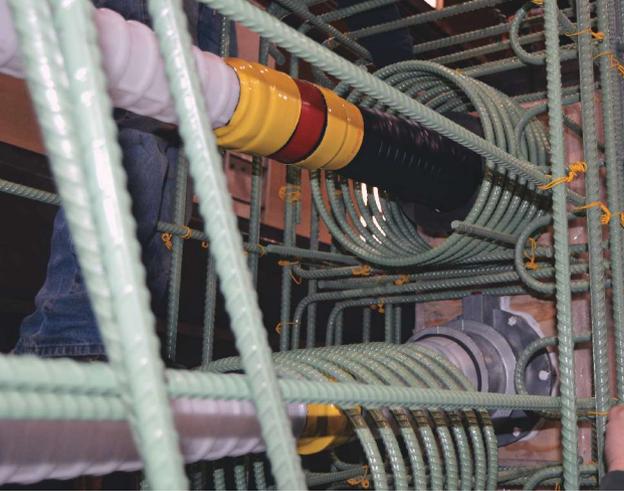
Post-tensioning anchorages in precast concrete beams during spiral reinforcement installation, with an electrically isolated tendon trumpet (top) and a traditional trumpet (bottom).

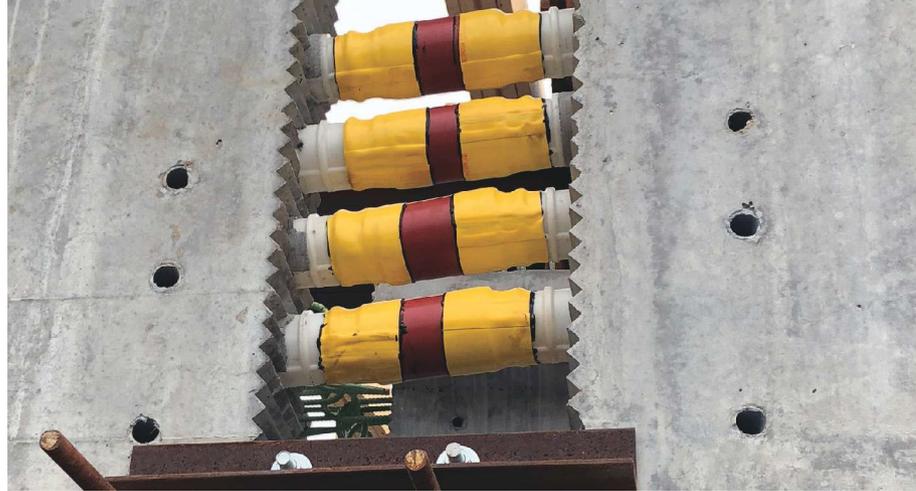
Post-tensioning splice prior to placement of the closure joint. No difference can be seen between the electrically isolated tendon at the top and the three conventional tendons below.

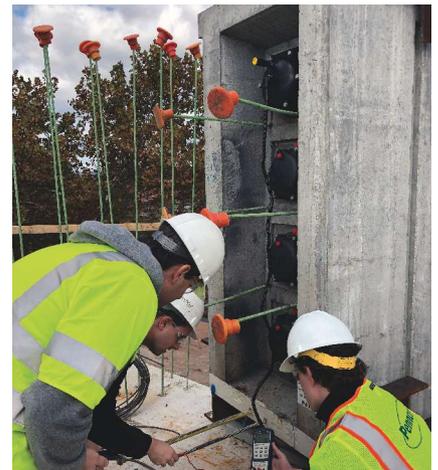
Measurement of the electrically isolated tendon (EIT) system after grouting. The inductance/capacitance/resistance meter is connected to the exposed steel located at the bottom flange and to the post-tensioning strands using the wire connection to the top EIT anchorage.

Engineers at Lehigh University deployed a monitoring system for impedance and capacitance, which is intended to provide an indication of performance of the corrosion protection system. Initial results at 28 days met expectations, and designers expect electrical resistance readings will rise as the grout ages. A significant drop in resistance would be indicative of leakage or ingress of moisture.

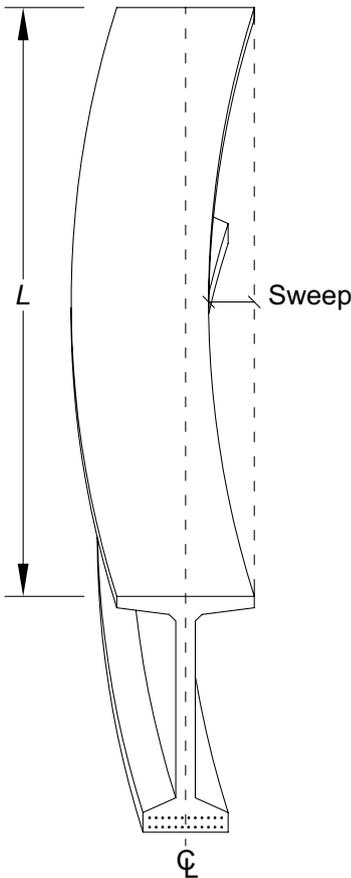
Figure 1. A generalized representation for sweep in a girder. Figure: Dr. Bruce Russell.

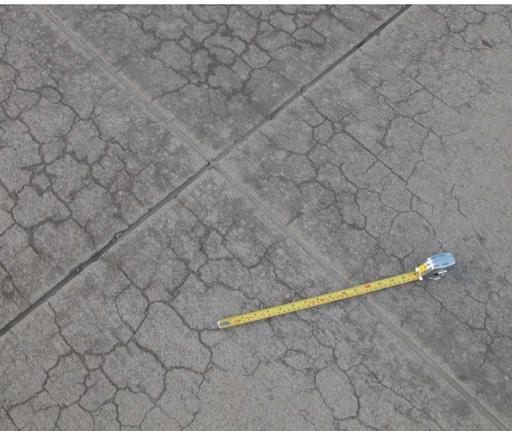
Photograph of map cracking on concrete pavement affected by alkali-silica reaction. All Photos and Figures: Dr. David Rothstein.

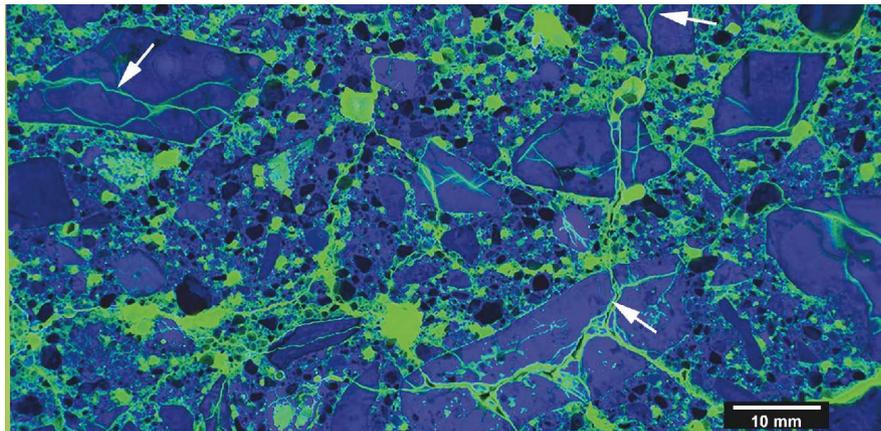
Ultraviolet light photograph of polished slab from a concrete core affected by alkali-silica reaction. The core was impregnated with a fluorescent epoxy. The yellow-green areas are filled with the epoxy. The white arrows indicate examples of cracks.

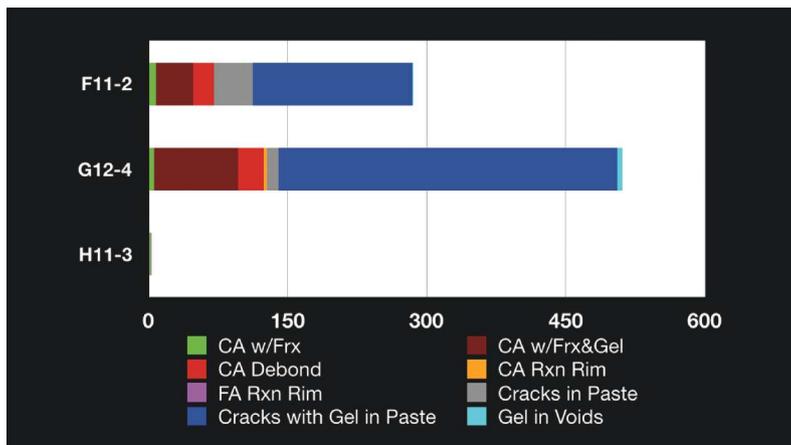
Summary diagram of Damage Rating Index (DRI) results, showing how the method documents variations in the amount of damage. The bar chart summarizes the amount of distress associated with different indicators of distress associated with alkali-silica reaction (ASR). An entire bar represents a total DRI score, with higher numbers indicating more damage. The different colors within a bar indicate the different forms of damage that contribute to the total score. F11-2 and G12-4 show extensive damage, primarily associated with cracks with gel in the paste, and H11-3 shows essentially no damage. Abbreviations are as follows: CA, coarse aggregate; FA, fine aggregate; Frx, fracture; Rxn, reaction.

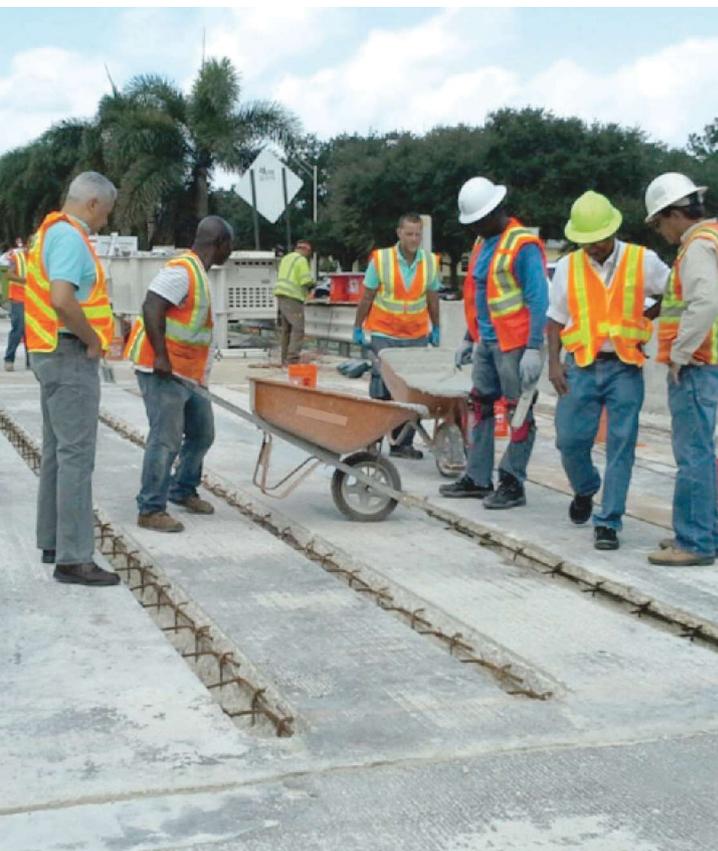
Ultra-high-performance concrete repair of connections between precast, prestressed concrete voided-slab beams in Florida. Photo: Florida Department of Transportation.

UHPC-class materials are known to be excellent candidates for closure pours for PBE connections because these materials can provide durable connections and very compact reinforcement details.¹ The Florida Department of Transportation (FDOT) leveraged these characteristics to repair an existing bridge (constructed in 1978) with precast, prestressed concrete voided-slab beams. The units were transversely post-tensioned and employed partial-depth, conventionally grouted shear keys. After years of service, reflective cracking became apparent in the bridge's asphalt overlay, and there was evidence of differential deflection between adjacent slab units. Instead of replacing the superstructure, FDOT decided to remove the existing connection regions using hydrodemolition, install additional reinforcement, and replace the removed concrete with UHPC. Laboratory testing of similar connections using UHPC between adjacent box beams has demonstrated that UHPC has the ability to create full composite action and robust performance.⁶

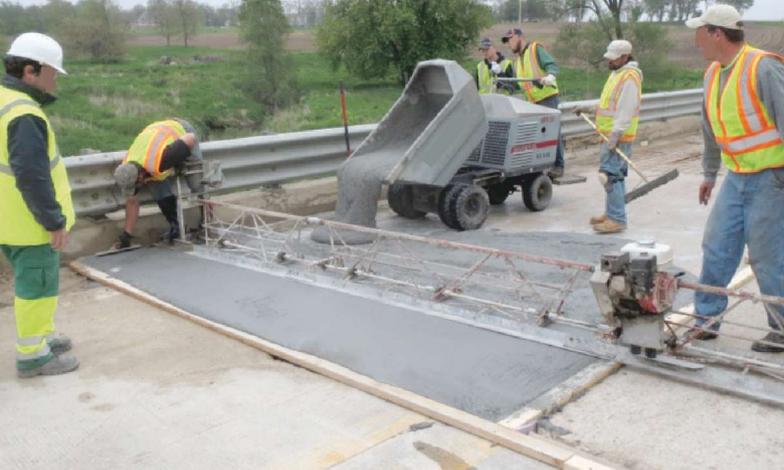
The first installation in the United States of an ultra-high-performance concrete bridge deck overlay was in Iowa. Photo: Federal Highway Administration.

In one of most promising UHPC-based bridge repair applications, UHPC is used as a thin, bonded overlay for bridge deck rehabilitation. As an overlay, UHPC can provide structural strengthening, protection from chloride and water ingress, and good resistance to mechanical abrasion, which reduces the tendency for rutting. This deck rehabilitation can be achieved with a 1- to 3-in.-thick layer of UHPC, which minimizes material volume and additional dead load. This repair method, which was pioneered in Europe, and has been deployed on more than 20 European bridges, is particularly competitive when an owner is looking to extend the life of a structure that is otherwise difficult to replace, such as a life-line structure, a historically significant bridge, or a structure in a challenging geographic or urban area. To date, there have been three UHPC overlays installed in the United States. The first of these installations was on a reinforced concrete slab bridge in an agricultural region in Iowa.^{3,4} UHPC overlays are an active research topic at the Federal Highway Administration (FHWA) Turner-Fairbank Highway Research Center (TFHRC), and additional information can be found in references 3 through 6.

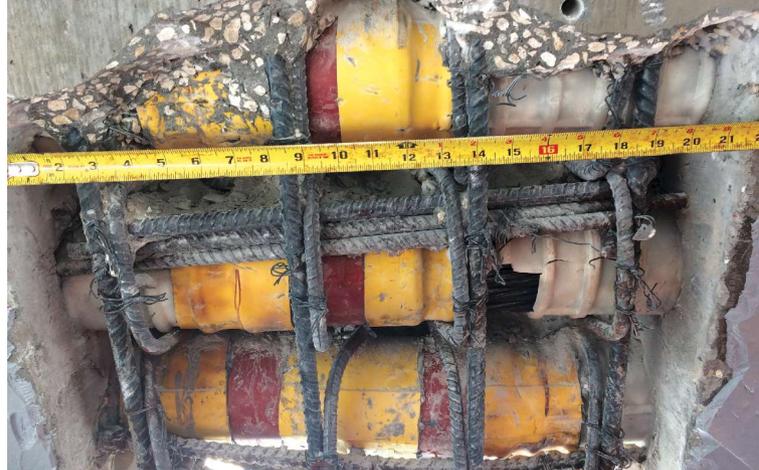
Ultra-high-performance concrete was used for the repair of a midspan spliced U-girder closure pour. Photo: SEMA Construction Inc.

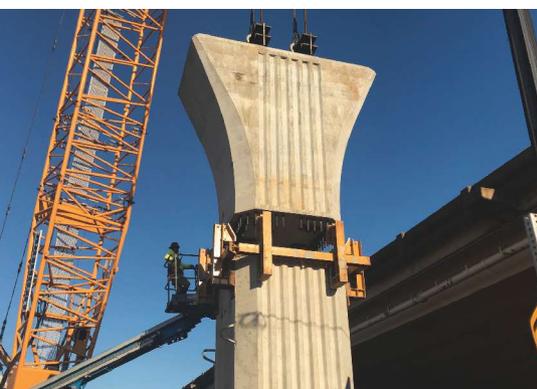
Precast concrete caps were set onto precast concrete columns for the Interstate 59/20 Central Business District Bridge project. Photo: ALDOT.

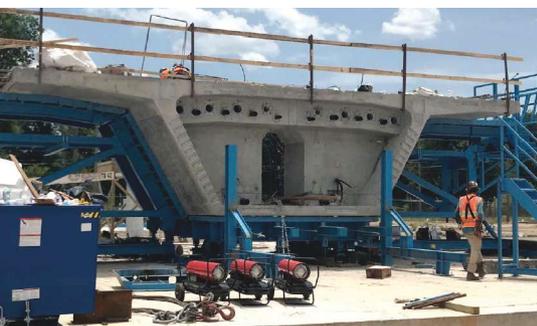
A segment for the Interstate 59/20 Central Business District Bridge project is removed from the casting bed. Photo: ALDOT.

The segments are being cast off site and stockpiled until a section of the bridge is closed, at which time the contractor will set the segments. Prior to closure, while the existing bridges are still in place, foundation work is being completed using long-overhead equipment that can operate in the confined space.

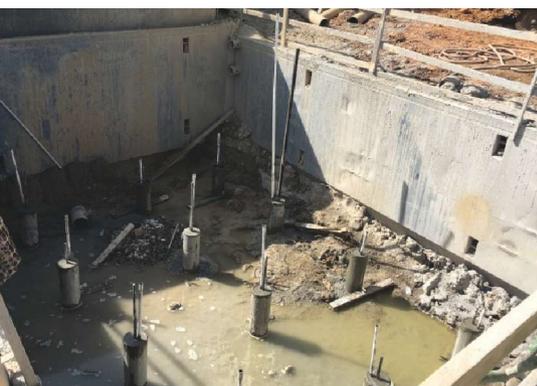
Micropiles were used in some locations of the Interstate 59/20 Central Business District Bridge project because of the varying soil conditions in the area. This was the first use of micropiles in the state. Photo: ALDOT.

Because of the area's karst geology, subsurface conditions vary within small distances; therefore, foundations include micropiles, driven-steel piling, and drilled shafts. Micropiles are being used for the first time in a widespread application on a bridge project in Alabama. Precast concrete columns and caps are further expediting construction, with grouted splice sleeves being used for connections between precast concrete elements and the footings.

Also, owing to the varied and complex soil conditions in Alabama, micropiles are expected to be used more often in the future. They offer a good alternative when soil conditions create challenges and the Birmingham Central Business District project has demonstrated their advantages.

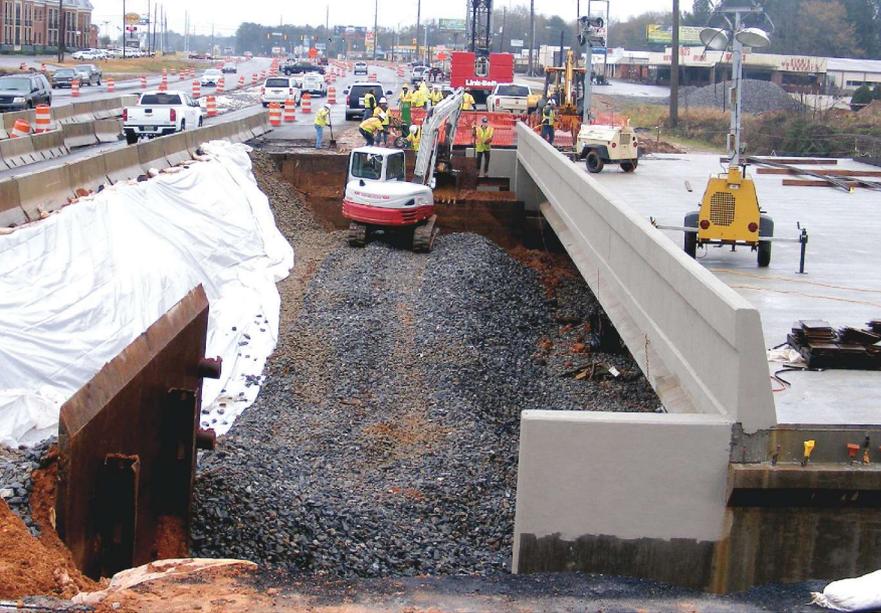
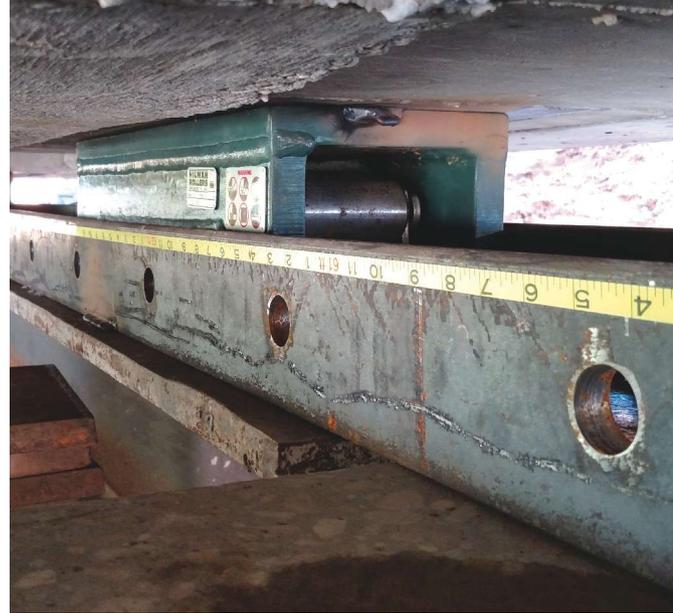
Construction of one of the new twin bridges on the Ross Clark Circle (U.S. Route 231) over Beaver Creek culvert in Dothan, Ala. The rollers and steel tracks shown in the photo on the right were used with hydraulic jacks to slide the new bridge into place. Photos: ALDOT.

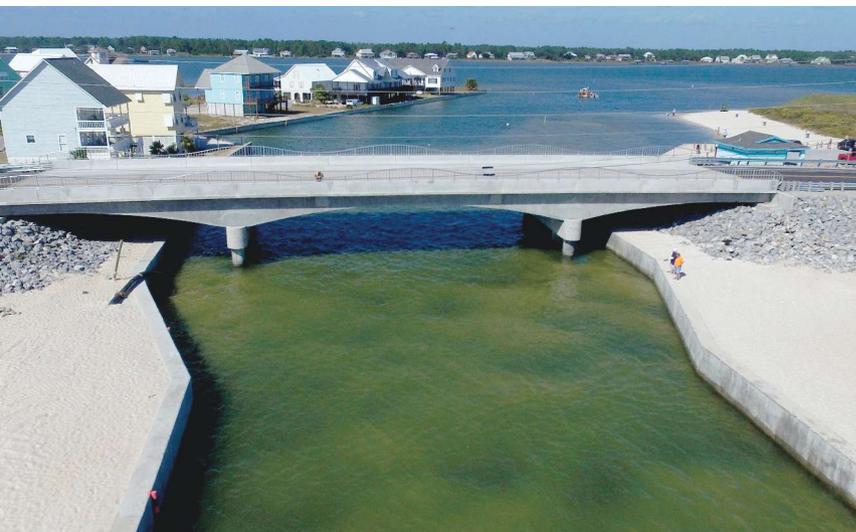
The top priority for the new State Route 182 Bridge over the channel at Little Lagoon in Gulf Shores, Ala., was durability, but designers also added aesthetic touches to play off the structure's oceanside setting. Photo: Scott Bridge Company.

Even along Alabama's coast, where durability is the primary consideration, aesthetic design is a growing priority. The recent bridge replacement on State Route 182 in Gulf Shores, Ala., shows how durability and aesthetic details can be combined. The new bridge is a 191-ft-long, three-span continuous structure that uses precast concrete arch girders with just mild reinforcement (no prestressing or post-tensioning). The bents are composed of spun precast concrete cylinder piles and precast concrete caps, which were chosen for their durability. The abutments feature

square prestressed concrete piles with cast-in-place concrete caps and deck.
