THE CONCRETE BRIDGE MAGAZINE

SPRING 2019

Gerald Desmond Bridge *Long Beach, California*

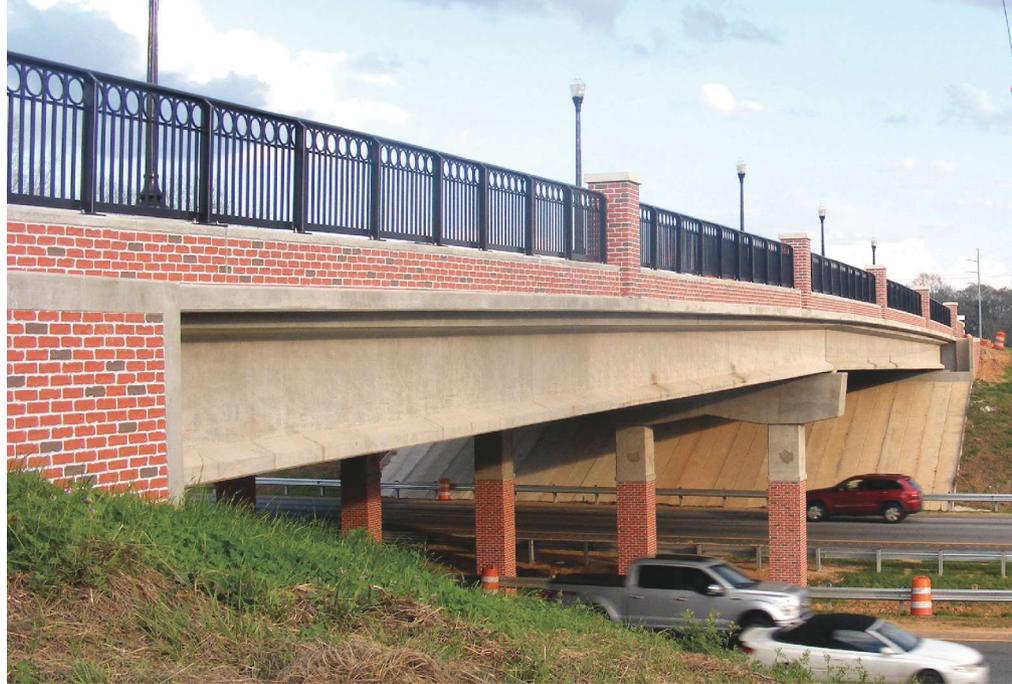
Formliners were used to simulate brick on the Moores Mill Road Bridge over Interstate 85 in Auburn, Ala. The "brick" was then stained to resemble the brick used for buildings at nearby Auburn University. Photo: ALDOT.

A recent project emphasizing aesthetics is the replacement of the Moores Mill Road Bridge in Auburn, which spans the busy Interstate 85 corridor between Atlanta, Ga., and Montgomery, Ala. Faced with growing ADT, Auburn wanted a wider bridge, with a dedicated sidewalk and aesthetic treatments that suited the structure's high-visibility location. The new design features two 120-ft-long spans using 54-in.-deep modified prestressed concrete bulb-tee girders, a 74-ft-wide deck between gutters, and a 9-ft-wide sidewalk. Precast concrete pier columns expedited the work in the I-85 median. Formliners were used to simulate brick on the barrier rails, portions of the columns, abutment wings, and toe wall. They were stained to closely resemble the brick color used at nearby Auburn University. Decorative lighting and railing were installed to complement the simulated brick. The \$3.79 million bridge opened in the spring of 2018.

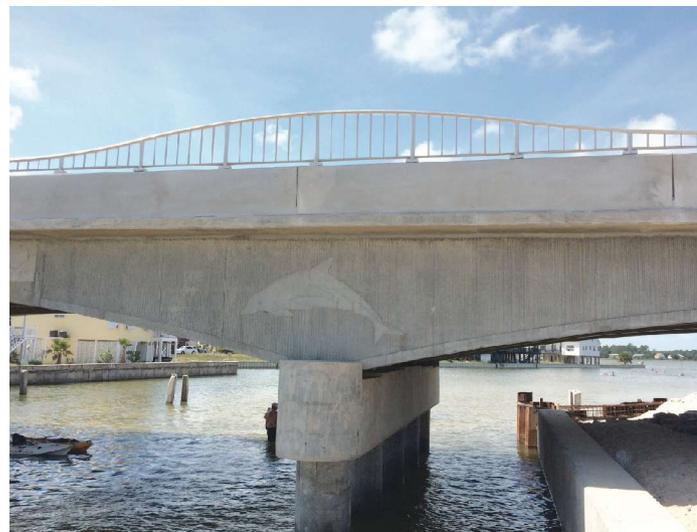
To reflect the maritime location, decorative elements including dolphin shapes, were cast into the fascia and a custom aluminum "wave" shape for the railing was added to the State Route 182 Bridge over the channel at Little Lagoon in Gulf Shores, Ala. Photo: ALDOT.

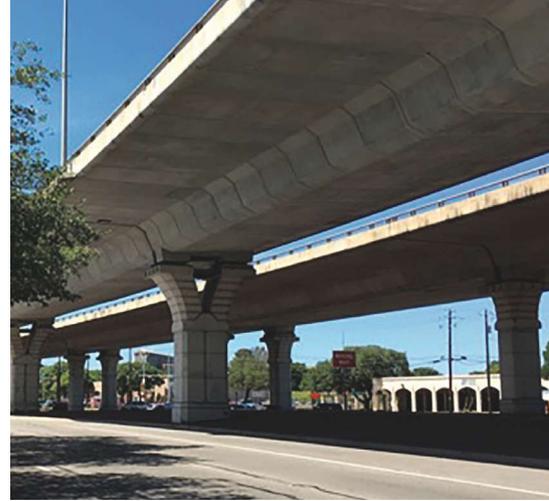
Service IV load combination was used to design the precast concrete segmental substructures for the U.S. Route 183 elevated viaduct in Austin, Tex. Photo: Dr. Oguzhan Bayrak.
