U.S. Route 206 Bridges Over Stony Brook

Using concrete to rehabilitate a historic stone arch bridge and replace an adjacent bridge over a flood channel

by David Hutchinson and Khairul Alam, Arora and Associates P.C., and Pankesh Patel, New Jersey Department of Transportation

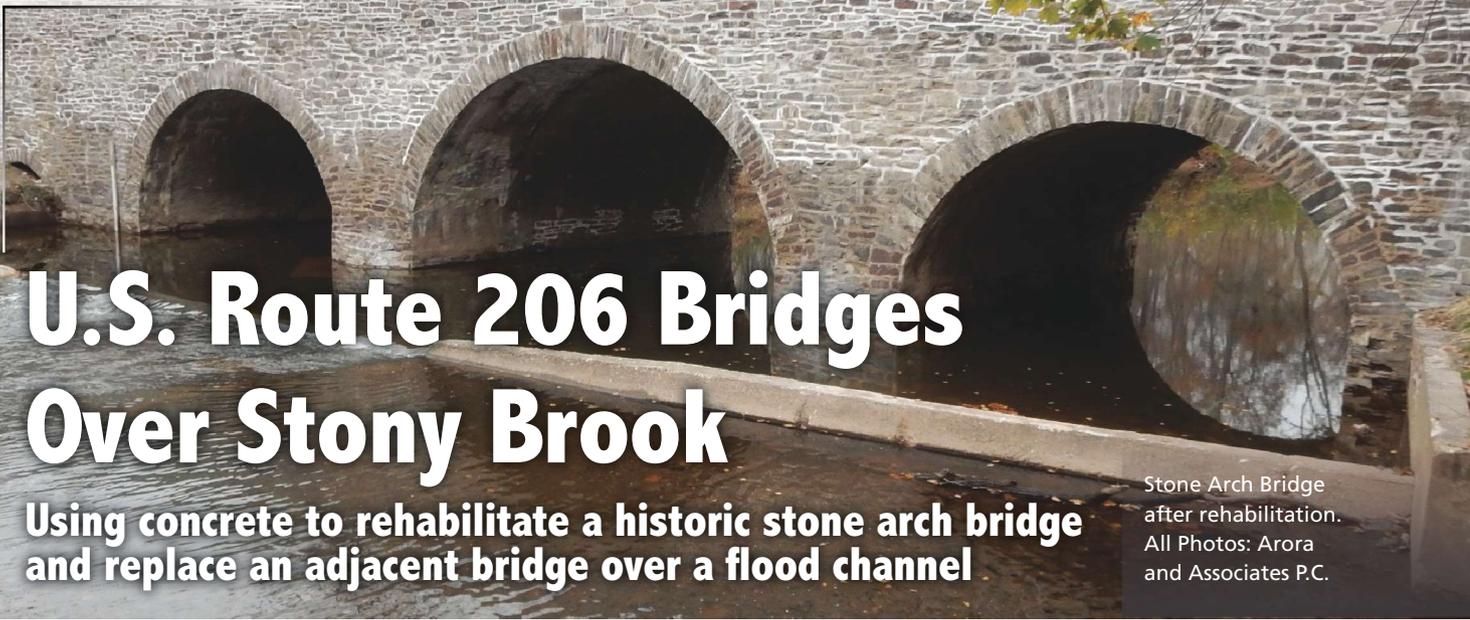
Stone Arch Bridge after rehabilitation.
All Photos: Arora and Associates P.C.

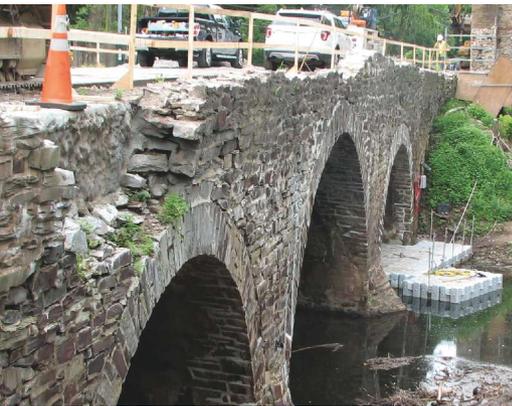
Partial collapse of the stone parapet and spandrel wall of the Stone Arch Bridge. The ruin wall of Worth's Mill is on the right. The Flood Channel Bridge is just beyond the ruin wall.

On February 22, 2016, the parapet and spandrel wall above the north arch on the upstream side of the structure partially collapsed, forcing closure of this section of Route 206. The failed area was stabilized, and an in-depth inspection of the bridge was performed, which revealed more areas that needed repair. The partial collapse was a sign that the bridge needed attention to address the underlying causes of the failure. The roadway was reopened to traffic on March 7, 2016. However, heavy truck traffic across the bridge was prohibited,

and the failed area and extensive leaning and bulging of the spandrel walls and parapets on the upstream face remained.

The emergency repair, including the installation of temporary concrete barriers to protect the collapsed area and other nonstable parapet areas, allowed for the continued use of the bridge while the project to retrofit the structure for strength, safety, and durability was undertaken.

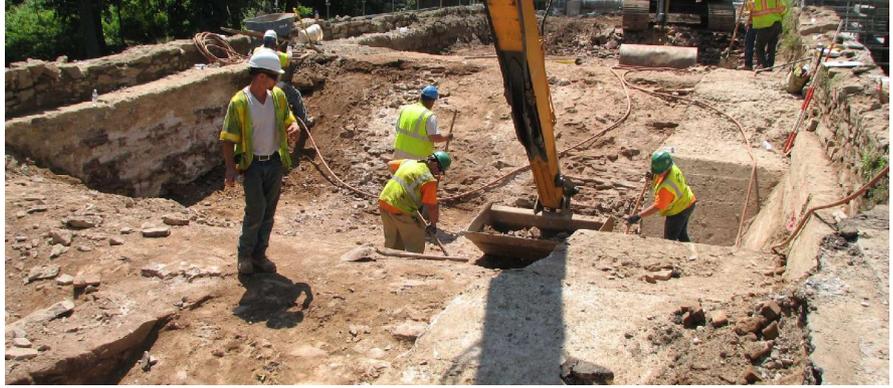
Excavation above the arches was accomplished by hand labor and small equipment.

The rehabilitation of the Stone Arch Bridge involved removing the fill above the arches; rebuilding out-of-plumb walls with the same stone and a lime-based, historically appropriate mortar; and constructing reinforced concrete saddles and walls within the roadway fill to strengthen the arches. The replacement fill of the roadway above the arches was constructed with lightweight concrete to eliminate water infiltration. A reinforced concrete core was used for the parapets for crash worthiness and was faced with existing stone. The concrete core for the parapets extends up from the cast-in-place spandrel walls. The parapet maintains the existing draping pattern across the bridge but is raised to meet the American Association of State Highway and Transportation Officials (AASHTO) Test Level 4 crash rating.

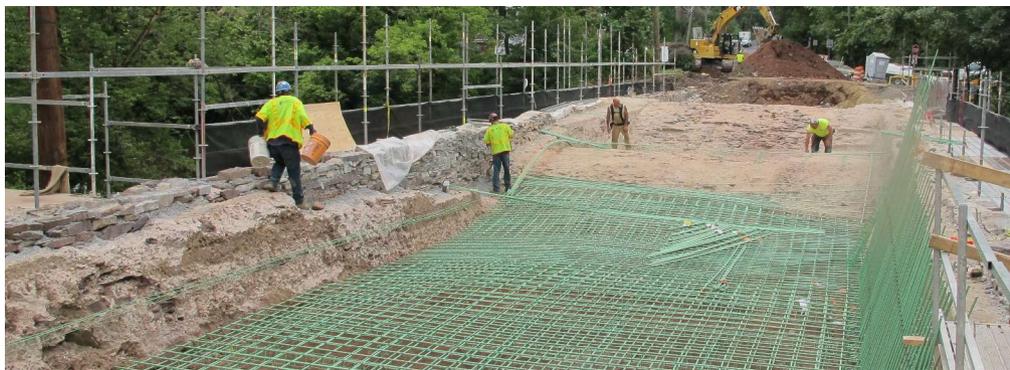
Construction of concrete saddles to strengthen the arches of the Stone Arch Bridge.

Although the existing stone arch was not designed to be composite with the new saddle, some composite action is anticipated because the top of the stone arch has an irregular shape due to the original coursed stone construction. The saddle and spandrel walls are reinforced and are the structural system that takes the vertical and horizontal loads. The top of the existing stone arch was cleaned of all dirt and loose material. The original design called for the remaining fill above the arch to be filled with a lower strength lightweight flowable fill, but the contractor decided to use Class A lightweight concrete throughout the fill because it did not want to form out the spandrel walls. Because it was designed to current loads, the bridge is no longer posted.

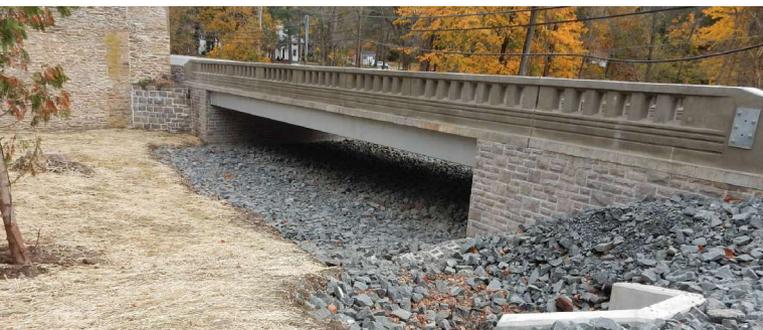
The new prestressed concrete box-beam Flood Channel Bridge. Worth's Mill ruin wall is on the left.

For the Flood Channel Bridge, adjacent prestressed concrete box beams with P-3 concrete were used to construct a single-span, 65-ft-long structure. Class P-3 concrete has a compressive strength of 7 ksi and is typically used for prestressed concrete members. High-performance concrete was used for the deck, parapet, suspended backwall, and sleeper slabs on the project. The shallow 27 in. depth of the box beams helped maximize the hydraulic opening. Removal of two piers within the channel allowed the new north abutment to be located in front of the existing abutment, portions of which remained in place to avoid demolition and excavation close to the ruin wall. The precast, prestressed concrete box beams

were quickly installed and, without the need for deck formwork, allowed the contractor to quickly traverse the new bridge and access both sides of the arch bridge to remove the fill and place concrete.

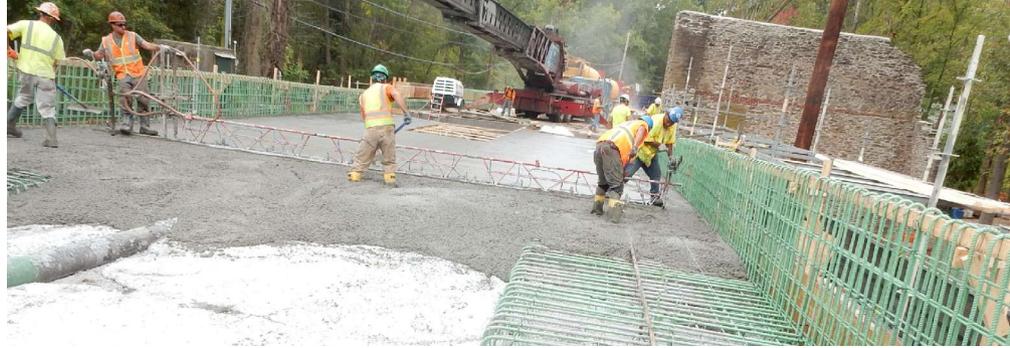
Placing lightweight concrete for fill above arches. Note the epoxy-coated reinforcement for concrete core for the parapets.

ground penetration radar and pavement corings) can be inconclusive. The use of cast-in-place concrete allowed for quick adjustments to the reinforced concrete saddles and spandrel walls based on the actual field conditions after excavation. Much of the concrete that had been placed during the 1916 widening of the bridge was incorporated into the 2016 rehabilitation to avoid further impact on masonry areas that did not need to be reconstructed. Epoxy-coated reinforcing steel was used in the concrete saddle and spandrel walls to provide additional corrosion protection. The flexibility of cast-in-place concrete also proved beneficial for construction of the reinforced concrete collars, which were placed in the waterway to protect the footings against scour and doubled as a support for the framing system designed to temporarily support the arches during construction.

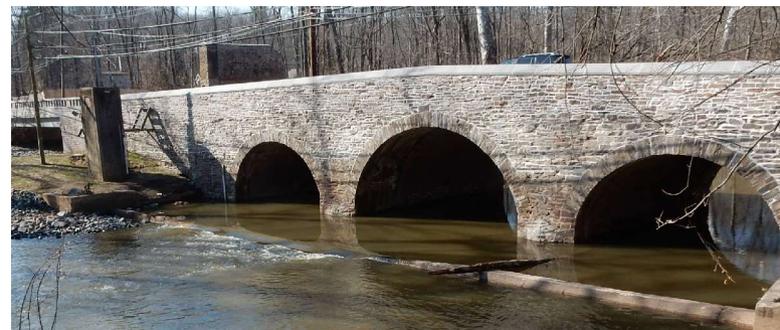
Downstream view of the rehabilitated Stone Arch Bridge and new Flood Channel Bridge.
