# Alkali-Silica Reaction: Testing Demonstrates Unexpected Capacity

by Dr. Oguzhan Bayrak, University of Texas at Austin

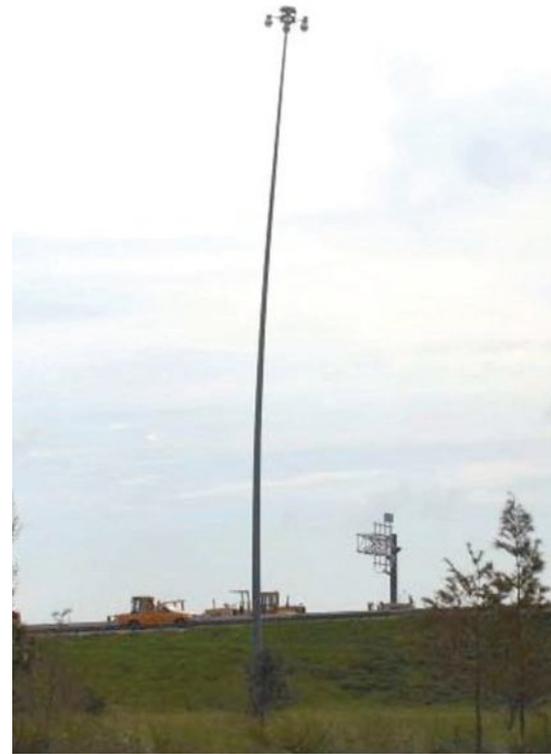
Figure 1. Florida Department of Transportation photo showing high-mast illumination pole during a high wind. All Photos adapted from Reference 2.

drilled-shaft foundations in Houston, Tex. HMIPs are commonly used in urban areas to illuminate intersections, direct connectors, and highways. **Figure 1** shows that under strong winds, HMIPs experience substantial loads. Potential failure of foundations—more specifically, the anchor rods in the concrete supporting the HMIPs—during hurricane-level winds prompted TxDOT to contract with the University of Texas to study the structural performance of deep anchor rods embedded in ASR-affected drilled-shaft foundations with significant cracking. **Figure 2** is a close-up view of typical ASR cracks that were present in one of the drilled shafts tested. One of the additional concerns in the investigation was the presence of below-grade cracking, with ASR cracks serving as conduits to the reinforcing cage in the foundations that could allow water and other corrosive agents to penetrate the foundations. In addition to the structural implications of ASR, the owner was concerned about potential corrosion of the steel reinforcement within the drilled shafts.

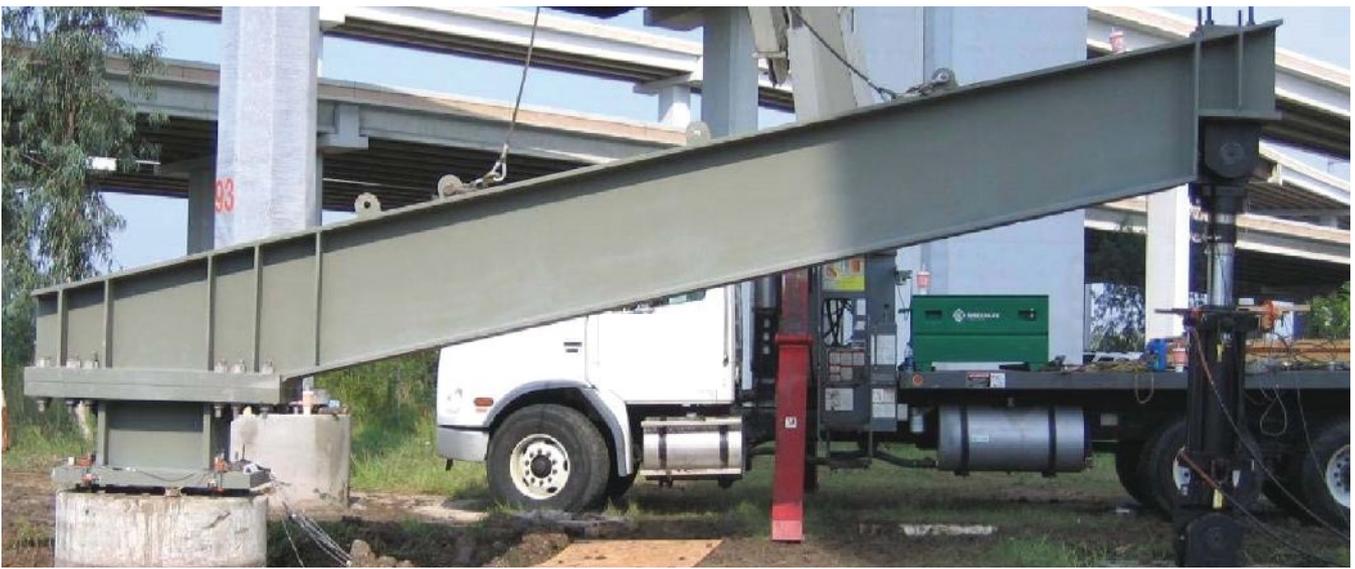
Figure 3. Setup for field testing the deep anchors in the ASR-damaged drilled-shaft foundation of a high-mast illumination pole.

Field tests were performed on six drilled shafts with substantial ASR damage to provide a basis for evaluating the structural adequacy of hundreds of other foundations with similar, or lesser, levels of damage and the same structural details as those tested. **Figure 3** shows the test setup.

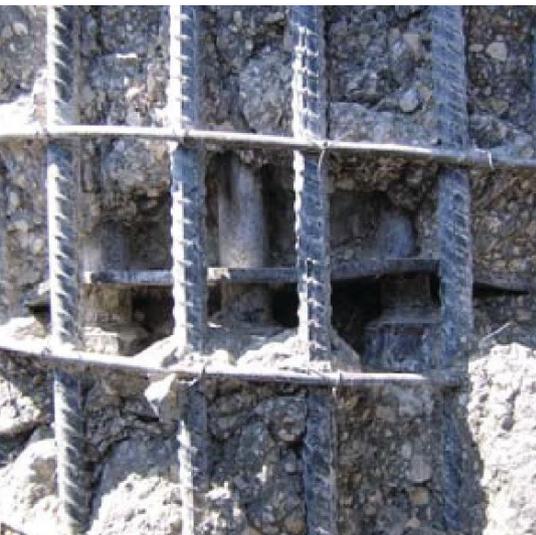
Figure 4. No corrosion of the reinforcement was evident in the drilled shafts having significant cracks likely caused by ASR.

at, or below grade in concrete with extensive ASR cracking showed no signs of corrosion despite frequent exposure to rainstorms. Reinforcing bar corrosion was not observed because the highly alkaline (high pH) levels in the pore solution in ASR-affected concrete cause passivation on the surface of reinforcing bars and therefore create an environment that may not promote corrosion of typical ASTM A615 carbon steel reinforcing bars. In general, the corrosion rate of reinforcing
