# Repair and Maintenance of Post-Tensioned Bridges: An NCHRP Synthesis Report

by Dr. Natassia Brenkus, Ohio State University

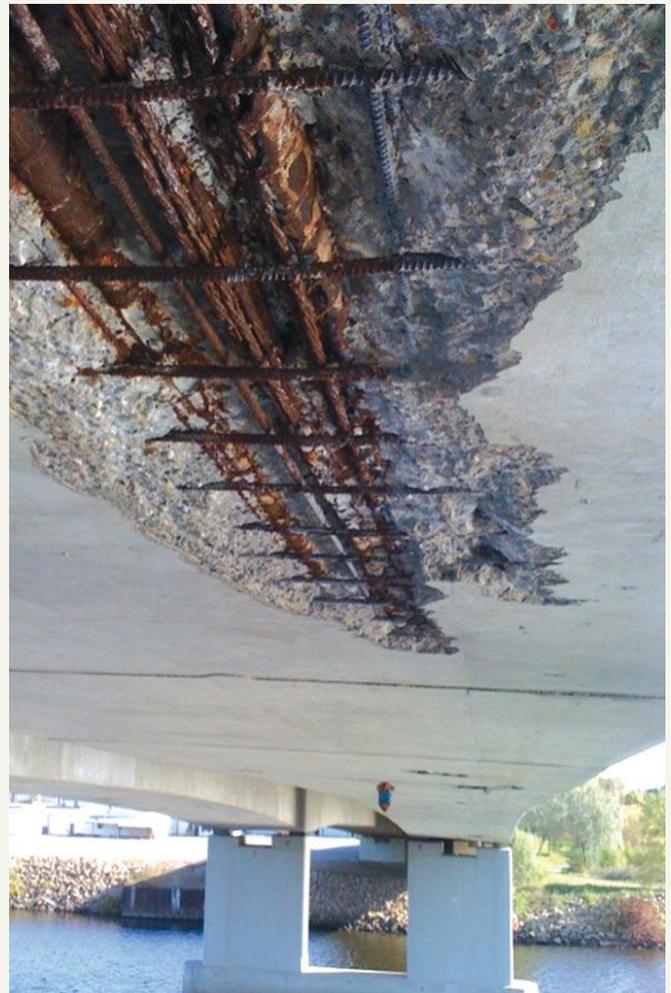
In 2010 an inspector noted light penetrating the interior box of the Plymouth Avenue Bridge in Minneapolis, Minn. The inspection findings prompted further investigation and rehabilitation plans. All Photos: Corven Engineering, a Hardesty and Hanover company.

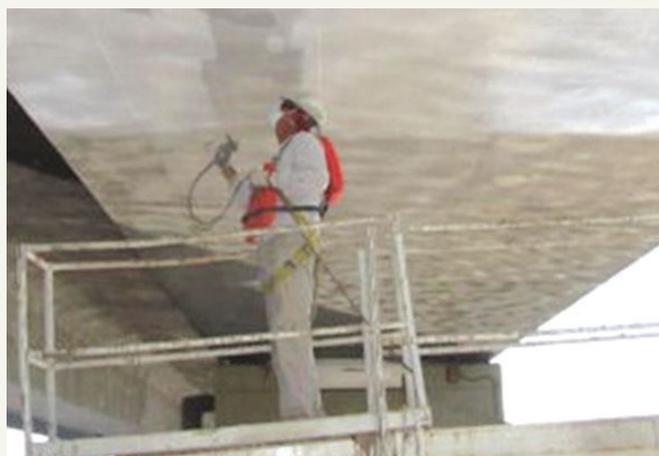
The Plymouth Avenue Bridge in Minneapolis, Minn., is coated with surface seal for enhanced protection after repairs.

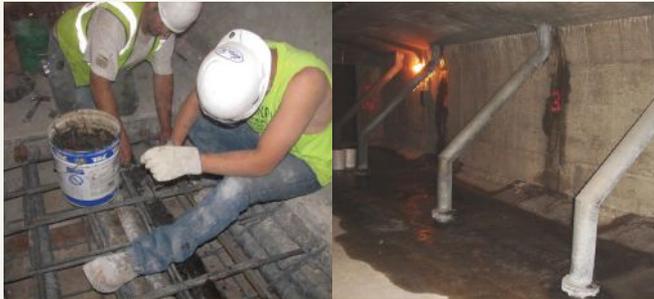
The Plymouth Avenue Bridge's failed drainage system allowed water from the deck passing through pipes in the post-tensioned box girder to be a source of moisture intrusion for many years. Remediation included tendon replacement, re-entombment of exposed tendons, repair of pour backs, crack injection, and removal of the original drainage system.
