Eliminating Bridge Joints with Link Slabs

by Raj Ailaney, Federal Highway Administration

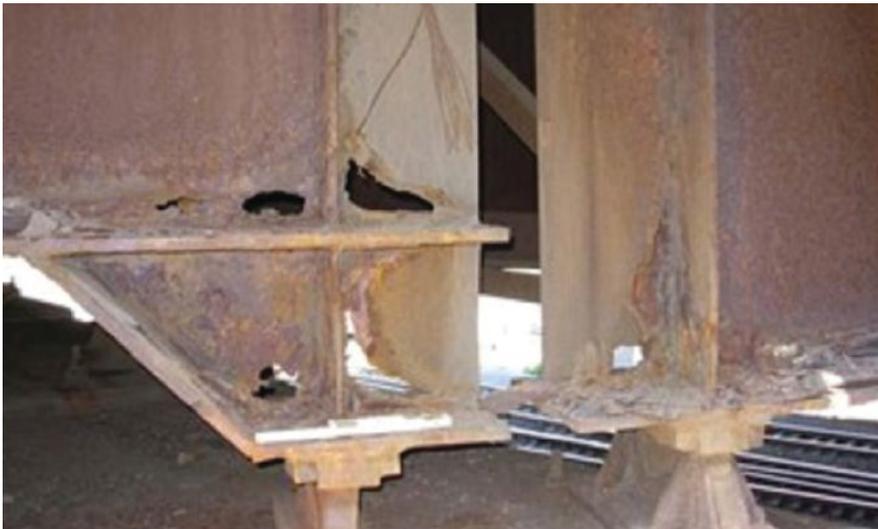
Figure 1. Leakage from failed or deteriorated bridge deck expansion joints can cause deterioration of beam ends, bearings, and substructure elements. All Photos and Figures: Federal Highway Administration.

A functional expansion joint is paramount to the longevity of a bridge. When adequately designed, correctly installed, and maintained, it allows the bridge to expand and contract as temperature changes, accommodates rotation of the beam ends, and contains surface runoff. However, bridge owners have struggled in the past to maintain expansion joints. Joint failure can cause leakage that leads to premature deterioration and failure of beam ends, bearings, and underlying substructure elements (Fig. 1, 2).

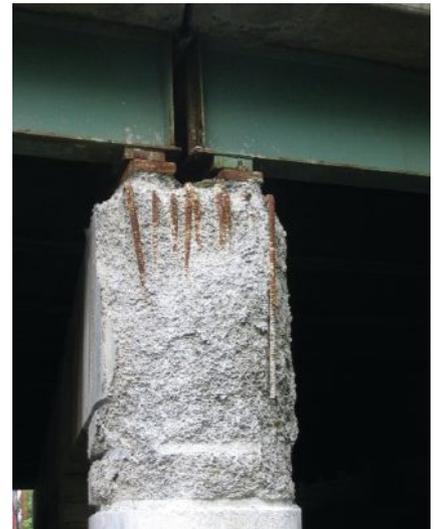
Figure 2. Chemical-laden surface runoff can accelerate substructure deterioration beneath an expansion joint.
