Pilot Project Using Electrically Isolated Tendon Post-Tensioning System and Grout Sensors

by Jordan Sessa and Dr. Zuming Xia, Structural Technologies, and Jean-Baptiste Damage and Adrian Gnagi, VSL International

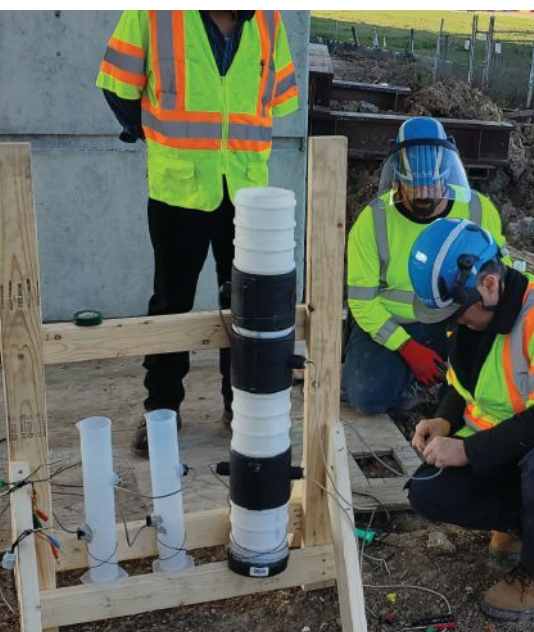
To interpret data from the proprietary grout sensors during grout placement, normal ranges for the prepackaged grout are established by mixing grout at the correct water-cement (w/c) ratio and at an excessive w/c ratio. All Photos and Figures: Structural Technologies/VSL International.

Current post-grout inspection practices include drilling into the duct and trumpet for void inspection. Proprietary sensors were incorporated into the EITs on the SH 146 project to facilitate nondestructive testing. These sensors are placed at the top and bottom of the duct and anchorage. Using software, an electrochemical measurement based on the potential/pH diagram is taken to determine whether the tendon is full of grout at the location of the sensors. Through calibration, the data collected by the sensors allow the user to distinguish between well-mixed grout, watery grout, water, or a void. The sensors provide immediate feedback during the grouting process. Should an abnormal reading be found, additional grout can be pumped into the tendon to displace the defect and completely fill the tendon with high-quality grout.

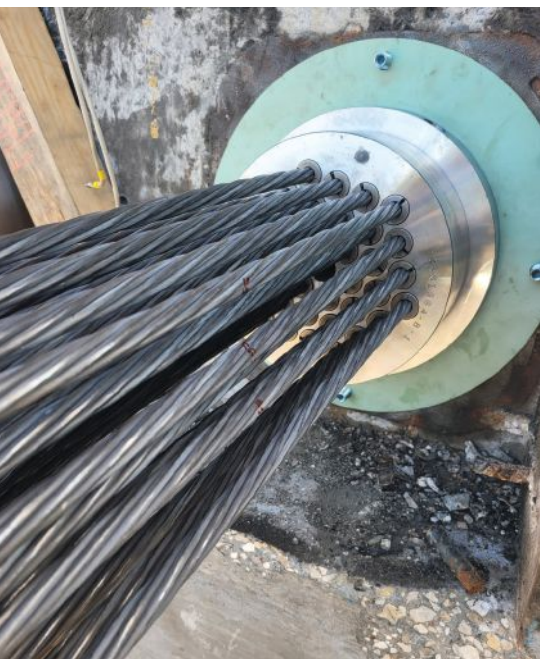
Electrically isolated tendons after tensioning. The electrical isolation plate underneath the wedge plate creates isolation between the strands and the bearing plate.

The first two items (plastic grout caps and plastic duct) are standard for PL2 tendons. The plastic trumpet must prevent contact between the strand and the bearing plate and may require some modification to existing PT system designs or an upgrade of the anchorage plate size. The plastic trumpet is the only new piece of hardware required to upgrade a PL2 tendon to PL3. Thus, existing PT systems can be upgraded to meet the PL3 requirements with only minor modifications to the existing hardware components.
