CONCRETE BRIDGE SURVIVES CRASH TO RISE AGAIN

After a backhoe ripped through the Hays, Kansas, bridge, the damaged span was repaired with cast-in-place concrete to reopen the roadway in just six months

HALL STREET BRIDGE / HAYS, KANSAS

BOX GIRDER BRIDGE/KANSAS DOT, OWNER

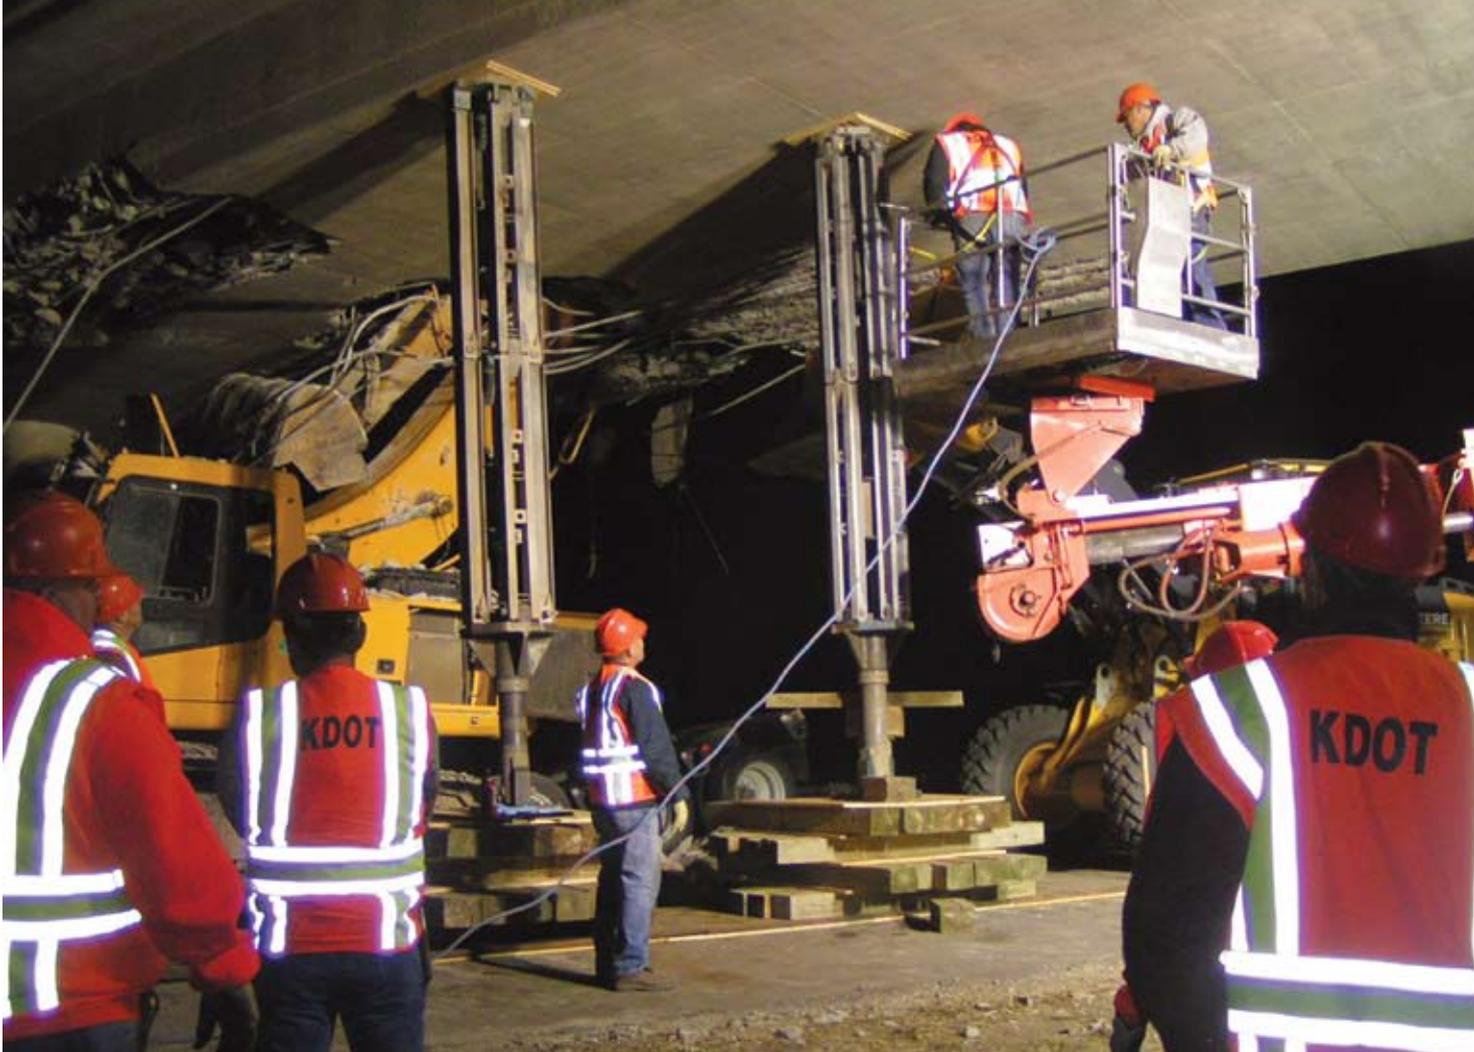
the bottom half of the east web was destroyed for a length of 12 ft," reports Burnett. "The remaining interior web was somewhat obscured by the rubble, but while it seemed to be intact, it exhibited several shear cracks."

Also destroyed were a 6 ft width of the bridge deck and the bottom slab of the box girder stretching from the west edge to the face of the remaining intact interior web. Additional damage was observed in the bottom slab along the east half of the bridge. The boom of the backhoe had caused spalling in the concrete on the bottom slab and reinforcing steel had been ripped out of the slab.

Kansas DOT crews moved quickly to prop up the damaged bridge in Hays, Kansas. The central column of the bridge, which spans I-70 near the west-central Kansas town, was undamaged by the impact with the backhoe.

piers. Within hours, KDOT supplied Super Props to stabilize the damaged bridge. The four Super Props were installed under each web to support the weight of the now almost suspended portion of the superstructure so that the backhoe could be removed.
