RAPID RISE FROM THE ASHES

GDOT's team rebuilds I-85 segment in 44 days using precast concrete bulb tees after devastating fire destroys three spans in both northbound and southbound directions

INTERSTATE 85 BRIDGE OVER PIEDMONT ROAD / ATLANTA, GEORGIA

BRIDGE DESCRIPTION: Replacement of three spans both northbound and southbound (six in all) of the 4150-ft viaduct of Interstate 85 over Piedmont Road following fire

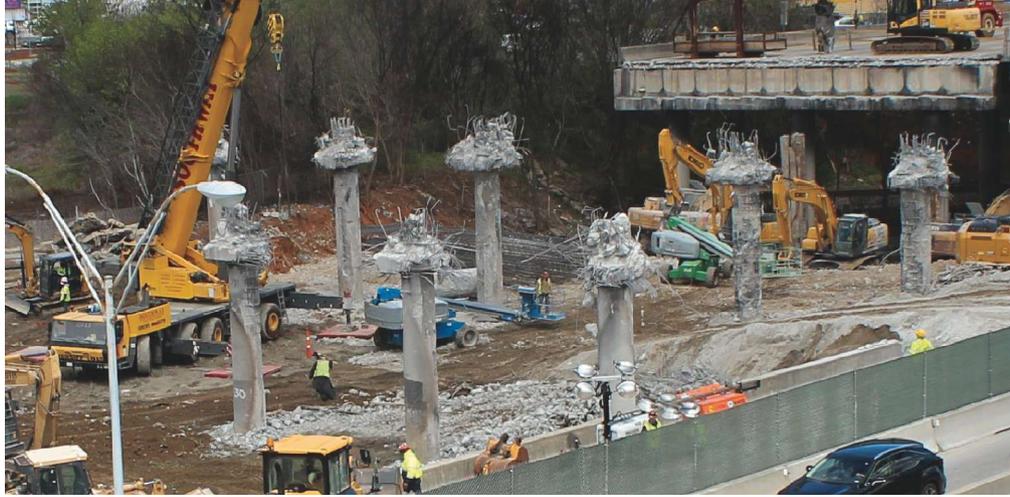
cracking of the bottom flanges of the inverted-tee bent caps. Ultimately, it was determined that three spans in each direction needed to be replaced: spans 29, 30, and 31 northbound (ranging from 76 to 92 ft) and spans 28, 29, and 30 southbound (ranging from 80 to 120 ft). Four bents also had to be replaced. They were similar in type, with round columns and inverted-tee bent caps, but the cap lengths varied due to the skew and number of beams supported.
