Protecting Against FIRE

Concrete can help bridges resist a blaze's high heat and return quickly to service

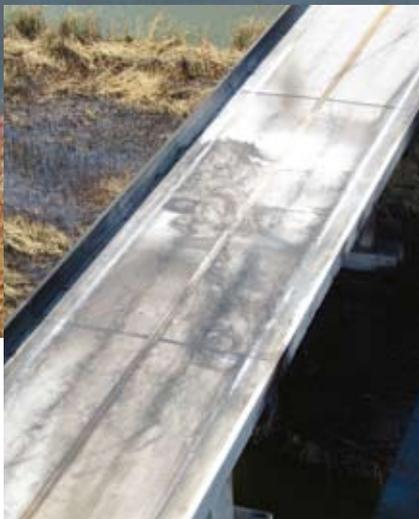
'The analysis showed that the bridge endured much heat but sustained very little damage.'

On June 20, 2007, a fuel tanker truck rear-ended a loaded dump truck on State Route 386 under the Stop Thirty Road Bridge north of Nashville, Tennessee. The tanker erupted into flames beneath the 233-ft-long structure, a two-span, two-cell, hollow box-beam bridge. Fearing damage that would interrupt traffic for

"The analysis showed that the bridge endured much heat but sustained very little damage," says Wayne Seger of the Office of Bridge Inspection and Repair at the Tennessee Department of Transportation. The affected span was 120-ft long. The bottom slabs of the hollow box-beams are 7.25-in. thick, and the sides of the box sections along with the common wall between the cells are 1-ft thick with two mats of reinforcement. Class A, 3000 psi concrete and epoxy-coated

After the bridge cooled, potential spalls were chipped off and concrete cores were cut to allow engineers at CTLGroup in Skokie, Illinois, to perform petrographic analysis. "The evaluation showed that the concrete was in good shape, so we removed the restricted load posting signs and returned the bridge to service," he says.
