The Brotherhood Bridge over the Mendenhall River

by Elmer Marx, Alaska Department of Transportation and Public Facilities

BRIDGE DESCRIPTION: Three-span, prestressed concrete decked bulb-tee girder superstructure on reinforced-concrete-filled steel pipe pile extension bents

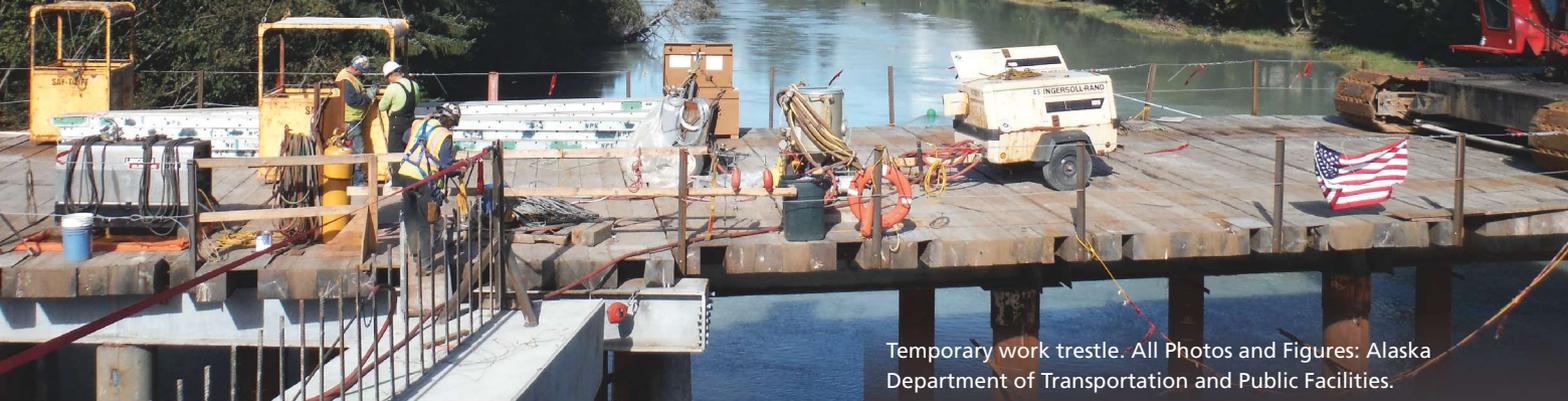
Temporary work trestle. All Photos and Figures: Alaska Department of Transportation and Public Facilities.

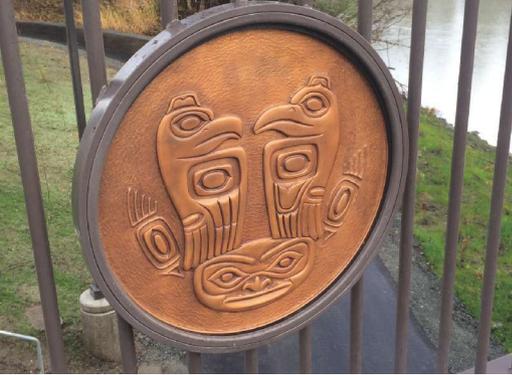
Ten bronze medallions from the 1965 bridge commemorating the 50th anniversary of the Alaska Native Brotherhood were reused in the new bridge railing. The sculptor, Roy Peratrovich Jr., was a member of the Alaska Department of Highways team that designed the 1965 structure. He was the first Alaska Native person registered as a professional civil engineer in Alaska.

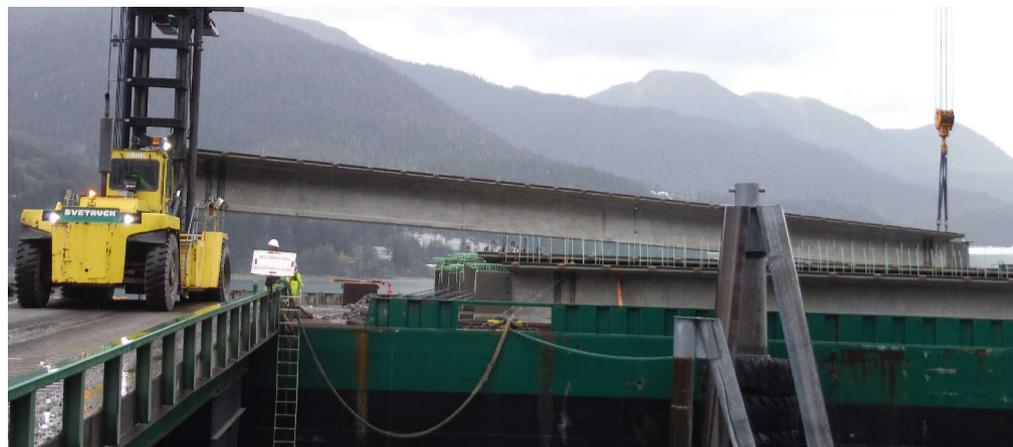
Installing the precast, prestressed concrete decked bulb-tee girders during nighttime construction. During the summer in Alaska, there is still daylight or twilight during “nighttime” construction.

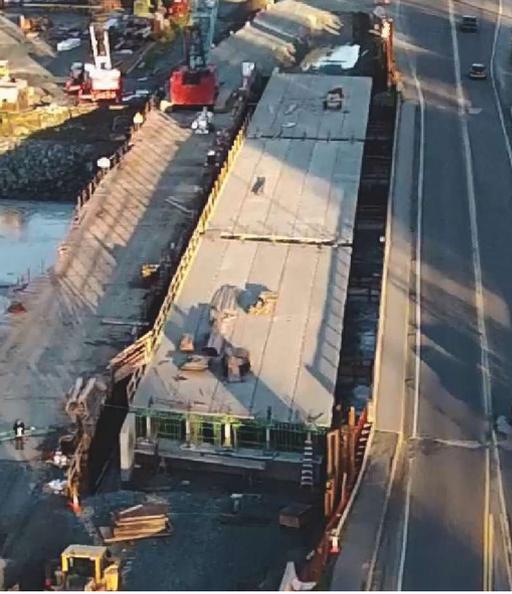
Aerial view of the bridge with the first stage of construction nearly complete; the work trestle is on the left, and the old bridge is on the right.

Because the AKDOT&PF right-of-way is relatively narrow at this crossing, staged half-width construction was selected to allow traffic during construction. About one-third of the new bridge was built upstream of the old steel girder bridge without affecting traffic. Once the first stage of construction was complete, vehicular and pedestrian traffic was routed over the new bridge. The old bridge was demolished, and the steel was sent to a recycling facility outside of Alaska. The rest of the new bridge was constructed and traffic was placed in the final configuration.

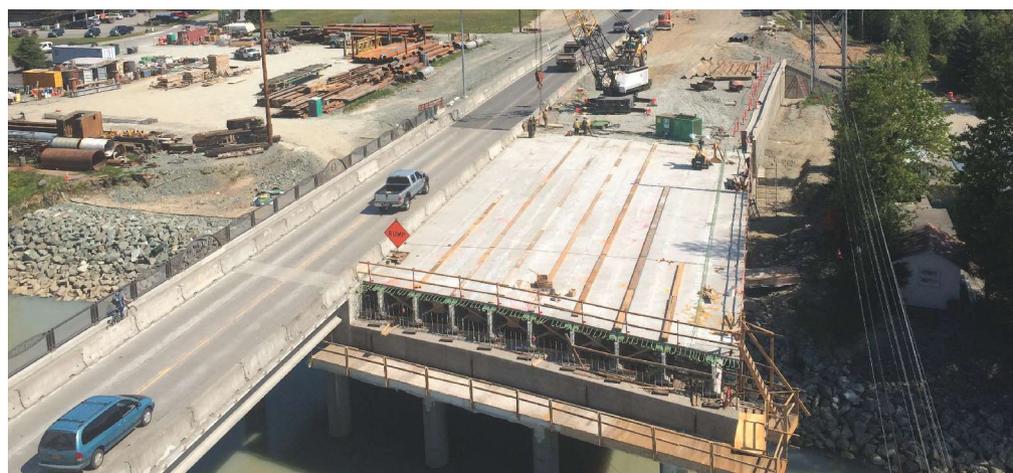
Aerial view of the bridge carrying traffic while the second stage of construction was underway.
