J-45 Galveston Causeway

Utilizing concrete to avoid corrosion issues

I-45 GALVESTON BAY CAUSEWAY BRIDGE / GALVESTON COUNTY, TEXAS

PARALLEL BRIDGES WITH PRECAST CONCRETE I-GIRDER APPROACH SPANS AND THREE-SPAN CAST-IN-PLACE SEGMENTAL BOX GIRDERS/ TEXAS DEPARTMENT OF TRANSPORTATION, OWNER

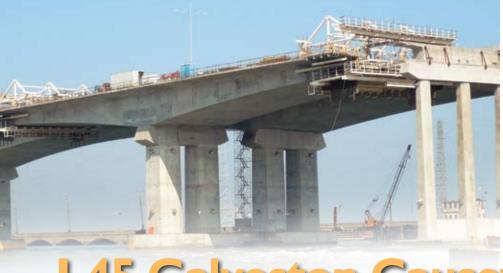
Segments were offset by one-half segment length to reduce the out-of-balance moment. Photo: Traylor Bros.

The segmental unit was designed using ADAPT-ABI software with CEB-FIP factors included for shrinkage and creep. The contract plans detailed 15-ft-long typical segments, but the contractor suggested modifying that length to 5 m (16.4 ft) to optimize the benefits of their chosen form traveler and reduce the total number of segments. A production rate of two segments a week with a pair of travelers on each pier was achieved.

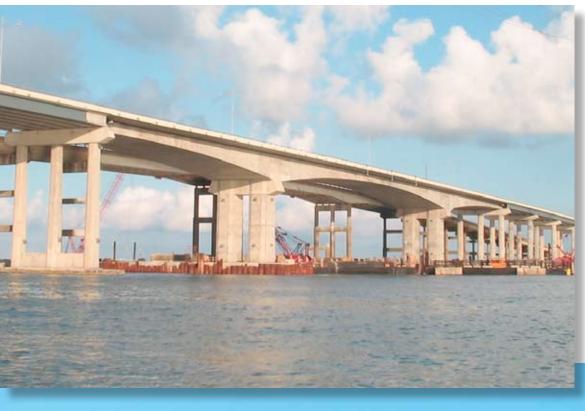
The new I-45 Galveston
Causeway Bridge over
Galveston Bay features
three main spans 740-ft
long consisting of cast-inplace concrete, doublecell, segmental box
girder units that were
con-structed using the
balanced cantilever
method.
Top left photo was
courtesy of Traylor Bros
in ASBI SEGMENTS Vol. 48.

The main section of each bridge over the GIWW features a three-span, 740-ft-long section consisting of a cast-in-place concrete, double-cell box girder varying in depth from 8 ft to 19 ft. The three spans consist of two 195-ft-long end spans and a 350-ft-long center span. Twelve segments were used in the end spans and 19 segments were used in the center span.

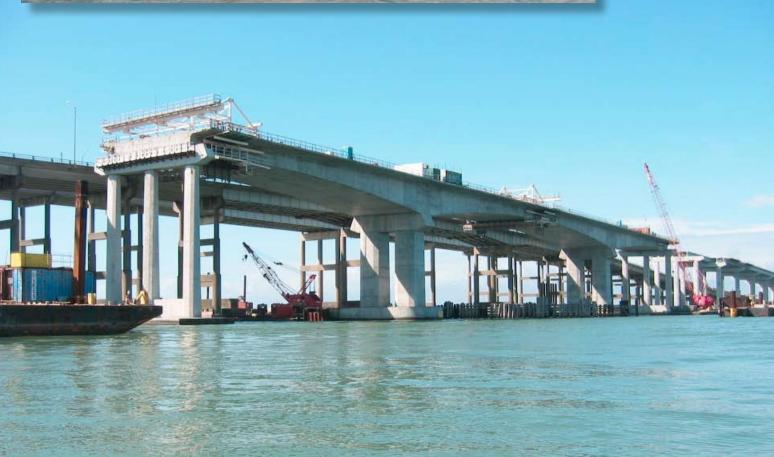
The main spans were constructed using the balanced cantilever segmental method.

The bridges were constructed using the balanced cantilever method. The design provided minimum vertical clearance of 73 ft at the edges of the 125-ft-wide navigational channel limits, and 310 ft horizontal clearance to the face of the pier bulkheads. The goal was to open the horizontal clearance as much as possible within the limits available.

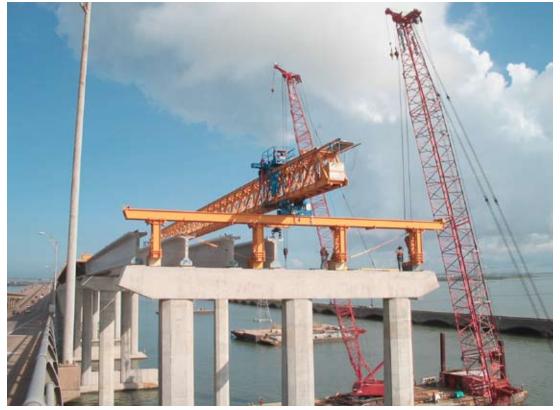
In areas where precast girders were erected from the temporary trestle bridge, a hydraulic girder erection truss was used to distribute girders laterally on the piers to compensate for the crane's limited reach.

Even with the trestle bridge, the reach of the crane was limited to setting only three of the eight 155,000 lb girders in a span. For these spans, a hydraulic erection truss was used to distribute the girders on the piers beyond the reach of the crane.

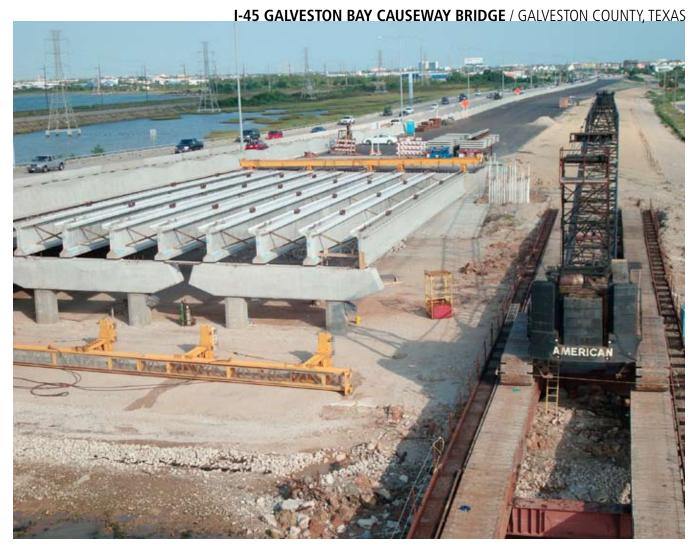
The construction was accomplished in three phases, to maintain existing traffic.

Construction was accomplished in three phases, to continuously maintain three lanes of traffic in each direction during the project. In the first phase, the northbound bridge was constructed, erecting the concrete approach spans north and south of the GIWW and the navigation span concurrently. Once this bridge was completed, both northbound and southbound traffic was relocated to the new structure and the existing bridges were demolished. In the third phase, the second structure was erected directly adjacent to the first.
