# PIONEER CROSSING

## A diverging diamond interchange on the move

### PIONEER CROSSING INTERCHANGE BRIDGES, I-15 TO REDWOOD ROAD / AMERICAN FORK, UTAH

TWO PRECAST, PRESTRESSED CONCRETE BULB-TEE GIRDER BRIDGES BUILT WITH CAST-IN-PLACE CONCRETE DECKS IN STAGING AREAS AND MOVED WITH HEAVY LIFTING EQUIPMENT INTO PLACE / UTAH DEPARTMENT OF TRANSPORTATION, OWNER

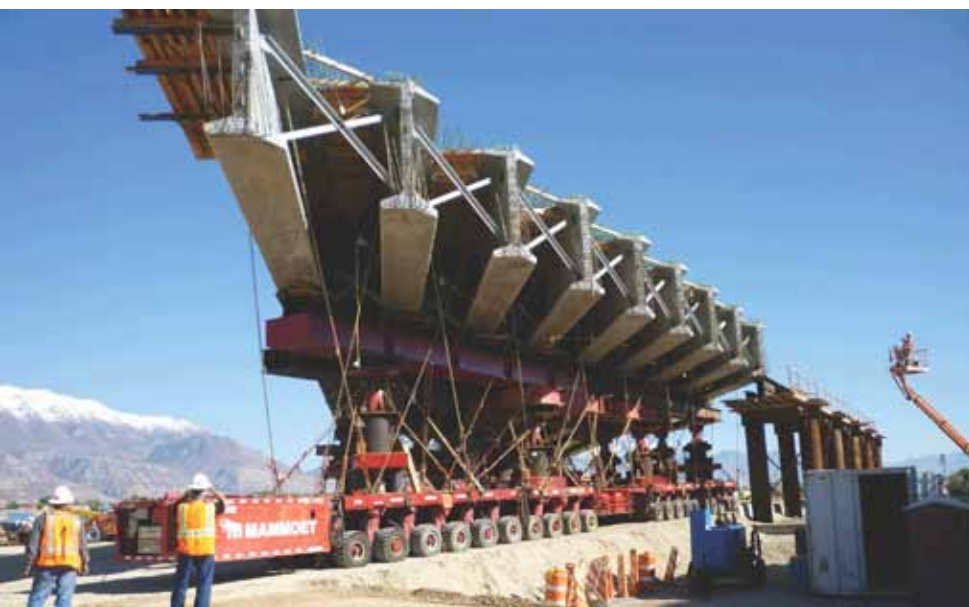
SPMTs were placed at approximately the twentieth points from the ends of the spans.

engaged to finalize the location of the SPMTs. The permanent abutments were supported on pipe pile foundations that were enclosed with two-stage mechanically stabilized earth (MSE) walls. Due to this configuration at the abutments, it was necessary to locate the SPMTs at approximately the twentieth points of the spans. This avoided conflicts between the SPMTs and the abutment walls.

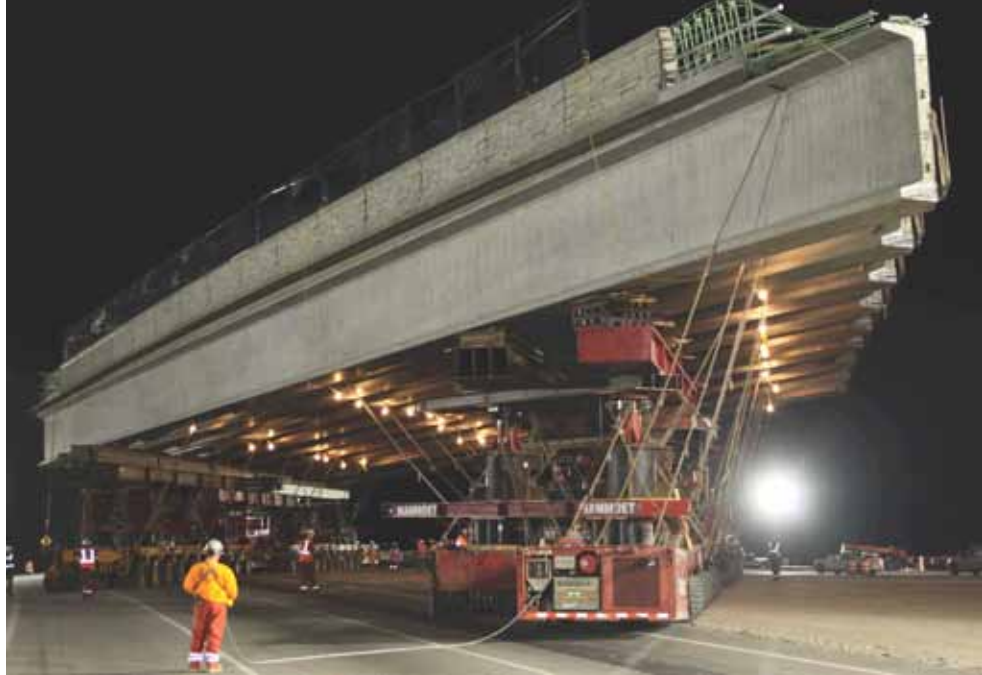
Bridge span on the move during 8-hour road closure.

The SPMTs' hydraulic systems were controlled to provide four-point support for each span. Strict monitoring of the superstructure was required to prevent excessive torsion. A simplified string line system was adapted from the UDOT *SPMT Manual* to monitor twisting during transport. This consisted of a base string line set along one diagonal of the bridge at a constant offset from the top of the deck. A dual string was mounted along the opposite diagonal. At one end of the dual diagonal, both strings were set at the same constant offset from the top of the deck. At the opposite end, one string was set at the constant offset plus the twist allowance dimension and the other was set at the constant offset minus the twist allowance dimension. The result was the ability to visually monitor the twist in the center where the strings crossed. The string lines were monitored during transport by personnel on the span and adjustments were made hydraulically to the supports as the move progressed. This resulted in a very efficient and simple method to control twisting.

The spans of the westbound bridge were placed on the weekend of October 16, 2009, and the spans of the eastbound bridge were placed on the weekend of June 4, 2010. Each individual span was placed in a single 8-hour traffic closure. This greatly minimized impacts to the traveling public and supported UDOT's Accelerated Bridge Construction goals. Pioneer Crossing was opened to traffic on August 23, 2010, and the DDI became just the third such interchange opened to traffic in the United States.

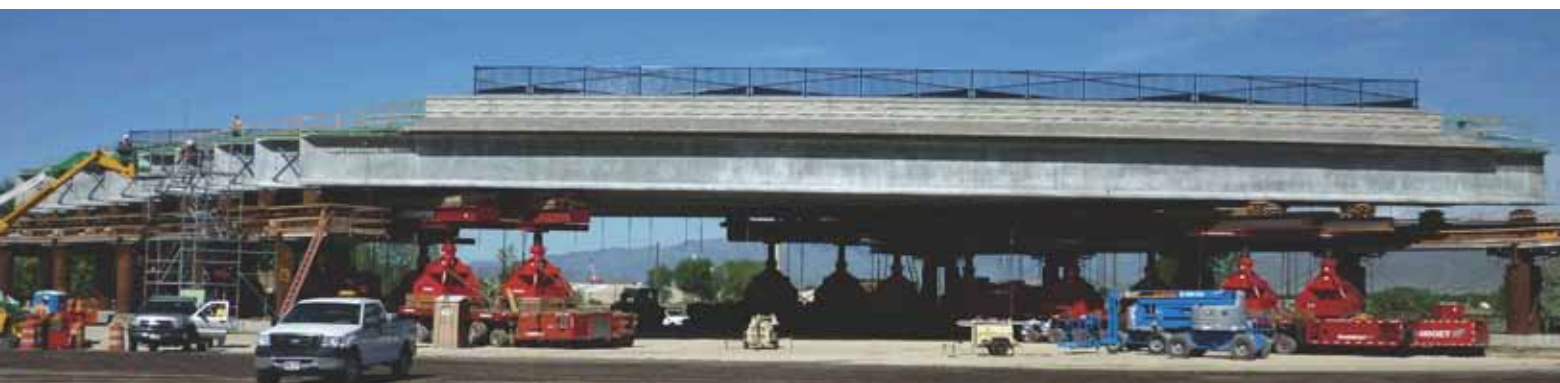
A finished single bridge span in the bridge staging area prior to transport to the final location with SPMTs.
