PROJECT / CRAIG CREEK BRIDGE

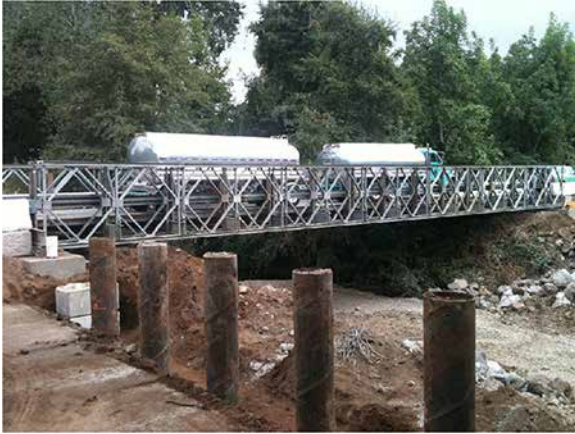
Pre-driven, cast-in-steel-shell concrete piles excavated after old bridge demolished. Traffic diversion took place on a rented bridge. All photos: Caltrans.

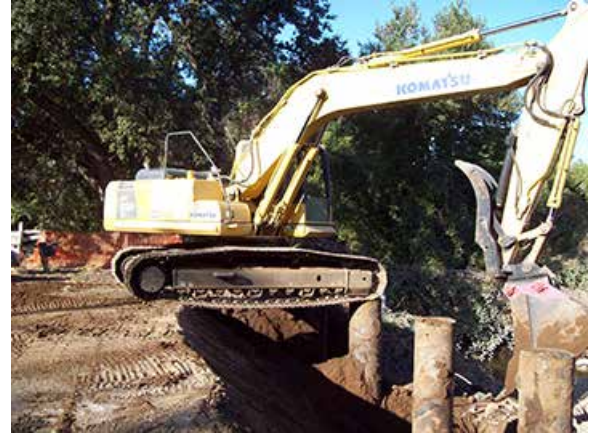
Cast-in-steel-shell concrete piles were ordered 9-ft longer and driven out of sequence to reduce impacts. They were excavated after traffic was detoured.

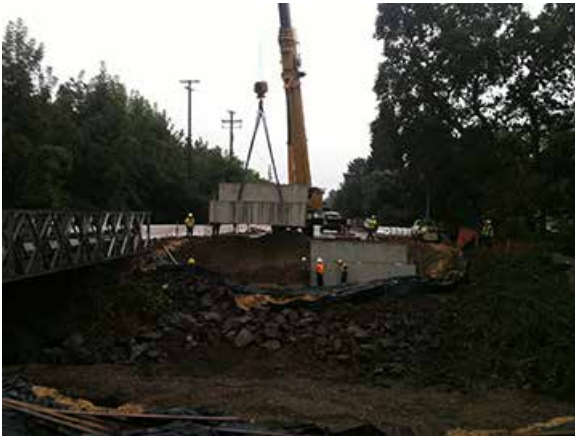
Precast concrete abutments were placed in single stage; no roadway shoring was required due to the value engineering cost-reducing proposal from the contractor.

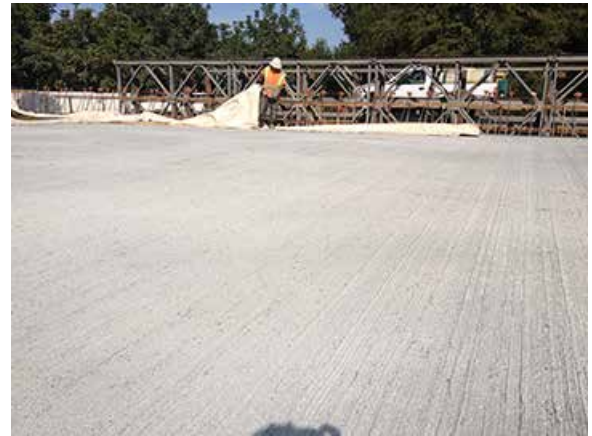
The high-performance concrete deck was cured using pigmented Type 2 compound and water.

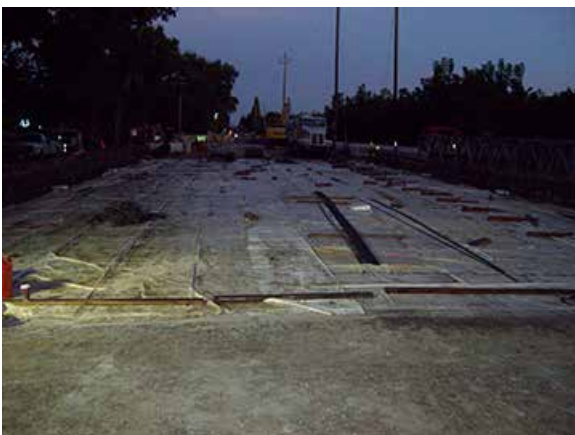
The high-performance concrete deck was water cured for three days – two-day strength was 3.2 ksi.

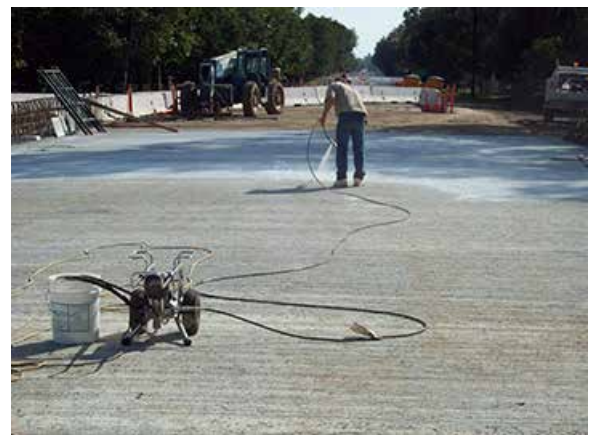
On the third day, the water cure was stopped, a heavy application of compound was applied, and traffic started to use the bridge.

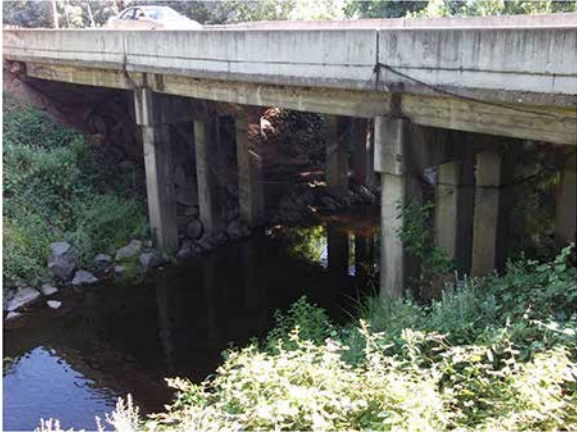
The old three-span Craig Creek Bridge that was replaced.
