Twyckenham Drive over St. Joseph River, South Bend, Ind.

by **Leslie Benson, American Structurepoint**

Getting Connected: Dearborn Island Bridge

Salvaged beams reused to link island to mainland

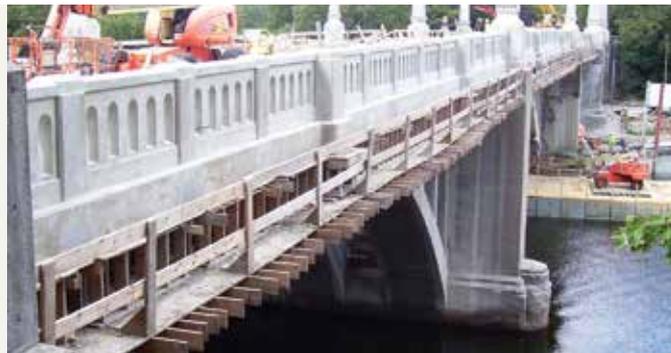
The spandrel arch bridge was restored to its original appearance using modern materials. Photo: American Structurepoint.

tems are intended to keep roadway salts away from the concrete, increasing the bridge's service life. To protect the bridge from future deterioration, zinc galvanic protection was placed at the interface of the new and original concrete throughout the bridge.

Additional structural improvements for the deteriorating bridge included repair of concrete elements and replacement of non-original aluminum railings with concrete ones that closely resemble the original. While some key portions of the bridge had to be replaced, one of the project's goals was retaining as much of the existing structure as possible in order to retain the aesthetically pleasing look of the historic bridge. This also resulted in a savings of time and money for the county.

The design scope also addressed removing and replacing all transverse beams and spandrel columns under the existing expansion joints, as roadway salts had saturated these. In addition, the existing concrete deck and sidewalk were removed and replaced with concrete deck panels, a 6-in.-thick concrete sidewalk, and a 12-in.-thick concrete curb. A coating was applied to all concrete sections of the bridge.

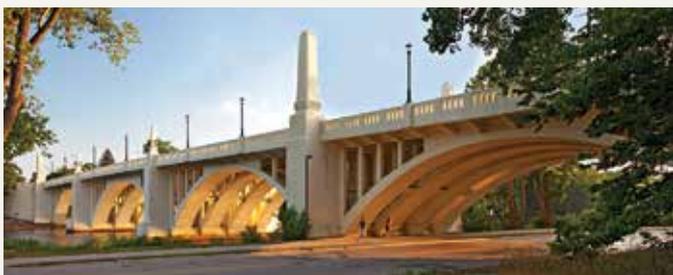
The concrete open spandrel arches of the Twyckenham Drive Bridge. Photo: Susan Fleck Photography.

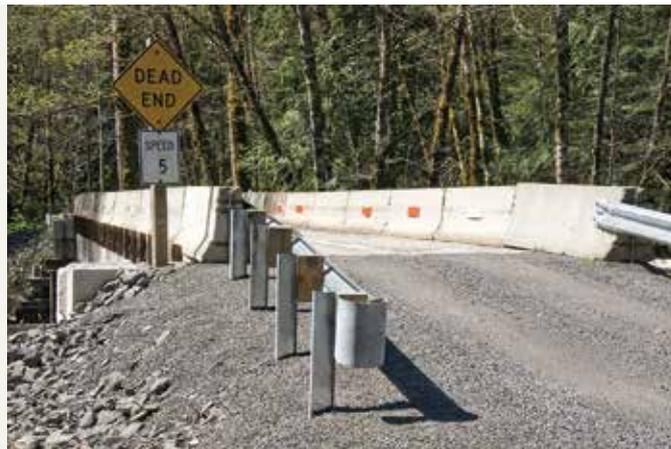
With the new bridge in place, larger vehicles such as delivery trucks and emergency equipment can directly serve the island’s 14 residences.

“The original bridge was 125 ft long,” said Harley. “We shortened the new bridge span length so that the 115-ft-long beams from the Willamette River Bridge’s temporary structure would fit perfectly and not need to be reshaped.”

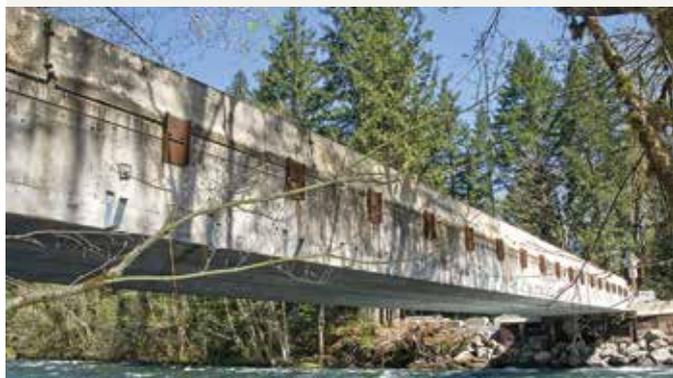
Four 115-ft-long beams from a temporary freeway detour bridge were salvaged to replace a severely load-limited bridge over Oregon’s McKenzie River. All photos: Oregon Department of Transportation.

OBEC has designed customized bridge abutments to accommodate salvaged beams for other agencies in Oregon, including Lincoln, Jackson, and Lane counties. The project team replaced the bridge in one week, limiting inconvenience to the island’s residents. Because of the salvaged beams, the new bridge will safely and economically carry traffic for at least a half century.
