RIEGO ROAD OVERCROSSING

Lessons learned on challenging bridge project north of Sacramento

by Sue Hida, California Department of Transportation

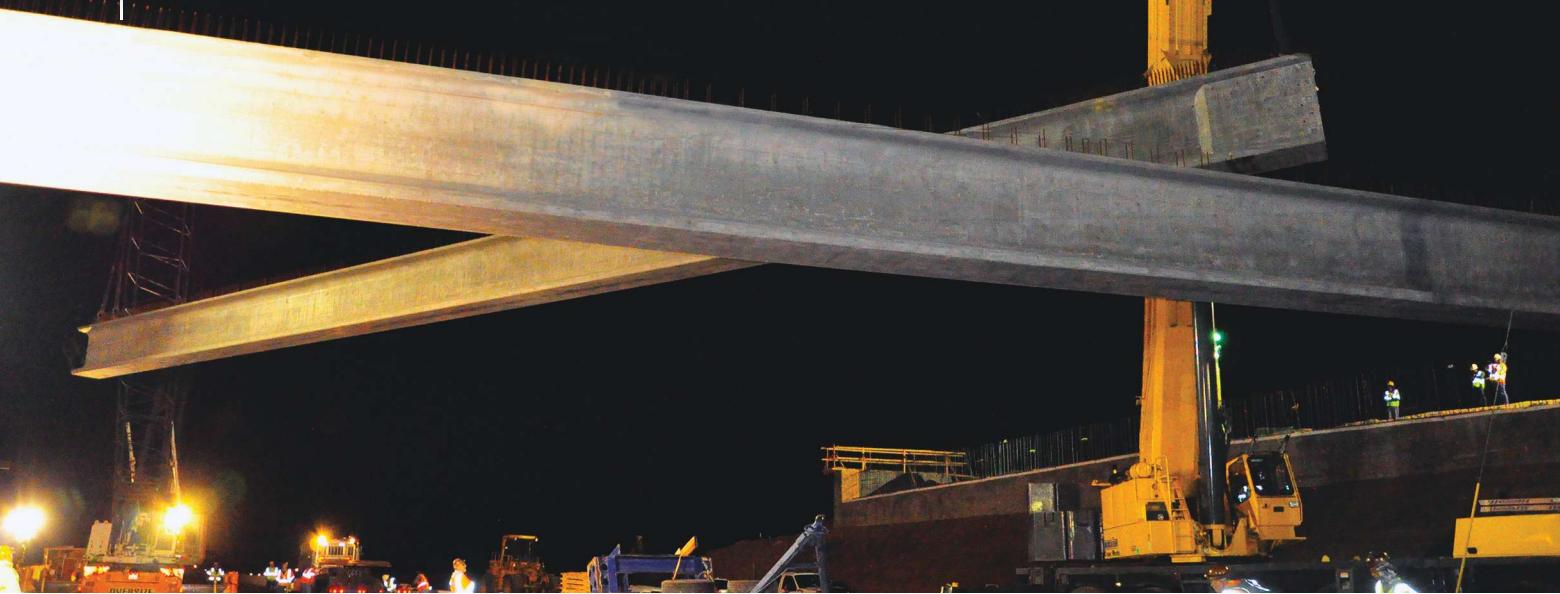
Positioning of the second wide-flange precast concrete girder for placement at the Riego Road Overcrossing. Photo: Brandi Matteoni.

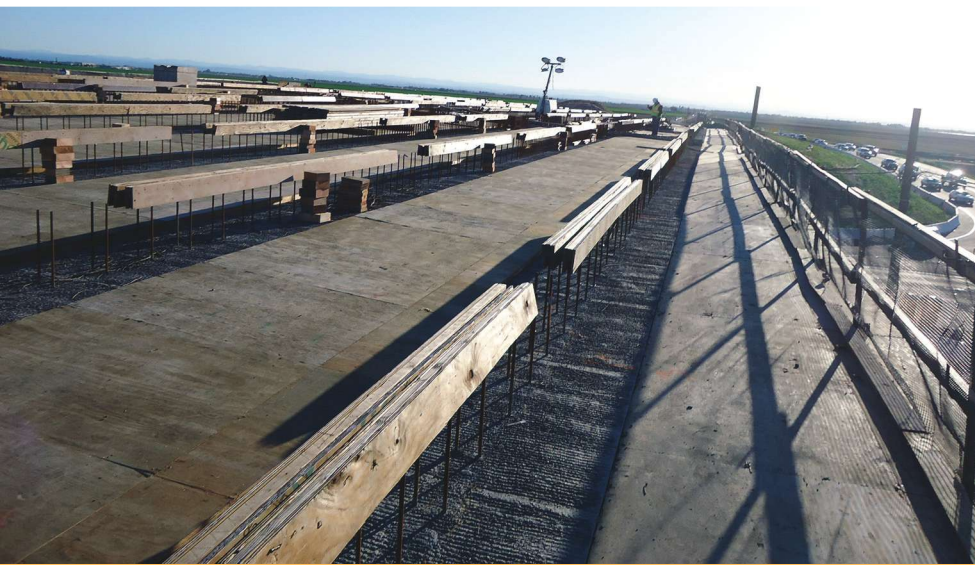
Removable formwork was used for the cast-in-place deck. Photo: Brent Bullard.

deck and bending it in the field. For Riego Road Overcrossing, which uses 11-ft 3-in. girder spacing, Caltrans requires an 8.25 in. deck thickness, and No. 5 transverse top and bottom deck reinforcement alternating every 2.75 in. for an overall spacing of 5.5 in. The standard design is controlled by serviceability.

In the longitudinal direction, No. 4 bars at 18-in. spacing support the top transverse reinforcement; alternating No. 5 and No. 4 bars are provided below and above the bottom transverse reinforcement. At the bent cap, an additional eight 60-ft-long No. 10 reinforcing bars are placed in the deck over each girder. These bars further enhance the bent cap joint performance during a seismic event and help resist negative bending due to long permit vehicles with multiple axles. The climate is temperate and conventional 60 ksi, ASTM A706 reinforcing steel is used in the 5 ksi concrete deck.

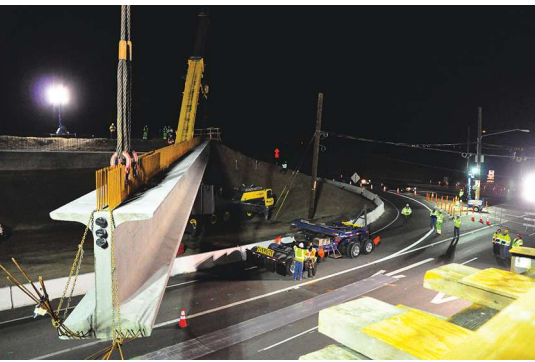
Setting the first of 14 California wide-flanged girders into the second span. Extensive shear reinforcement is required for the girder-slab connection adjacent to the bent cap so that the integral bent cap behaves as desired during a seismic event. Photo: Brandi Matteoni.

Top and bottom longitudinal bars of the integral bent cap consist of bundled No. 11 bars. Extensive joint shear reinforcement is required in accordance with both the *Caltrans Seismic Design Criteria v1.4* and the *AASHTO Seismic Design of Highway Bridges Guide Specifications*. After concrete placement, a minimum strength of 3.5 ksi is required prior to the first stage of post-tensioning. After the first stage of post-tensioning, the falsework towers were removed and formwork was placed for the deck.
