Precast Replaces Historic Bridge in Glacier National Park

by Linda Josephson, Oldcastle Precast Inc.

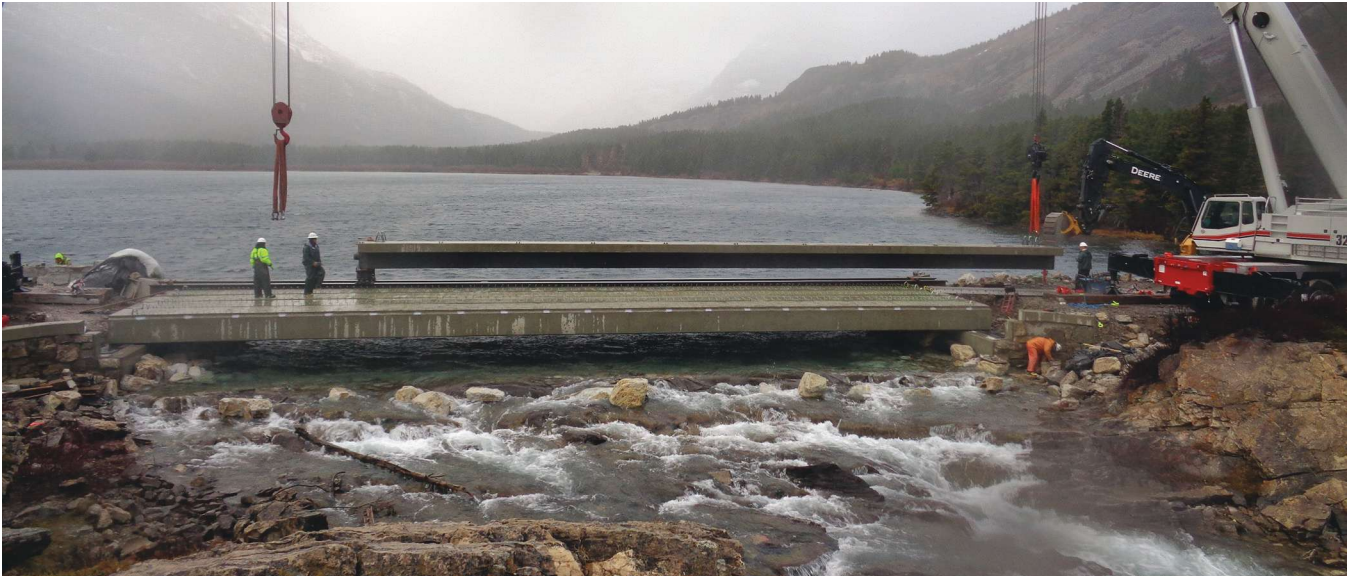
New bridge being installed. Photo: Sam Barchus, Northbank Civil & Marine.

The precast concrete deck consists of six voided slabs that are 85 ft long and 30 in. deep with a 12-in.-deep overhanging sidewalk on one side and a 12-in.-deep overhanging bridle path on the other. These exterior slabs are colored black, so with the overhanging portions it gives the appearance of a slimmer slab than it is, mimicking the 12 in. depth of the old bridge. Five of the voids have 8-in.-diameter pipe within them for utility runs.

of two 30-ft 8-in.-long pile caps with curved wing walls. The pile caps are installed just outside the old abutment locations resulting in slightly expanded clearance. Interior piers were eliminated. Otherwise, the new bridge matches the width and location of the old.

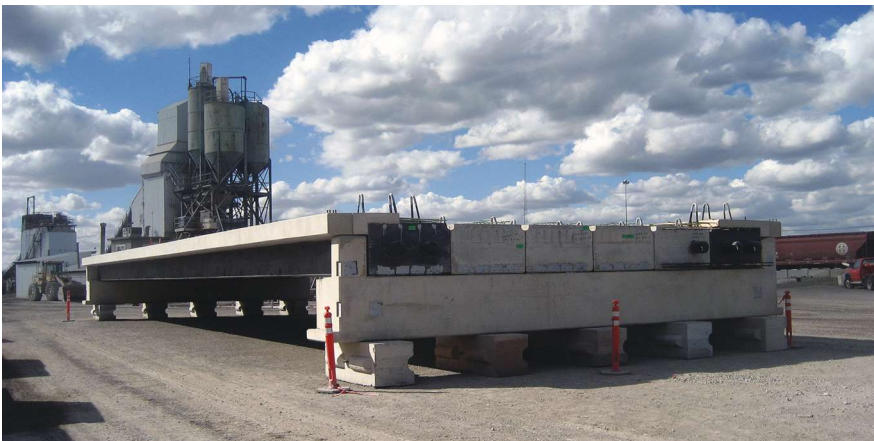
Trial fit in precast yard. Photo: Linda Josephson, Oldcastle Precast Inc.

The bridge replacement occurred between the close of the hotel in September and the onset of impending winter weather in the park at an elevation of 4800 ft. To minimize field time to erect, (in addition to precasting the overhangs) pile caps and slabs were trial-erected in the precast yard to ensure fit and identify any issues to be mitigated in the plant. Additionally, wing walls were welded to the pile caps before shipment. Even with some delays drilling for the pilings, relatively mild weather allowed the deck delivery to proceed. Driving rain and 55 mph winds at the site made difficult conditions when the trucks arrived. Mercifully, the weather calmed down in a few hours and all pieces were set. The end result is a handsome bridge in a spectacular setting. **A**
