US 131 over Muskegon River

Harped external post-tensioning used to strengthen, rehabilitate bridge

by Corey E. Rogers, Michigan Department of Transportation

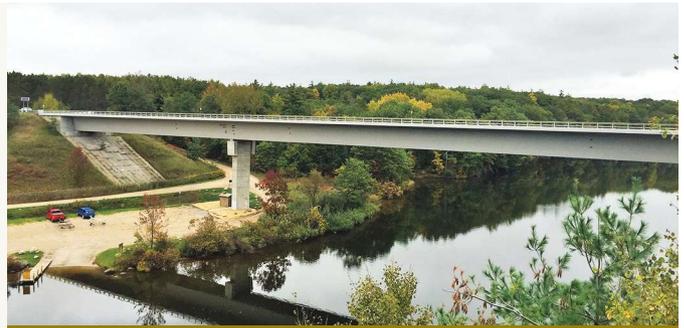
Northbound US 131 over Muskegon River bridge after project completion. Photo: Michigan Department of Transportation.
