Baby It's Cold Outside (for Your Concrete Bridge)

by Dr. Kyle A. Riding,
University of Florida

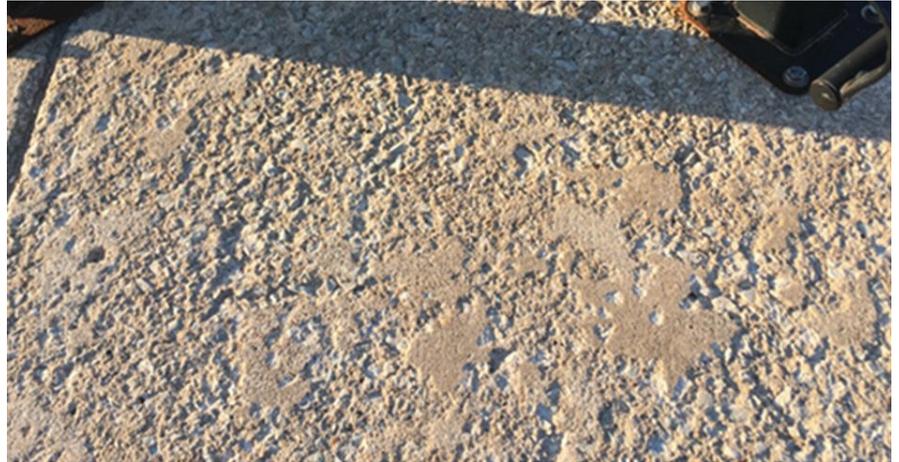
Figure 1. Concrete surface with severe salt scaling caused by use of deicers. All Figures and Photos: Kyle A. Riding.

Deicing salt scaling causes progressive flaking of the concrete surface, leading to a rough ride. Mild salt scaling can resemble an exposed aggregate finish, whereas more severe scaling such as that shown in **Fig. 1** can be more problematic for bridge durability. Saltwater can pond in the scaled areas, leading to further scaling damage and increased chloride penetration. Deicing salt scaling can occur on bridge decks, vertical surfaces of parapet walls or columns where water with deicing chemicals is splashed, or on bent caps below leaky joints. Like sodium chloride and calcium chloride deicers, magnesium chloride deicers can contribute to deicing salt scaling. Magnesium chloride salts also react chemically with the glue holding the

Salt scaling occurs in bridges where the concrete near the surface has low strength or a bad air-void system. Air entrainment should be used and measured during construction. Low water–cementitious material ratios (w/cm) below 0.45, curing with either curing compound or extended wet curing, and good finishing practices have been shown to improve salt scaling resistance by improving the concrete surface strength.^{1–4} Retempering concrete by adding water on the jobsite has been associated with some cases of salt scaling damage and should be avoided.⁵ There has been a concern that high dosages of supplementary cementitious materials (SCMs) increase salt scaling damage; however, field studies have shown that concrete containing SCMs can do well in the field if it is well cured and not overworked during finishing, and not finished while there is still bleed water on the surface.^{3,4} Machine-finished concrete tends to do better than hand finished concrete because more-aggressive finishing with multiple passes with a float, which often occurs with hand finishing, tends to coalesce air bubbles at the surface, causing a bad air-void system.⁴

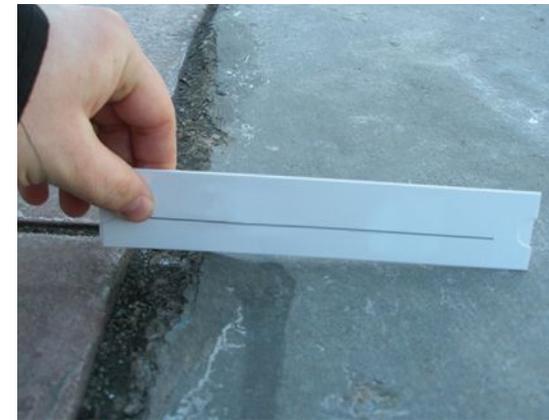
Figure 2. A concrete joint in the early stages of joint deterioration. A straight edge is used to show the expansion in the concrete near the joint caused by calcium oxychloride formation.

concrete pavements in cold regions of the United States; see **Fig. 2** for an example of a joint in the early stages of deterioration. Calcium oxychloride forms when chlorides from deicing salts react chemically with calcium hydroxide and water, which can result in large expansion, cracking, and deterioration.⁶ Calcium oxychloride formation increases with salt concentration and as the temperature drops below 40°F.⁷ Calcium chloride deicing salts are the most destructive, followed by magnesium chloride salts, with sodium chloride showing only a mild risk.⁶ Many salt suppliers use impure salts or add calcium chloride or magnesium chloride to salt to lower the ice melting temperature below that of sodium chloride.⁸

Instances of joint deterioration have significantly increased in the past 15 years because agencies have started to apply concentrated liquid salt brines before storms as an anti-icing treatment, which allows the dry concrete to absorb the saltwater. Joints, areas near drains, and the cold joint between the parapet wall and the deck are especially vulnerable to problems because saltwater can pond in these locations and concentrate when the water evaporates. Salts that penetrate the concrete are also hygroscopic (that is, they tend to absorb moisture from their surroundings), which causes the joints to dry at a much slower rate. Because concrete cold-weather related deterioration involves moisture, these locations that stay wet longer experience more deterioration than areas that dry faster.

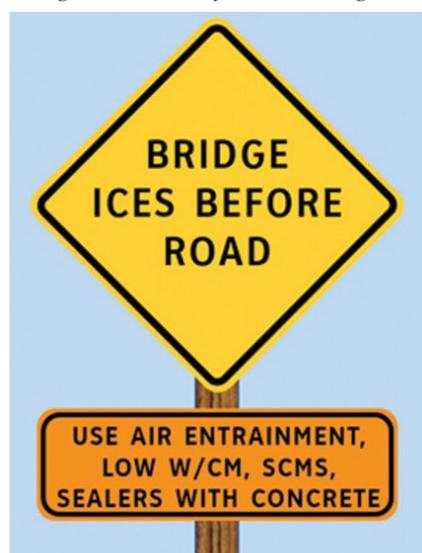
Figure 3. Proposed signage during concrete bridge construction. When proper materials are used along with proper construction practices, damage caused by freezing and thawing, salt scaling, and calcium oxychloride is mitigated.

Concrete bridges in cold climates can be very resistant to damage caused by freezing and thawing, salt scaling, and calcium oxychloride formation when proper materials are used along with proper construction and maintenance practices. Recommended construction practices include avoiding retempering or overfinishing the concrete, as well as using air entrainment, a w/cm below 0.45, SCMs to reduce permeability and calcium hydroxide content in concrete, and sealers in areas of concern like joints and around drains. To remind everyone involved in bridge construction about material needs and practices to prevent damage, I think we should consider installing signs that state “Bridge ices before road,” when construction projects begin, instead of at completion, and we should add the new sign proposed in **Fig. 3**.
